SEWAGE DISPOSAL SYSTEM

A REPAIR

ADDRESS 26108 Mullinix Mill Road, Mt. Airy. 21771 PHONE (301)253-5254

REPAIR - PURPOSE - SEPTIC SYSTEM HAD FAILED

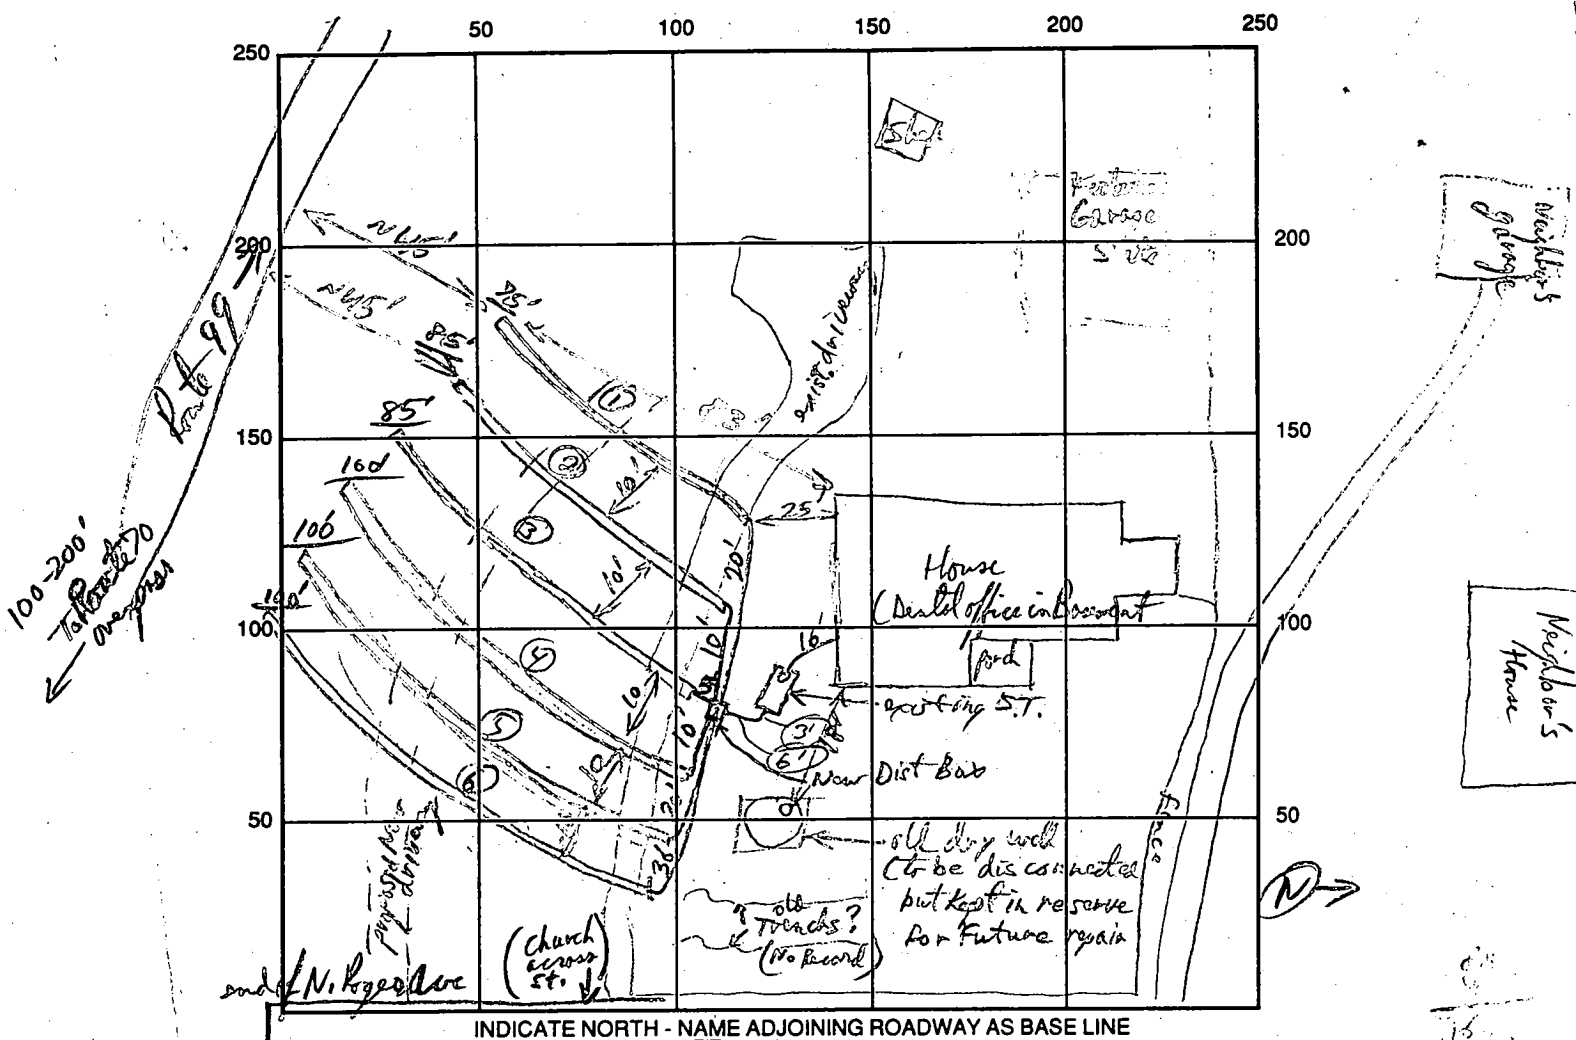
Note: Main house is gravity fed to S.T., basement feeds via pump to S.T.

DISTRIBUTION BOX LEVEL Used Dial-a-Flow's

REMARKS: Existing Dry well full - water level is 12" above dry lid - also seen wet spots ^{surface} on ground about 20-25 ft from D.W. Cleanout. Probed of clean. Noted CL to 4ft in To 3 under old driveway. Trenches 4, 5 & 6 will have to be shallow trench design. Trenches 1 & 2 OK to cover, Trench #3 OK to spread fill spread fill (Gravel depth is about 18" cover over drain pipe where future driveway is to go, using probed 2500 lb gravel PVC) OK to gravel fill last trench, OK to cover system when last trench complete. RVP 5/10/96

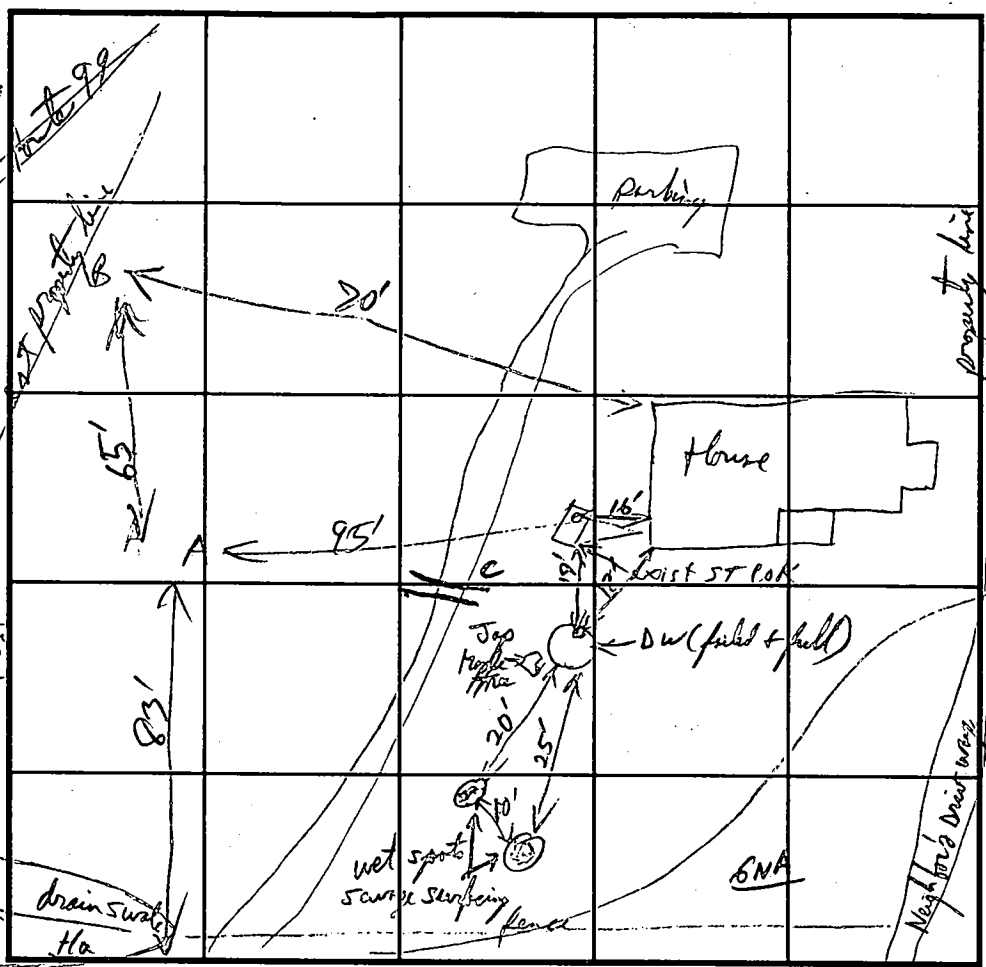
SOIL PROFILE
0' (M) (low) A
Mix of orange HL and orange SL
2 1/2 - 3
Mix Color mica loam
C30
and black bit (3-8')
Neutral mica loam
5
gray ESL
7
8
9
gray + gray brn mica PSL
Rocky bottom
Water level

B
Reddish yel - yel red mica SiCL - HL
drains water Ha
Middle mica loam
N Poplar Ave
8 1/2' gray brn + gray mica PSL
12' water seepage
14' water level

DATE	TEST NO.	DEPTH	PRE-WET		TEST - 1" DROP		TIME
			START	STOP	START	STOP	
5/9/96	A	19'	Wet Test OK soils below 2 1/2 - 3 ft, mica loam below 4 ft				
	B	14'	begin for water table OK loams between 3 and 5 ft (HSL loam at 3-5)				300 225 525
	C	(Fyio)	(water level) at 13 1/2'				
			section of Trench #3 under original driveway, as noted				
			Failed Drywell had a gray SiCL horizon with mottled boundaries typical of Glenville Soils.

REMARKS Limited depth at different elevations to water tables - split system design
TYPE OF SOIL Ch B₂, 6L B₂, (G₁ A, H₁) cherty, blends on high side, Glenville Harbor and outside
TESTED BY R. Kelly ALSO PRESENT owner, City & State Contractors
TRENCH DESIGN DATA: AVERAGE PERCOLATION TIME at 5-10 min in 600 mm - SL TRENCH WIDTH
INLET DEPTH MAXIMUM BOTTOM DEPTH SQ. FT./BEDROOM
split trench design - all Septic 3 legs in basement

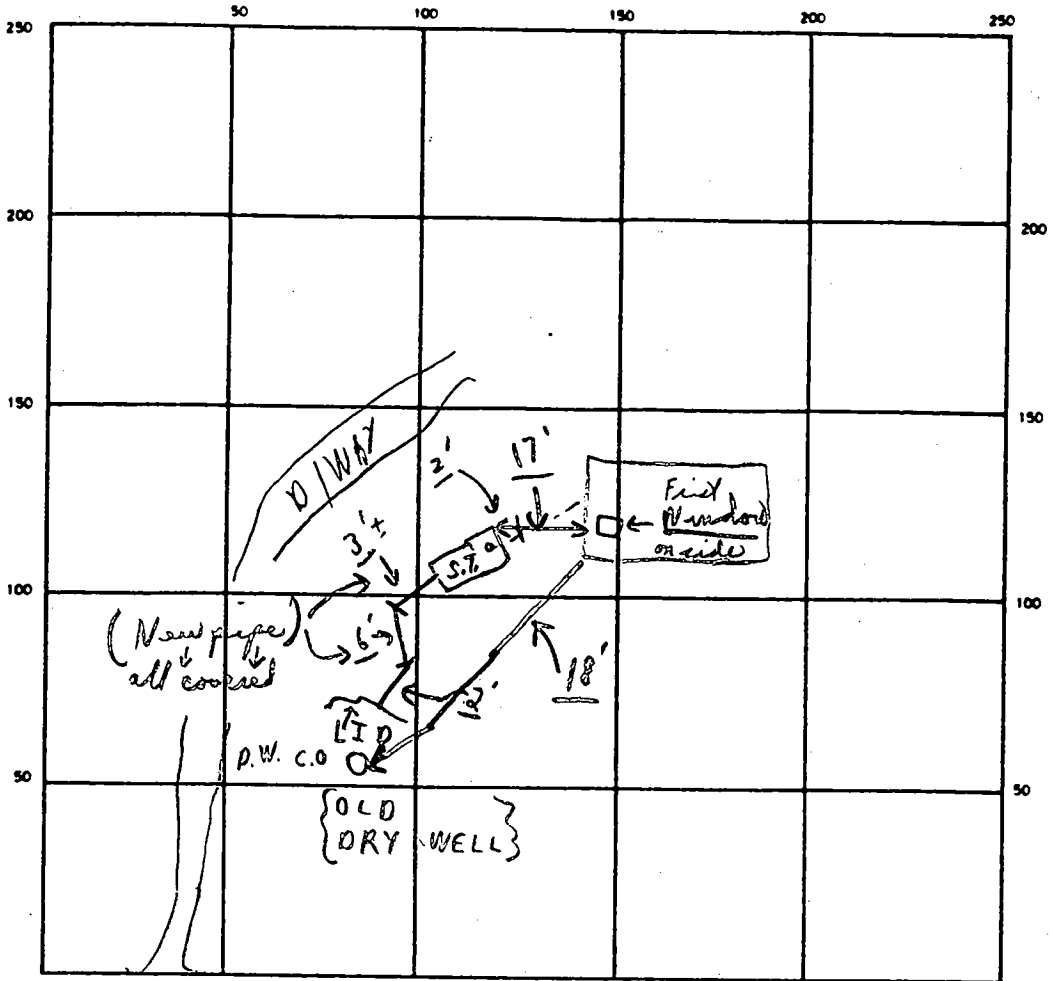
SEPTIC TANK LEVEL OK CLEANOUTS New S.T. OK

REMARKS 4/3/90 OK TO COVER ALL WORK, FINAL (1 New septic tank installed) C.B.D.
