PERMIT

SEWAGE DISPOSAL SYSTEM

HOWARD COUNTY HEALTH DEPARTMENT

PROPERTY OWNER PHILIP QUARRIER

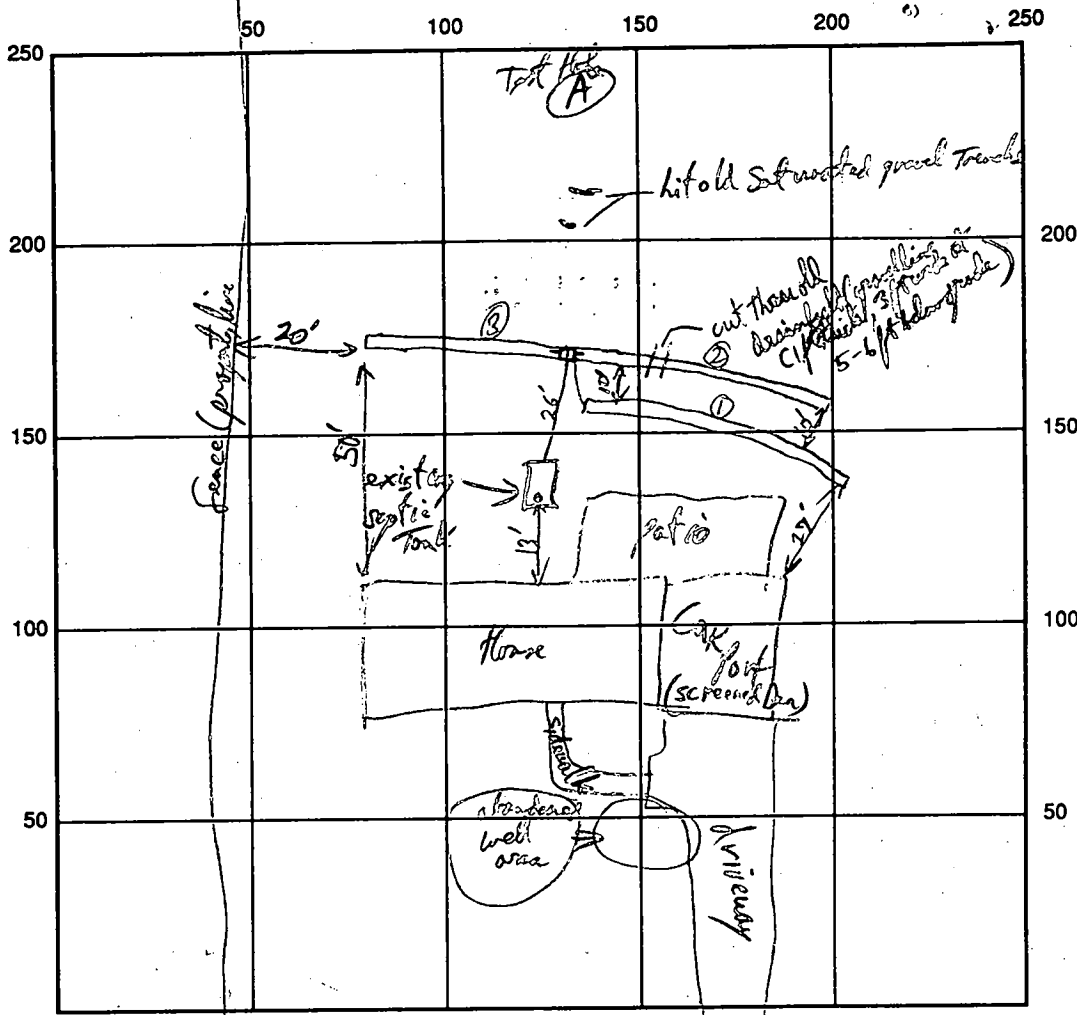
SEPTIC TANK LEVEL existing 1000 gal (estimated) PIP OK CLEANOUTS Exst. S.T.

DISTRIBUTION BOX LEVEL Level (water test ok) Need to cap access pipe on top

DRAIN FIELD/TITLE DEPTH 8 FT. TRENCH WIDTH 2 FT. INLET DEPTH 2 FT.

EFFECTIVE GRAVEL DEPTH 6 FT. TOTAL LENGTH 40/40/35 FT. = 115' (OK, PIP 5/14/97)

NUMBER OF TRENCHES 3 ONE SIDEWALL/BOTTOM AREA 690 SQ. FT.

REMARKS: last two open trenches OK to gravel fill. 115 ft trench total is OK (Kramer) OK to continue gravel filling trenches. Call for final inspection PIP 5/14/97. Trenches #3 & Dist box OK to cover, call when trenches #1 & 2 ready 5/15/97 PIP. Last ends of trenches OK to cover PIP 5/16/97

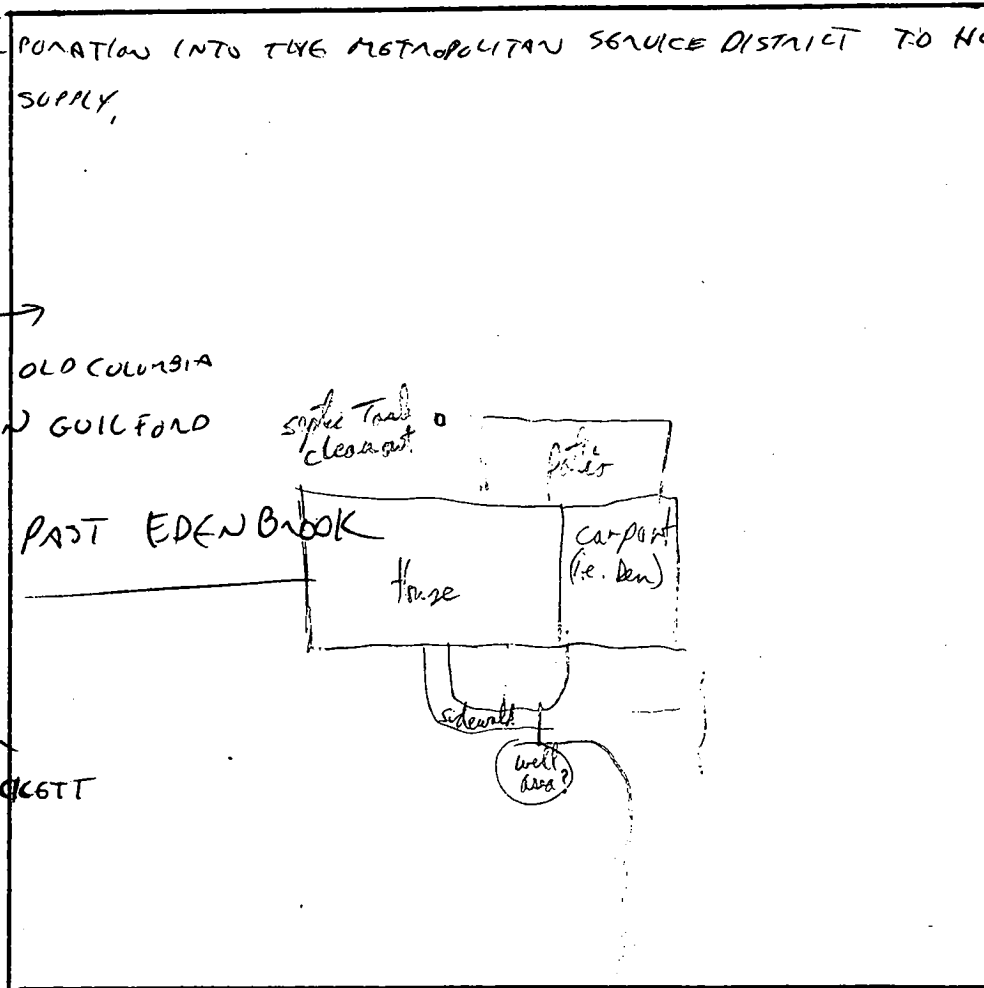
LOCATION DIAGRAM

OWNER REPORTS REPEATED

PUMP FAILURE / WATER CONDITIONING EQUIPMENT BREAKDOWN

3/5/93 VISITED SITE. MET WITH MR

QUARRIER. WATER HAS SEDIMENT. FIRE PLUG
IN FRONT OF HOUSE. RECEIVED LETTER FROM
MR QUARRIER RH
