TRENCH DATA

SEPTIC TANK DATA

Allnut Lane

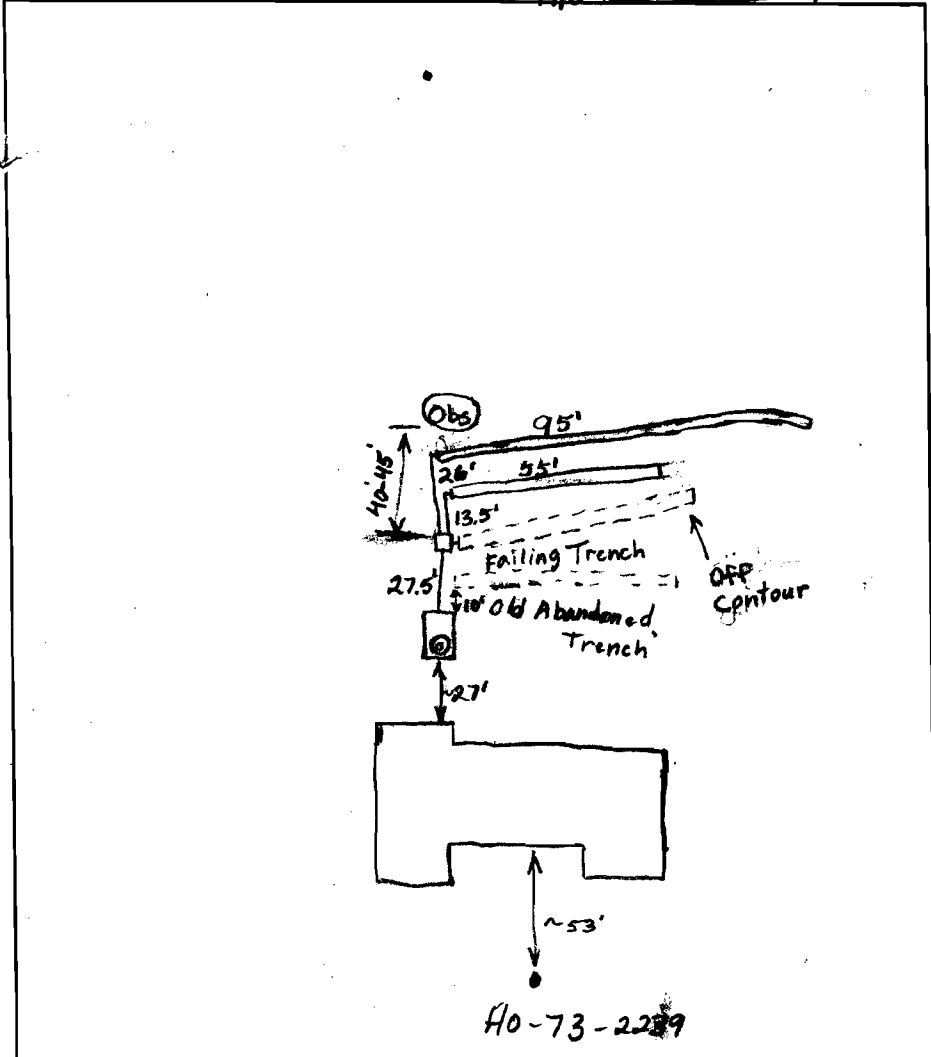
INSPECTION COMMENTS: 1/25/01 Existing trench is failing and off contour. Installed two trenches slightly off contour downhill of failing trench to conserve area. Contractor to install a 6" cleanout on top of buried manhole cover to facilitate access. O.K. to cover. (BB)
