P 515996-C

A REPAIR

## ON-SITE SEWAGE DISPOSAL SYSTEM HOWARD COUNTY HEALTH DEPARTMENT BUREAU OF ENVIRONMENTAL HEALTH

ADDRESS: 12620 Route 108 PROPERTY OWNER: Kirit Parmar

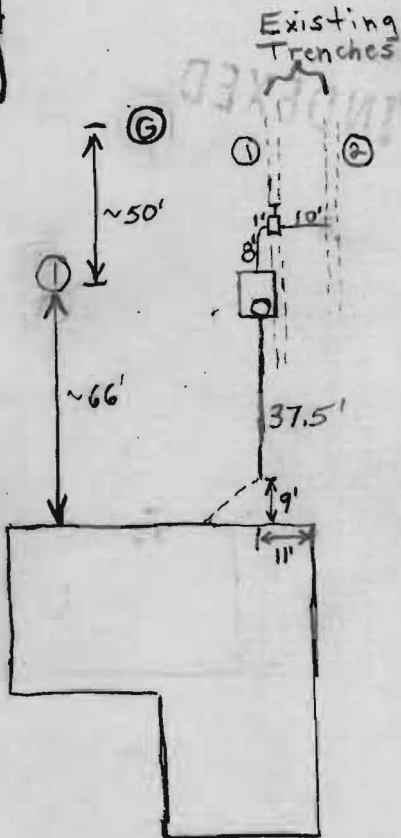
4' Red Br CI  
Loam  
10.5' Light Br  
Sd Loam  
~10% Rock  
12' Pockets of  
~40% Rock  
Getting Rocks

INSPECTION COMMENTS: 10/9/01 Approximately 30' abandoned on trench ①. Approximately 15' abandoned on trench ②. So around 150' of trench should be remaining. Which leaves enough for a 3 bedroom house considering that there is reported to be 3'-4' of stone in existing trenches. There is sufficient space remaining for 1 repair in area of pipe test holes ① and ②. (BB)

10/9/01 Move Septic Tank 1PM  
Abandon Part of Trenches  
Dig Test Hole Closer to House
