12673 Triadelphia Rd

SITE INSPECTION SHEET

PROPOSAL: verify condition of well/septic

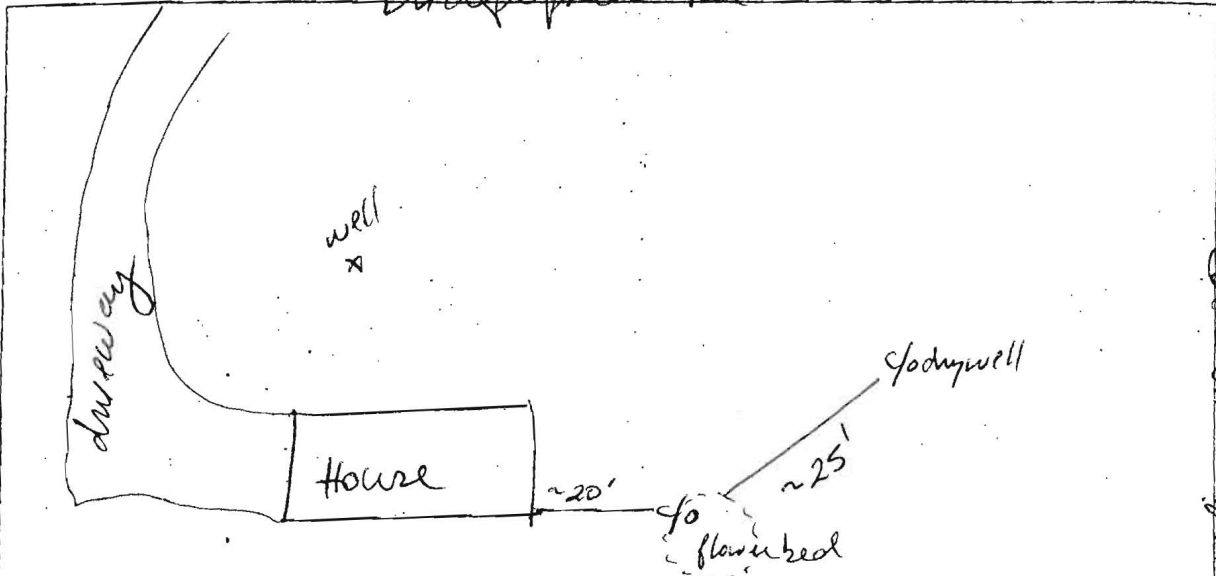
LOCATION DIAGRAM

4/13/06 Spoke to Mike Krans. Need to perform minimum of two holes. Location of addition eliminates area for drainfields between house and prop. line.

COMMENTS: Septic levels okay. Dry well top was ~2 1/2' below grade
effluent levels > 5' below. Septic top was 1' below
grade w/ effluent ~ 1 1/2' below.
