Re: Percolation Testing Support Building Permit
Building Permit # B00147070
16449 Ed Warfield Road

Mariani Property / Historical Home of Ed Warfield
16449 Ed Warfield Road, Woodbine

SITE INSPECTION SHEET

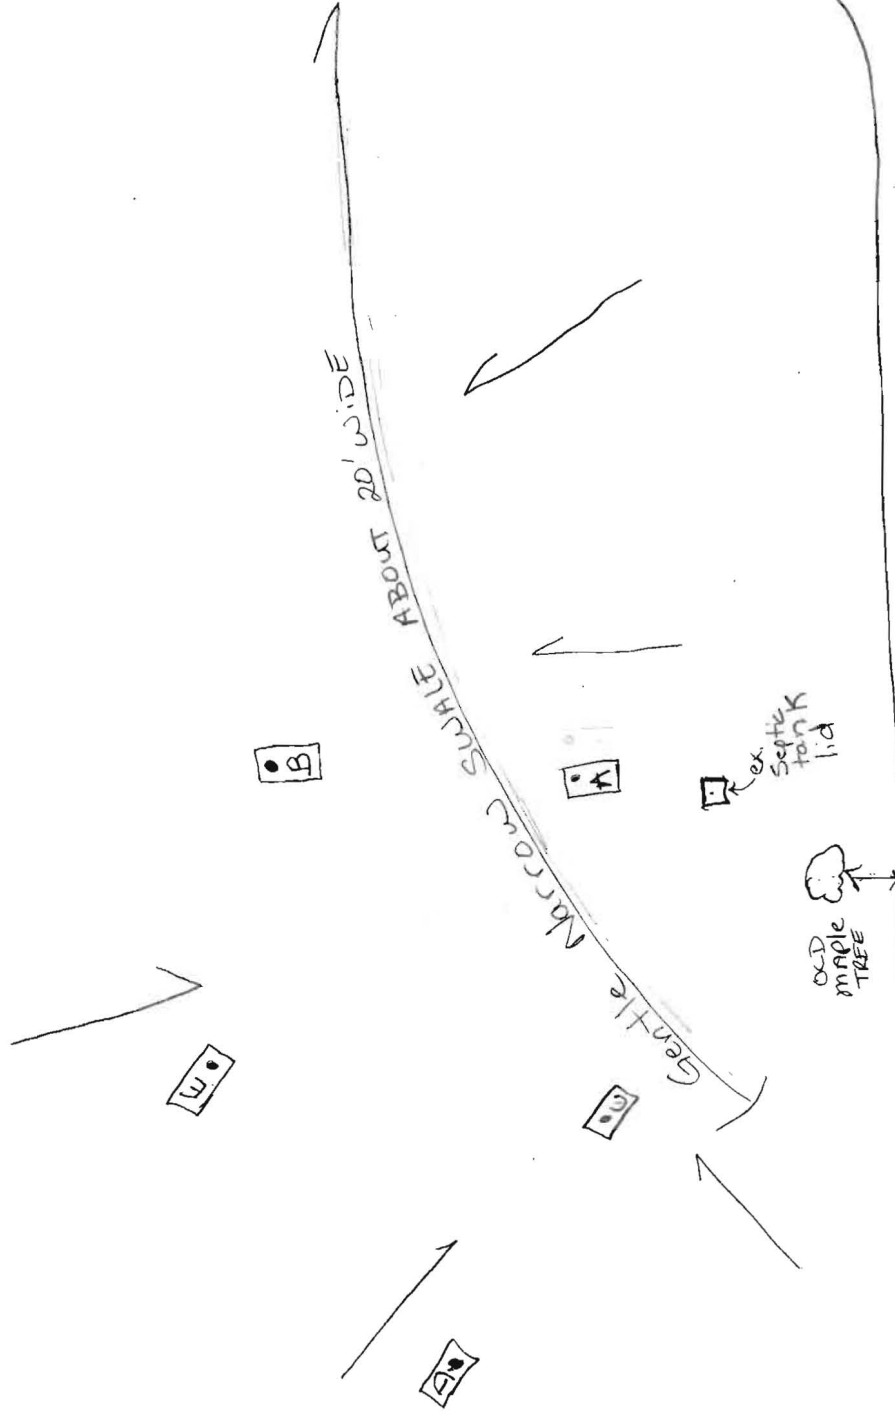
Notes: - Lower elevations typical of 6' clay, water at 12'. (Holes C, D)

- Higher elevations, holes D, E, perc around 3-4' with water around 12-14 feet

- Hole A - no water in bottom @ 14' after 1 1/2 hours +

- Future repair area best near perc holes D, E, & B. - INLET AT 3, bottom at 5.

- 4' Treatment buffer identified.

Rate \bar{x} = 20 min

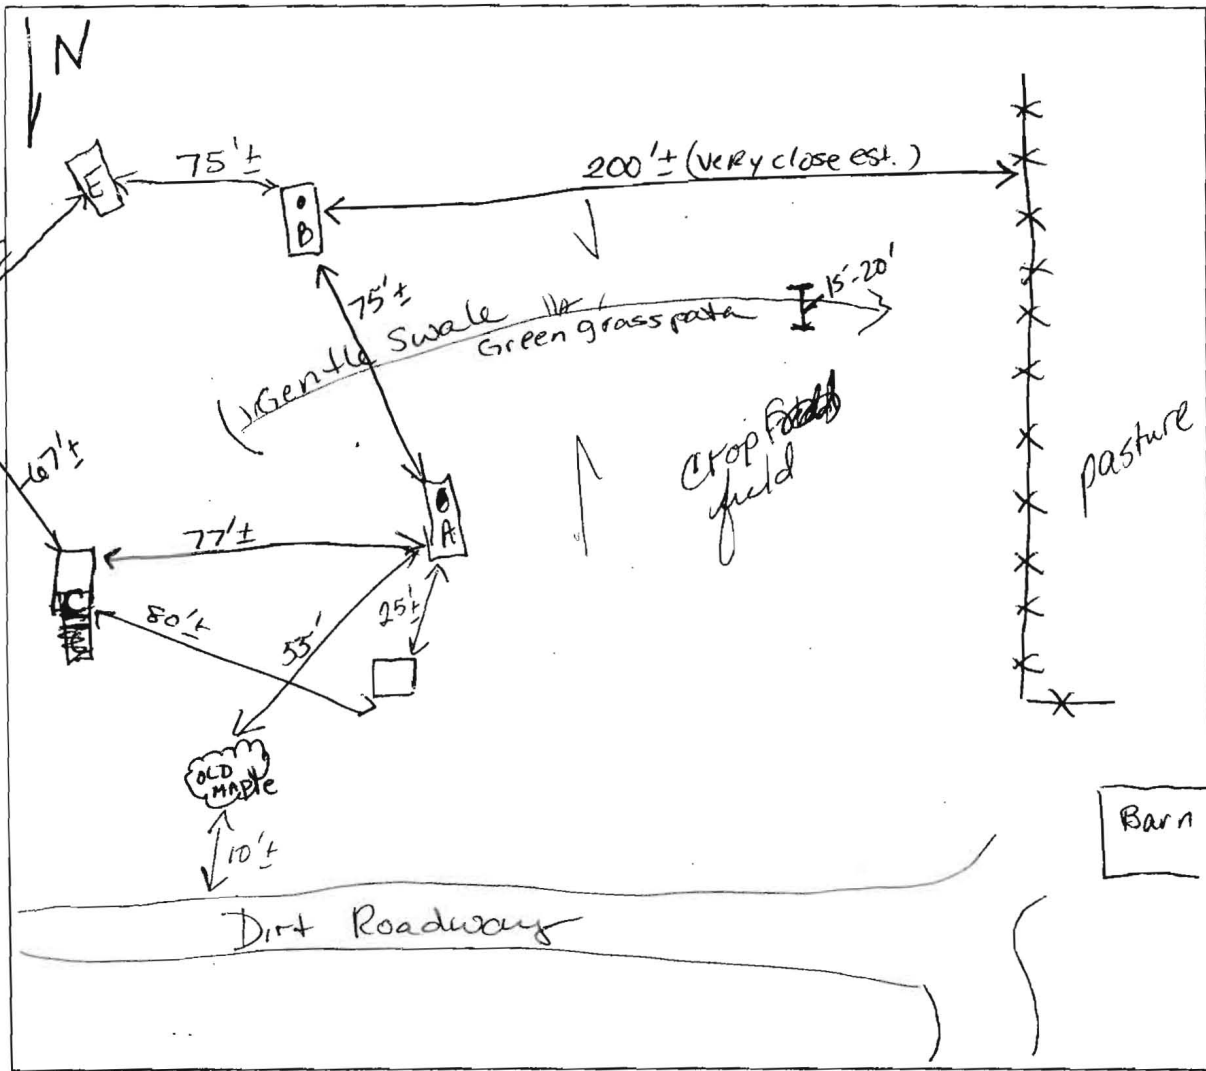
LOCATION DIAGRAM

COMMENTS: 4/23/04 Soil descrip. on other pages. Stay SE of Swale for permeable soils at shallower depth (for future repairs). Existing system appears to be functioning.
