DEMOLITION REQUEST FORM

RE: 9201 Old Guilford Rd.
Columbia, MD 20146
Map: 42, Grid: 15, Parcel 28
(Demolition of existing structures – rebuild new building)

9201 OLD GUILFORD ROAD – ABOVE GROUND STORAGE TANK REMOVAL

PHASE I ENVIRONMENTAL SITE ASSESSMENT

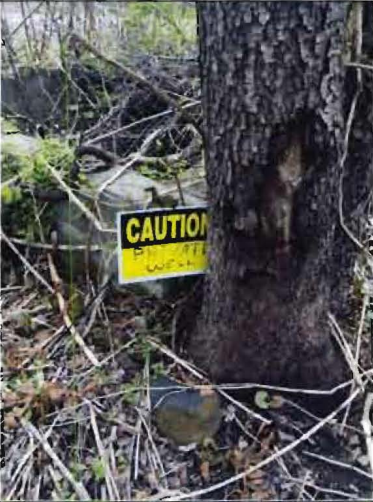
The well on the property does not appear in EDR's or MDE's database of wells. No pumping system or components were observed. This well could have been used to discard byproducts or other waste materials. Further investigation into the functioning of this well is recommended.

<p>Private well hidden from view located slightly southwest of main house</p>

The existing drilled well (Tag unknown) that was at one point utilized for the above referenced property has been located and sealed according to COMAR 26.04.04.34. An abandonment report was submitted by George Easterday (MWD 040) to this office which confirms well abandonment completion. This process was completed on 11/22/2016.

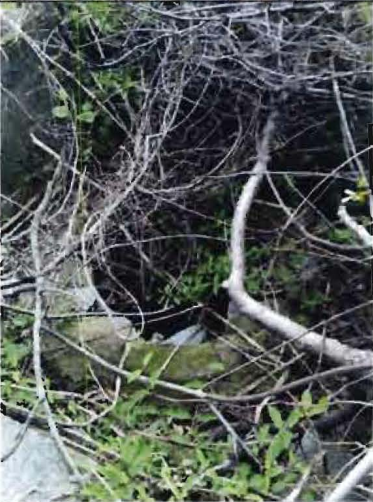
<p>Close-up of private well covered in vegetation located in the west of main house, slightly southwest perimeter of property</p>

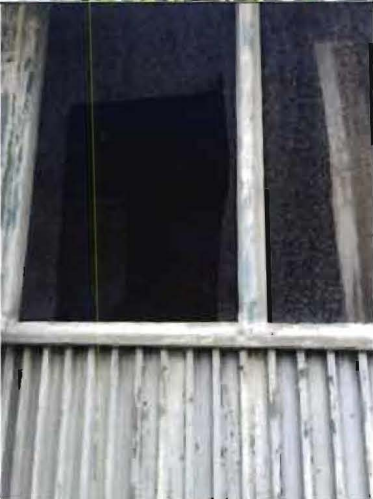
<p>Square cut damage to screen barrier on rear side, southeast elevation of main house</p>

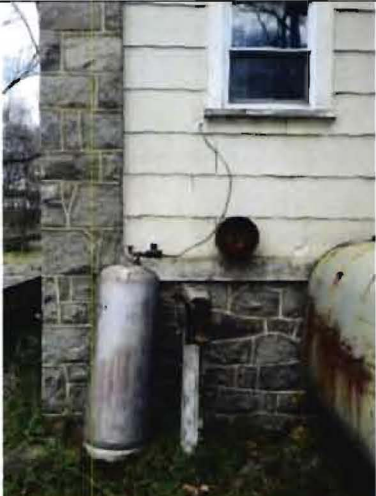
<p>Old propane tank located on the west elevation of main house</p>

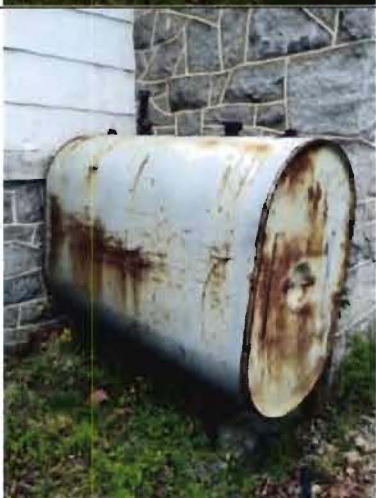
The ASTs around the single-family house could have had numerous spills or overfills over their years of use. Although stained soil and grasses were not observed, ATI cannot rule out potential petroleum spills or leaks around these tanks. Secondary containments or bunds are not present.

<p>AST located on West elevation of the main house</p>

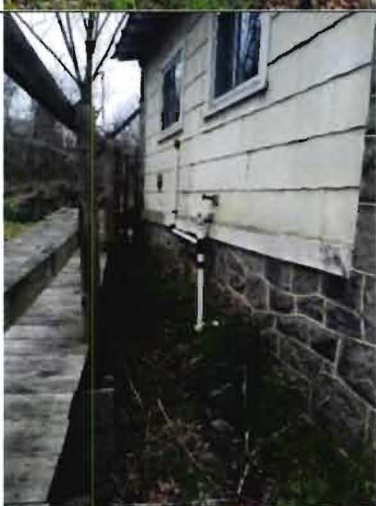
<p>PVC piping on the West elevation of main house next to wooden wheel chair ramp</p>

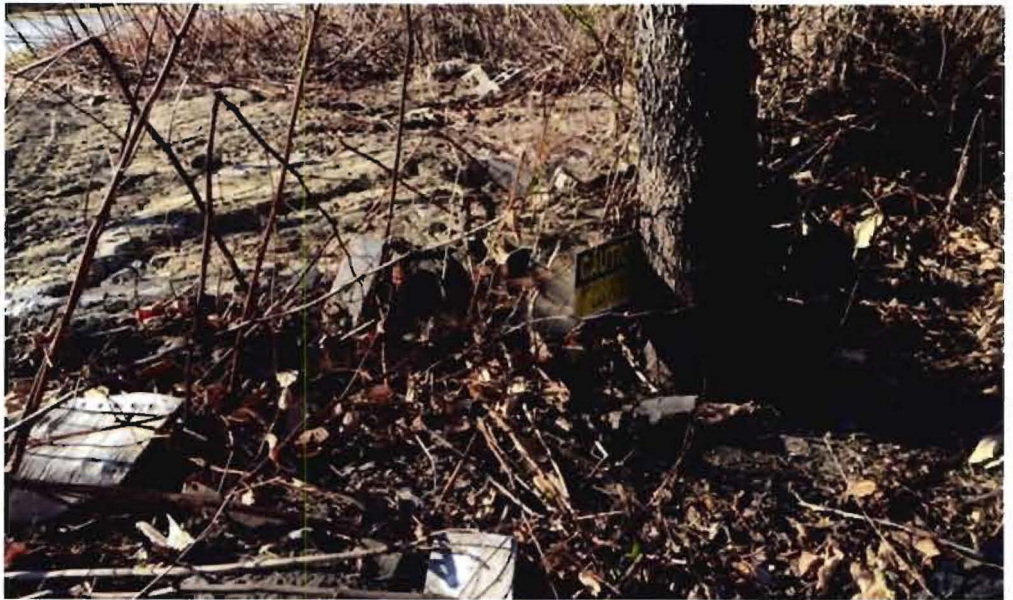
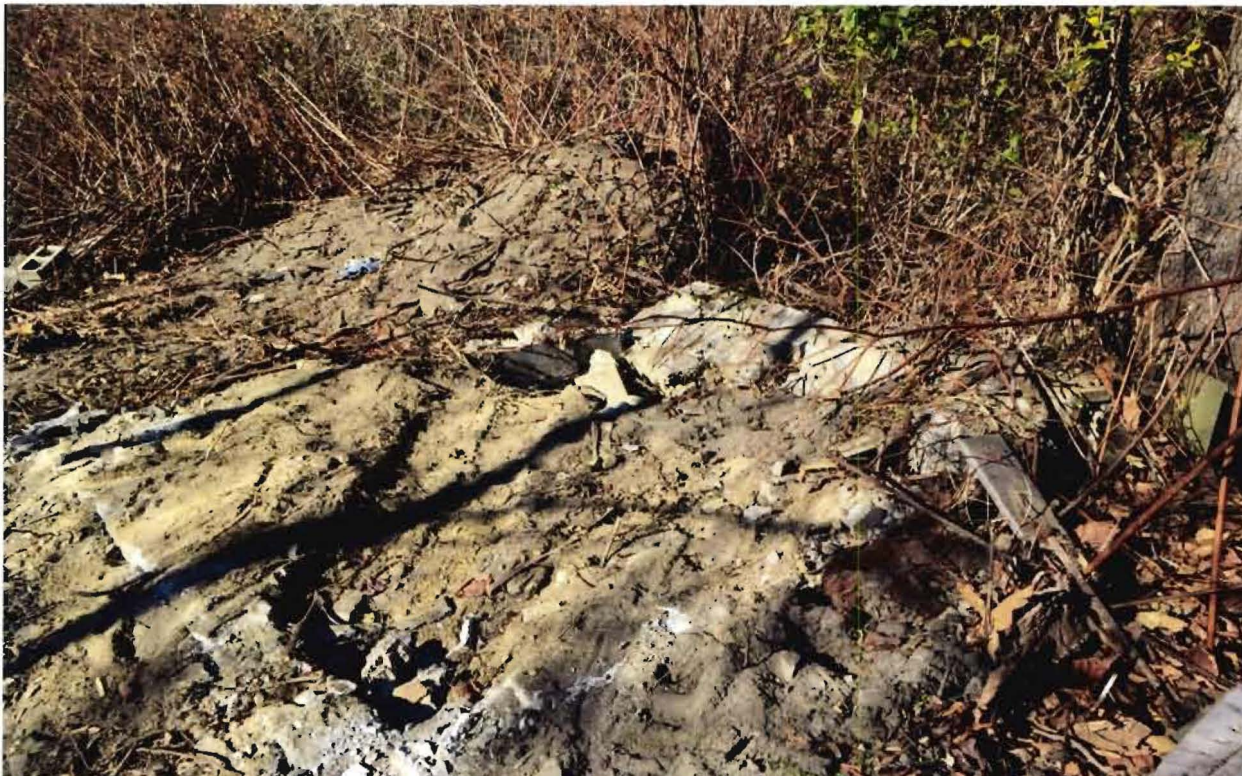
3 photos 11/23/2016

* photos of hand
dog well

- 2 AST's have not been removed
- septic not abandoned yet.

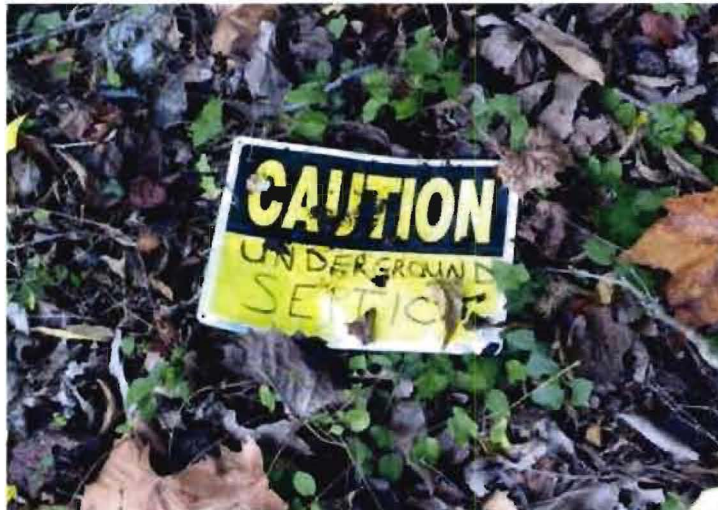
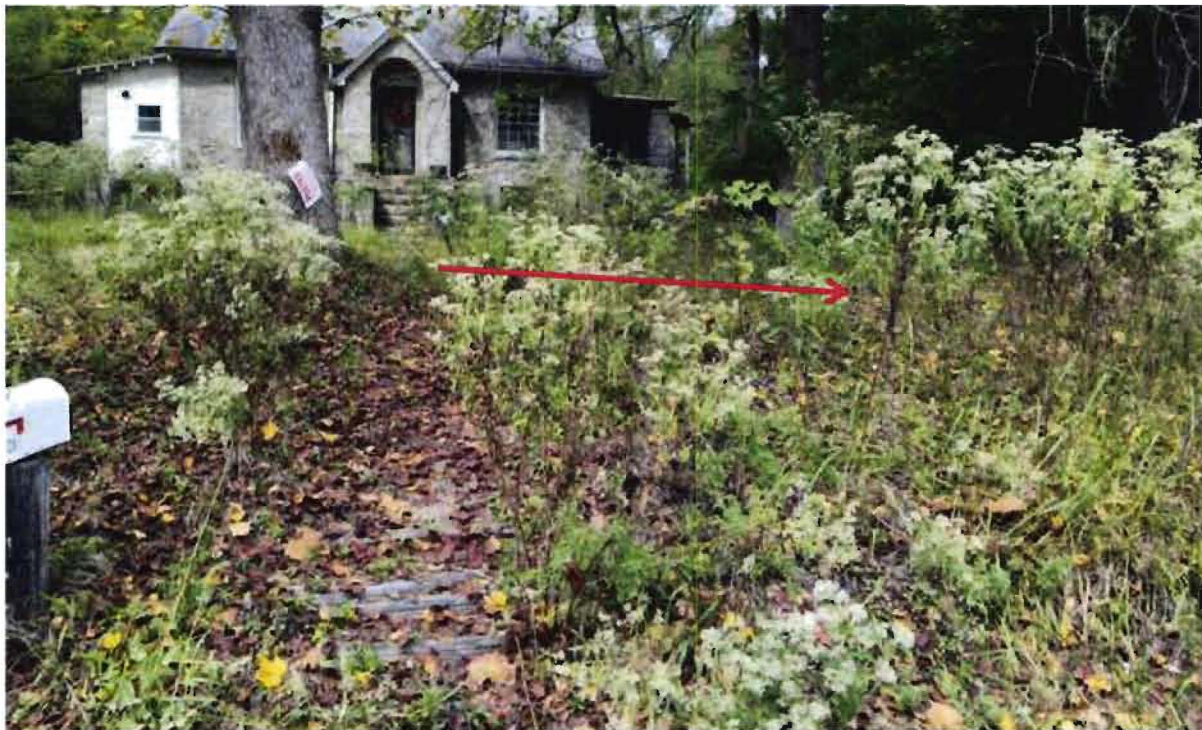
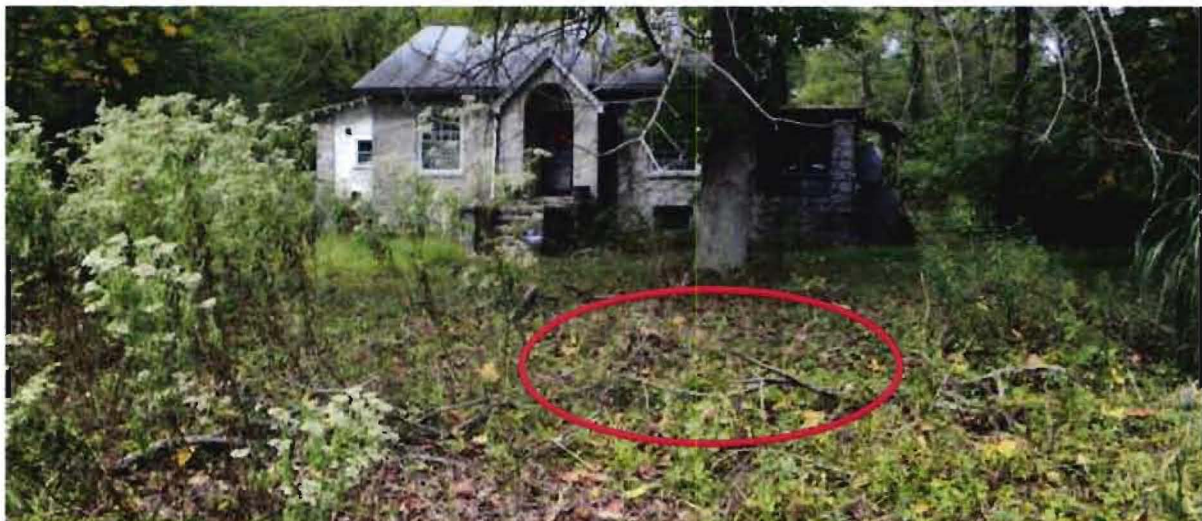
Howard County Health Dept – photos taken by R. Rappaport on 9/20/2016
9201 Old Guilford Road – Septic area which requires pump out & abandonment

The existing septic system on this property was located by Fogle's Septic Clean Inc. Documentation on letterhead was submitted to this office for record of compliance stating that the septic tank was located and had no liquid inside and therefore was crushed and filled in place on 1/20/2017.
