RE: Property Status for On-Site Sewage Disposal Systems: Soil conditions undetermined,  
(Tax Map 8, Parcel 266; 5.2285 acres)

Thomas Harrington  
Property  
Tax Map 8, Parcel 266  
5.2285 Acres

SITE INSPECTION SHEET

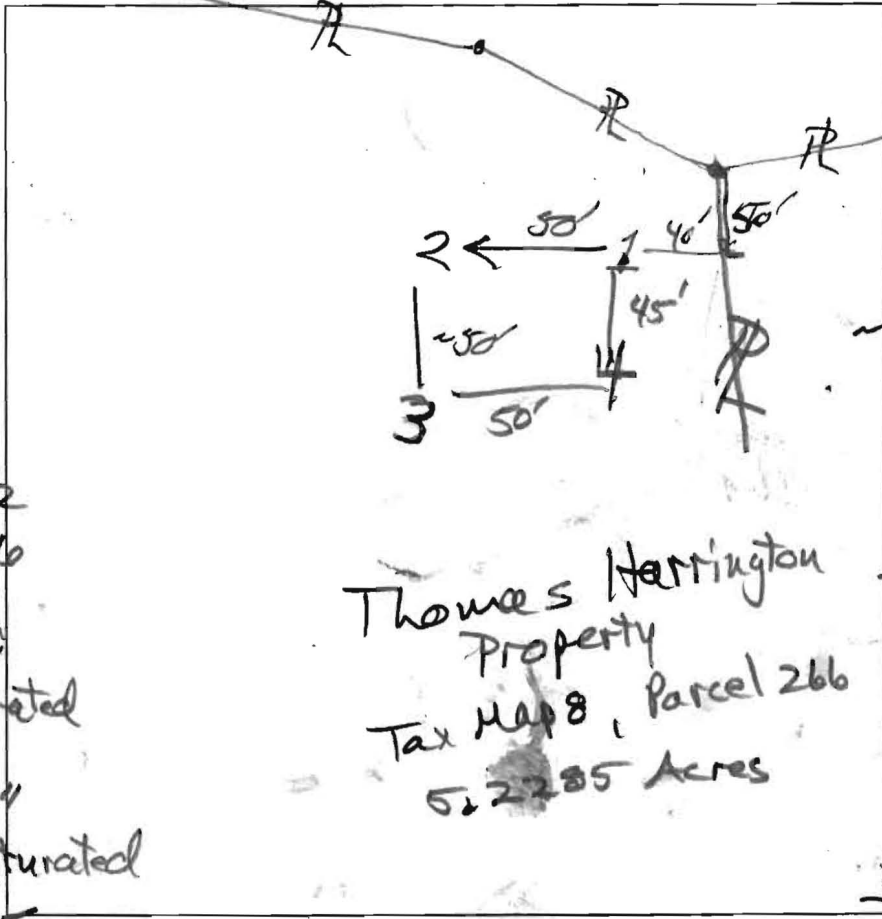
loam  
10YR 4/4 10"  
g. sl. 10YR 4/4  
c. mica 13"  
loam  
10YR 5/3  
m2f 10YR 5/2  
c1p 2.5YR 4/6  
common fine mica  
21"

fsc  
10YR 4/1  
Perched water

(4)

34"  
perched water  
7.5YR 5/6  
m1 2d  
10YR 6/1

45"  
perched water  
7.5YR 5/6  
m2d 10YR 6/1

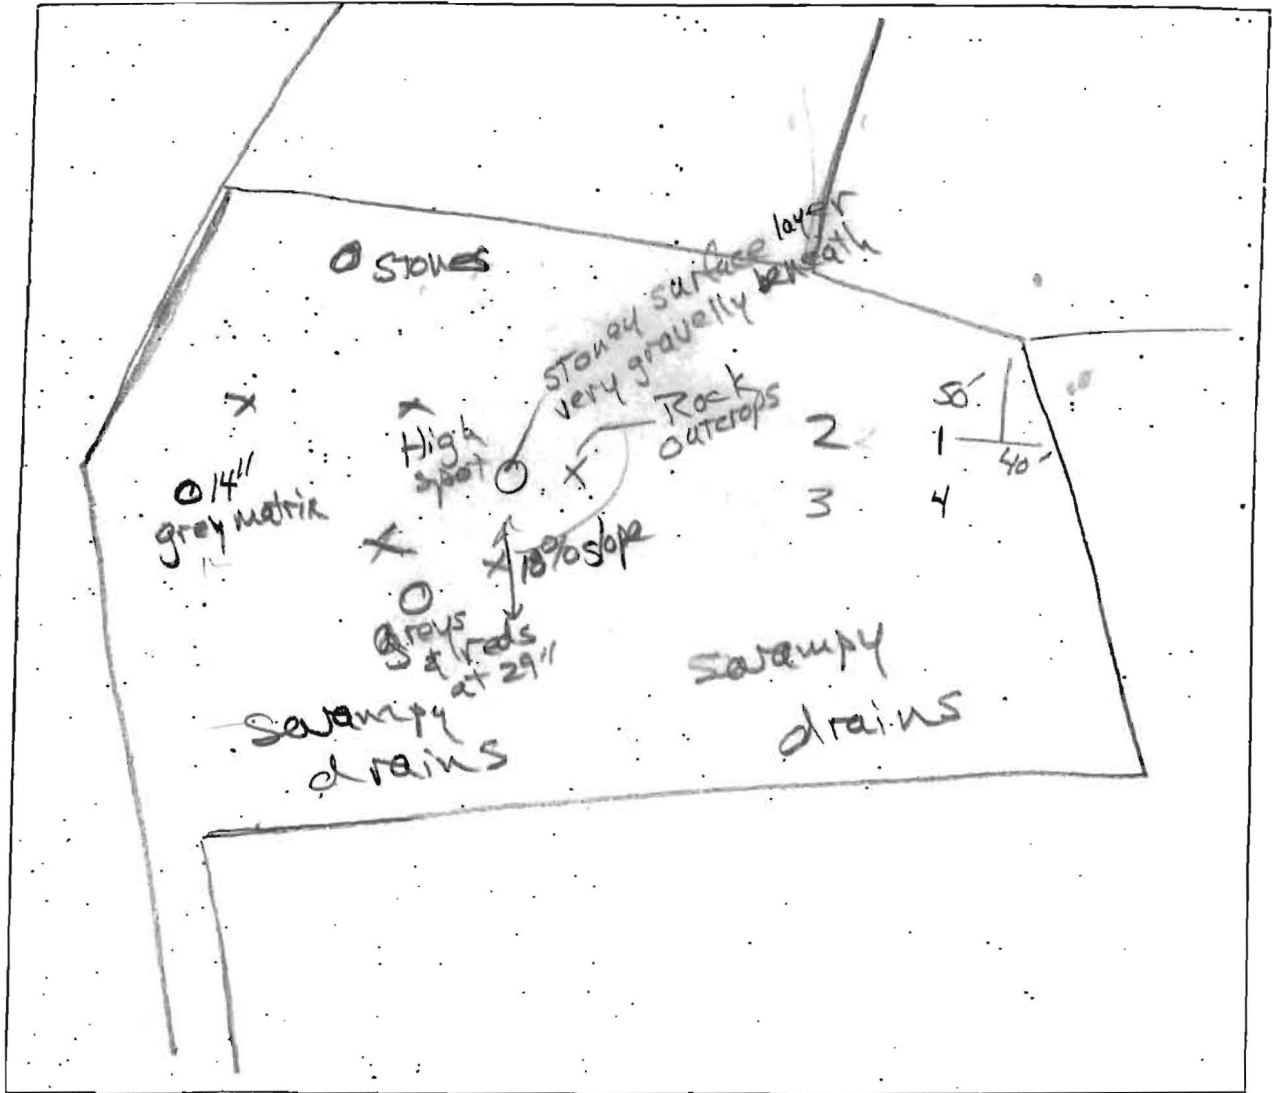
LOCATION DIAGRAM

COMMENTS: 2 or 3 potential sand mound locations  
may be tested. Until such testing occurs,  
Status remains as 'non buildable'
