Bureau of Environmental Health

RE: Complaint Investigation -  
Leaking Septic Tank

SITE INSPECTION SHEET

PROPOSAL: Inspect mound area on Historic Property  
at corner of Miller's Mill Rd & Rte. 97

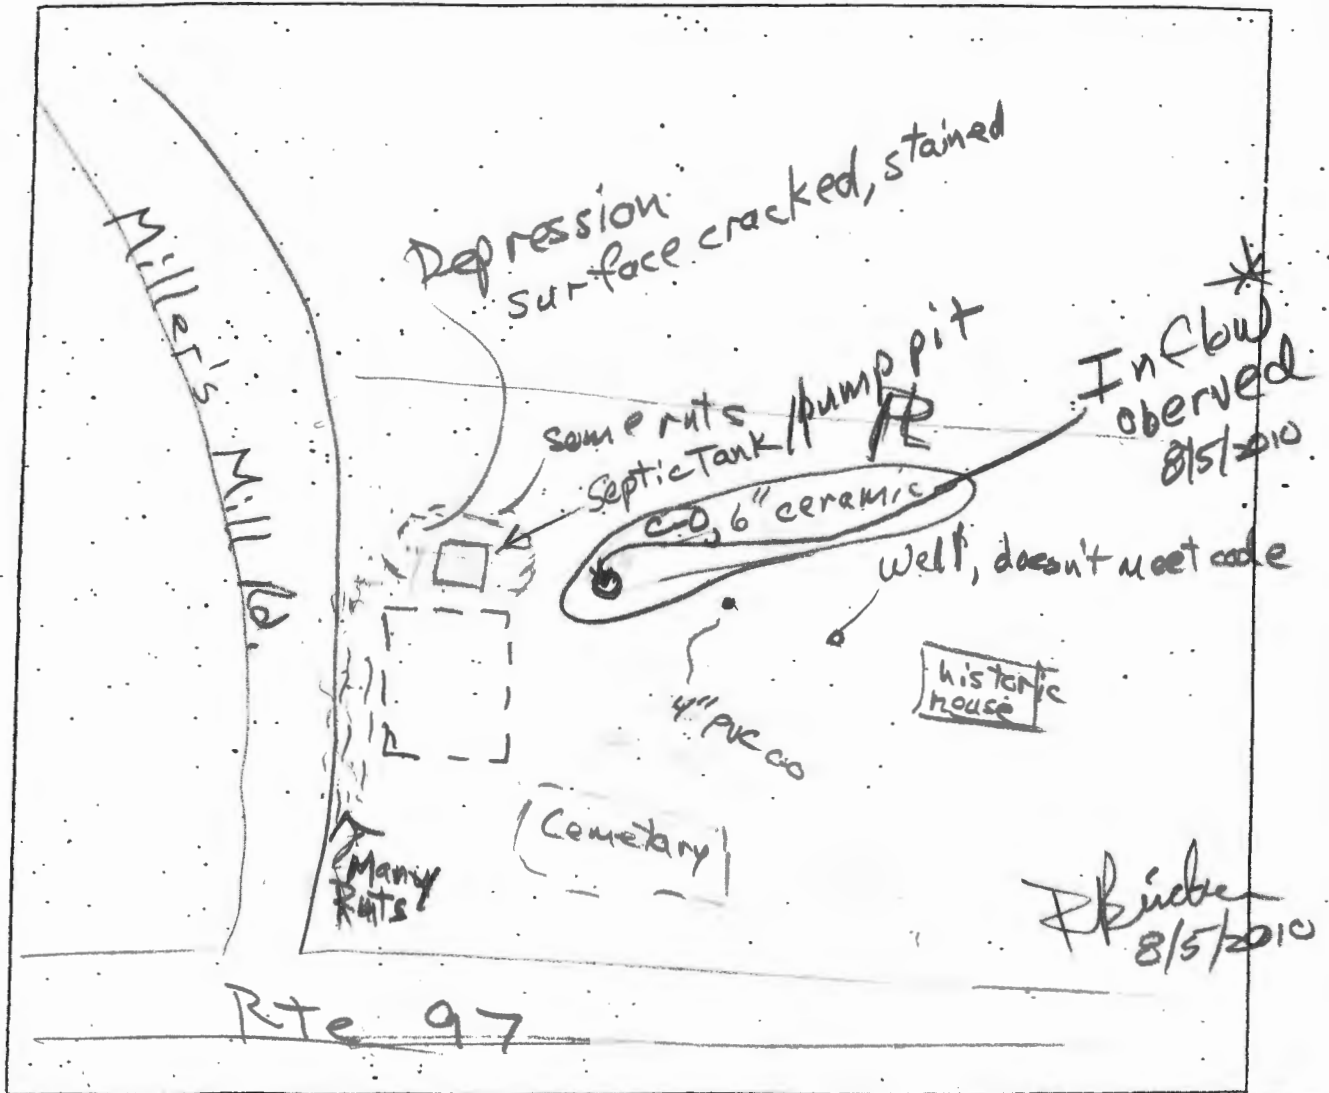
LOCATION DIAGRAM

COMMENTS: Site Inspection 8/5/2010 ~ 4:30 pm

Knocked on door - no answer. Inspected Well and Septic

- \* Well is definitely in need of maintenance/repair
- \* 2-pc metal cap lays on top casing that has been mangled.
- No conduit; roped wrapped around outside; electrical conductor not noticed.
