RECEIPT DATE: 3/29/2019    **ONSITE SEWAGE DISPOSAL SYSTEM**    P 524812  
 APPROVAL DATE: 04/10/2019    **PERMIT:**    **REPAIR**    A Repair  
 PROPERTY ADDRESS: 17106 Frederick Road  
 SUBDIVISION: \_\_\_\_\_ LOT: \_\_\_\_\_ TAX ID: 04-328833  
 CONTRACTOR: Fogle's Septic Clean Inc.    EMAIL: Kurt@foglesinc.com  
 CONTRACTOR ADDRESS: 580 Obrecht Road Sykesville, MD 21784    PHONE: 410-795-5670  
 PROPERTY OWNER: Stacy Sauerhoff    EMAIL: \_\_\_\_\_  
 OWNER ADDRESS: Same as above    PHONE: 240-876-3901

**INFORMATION FORM – SEPTIC SYSTEM REPAIR/UPGRADE**

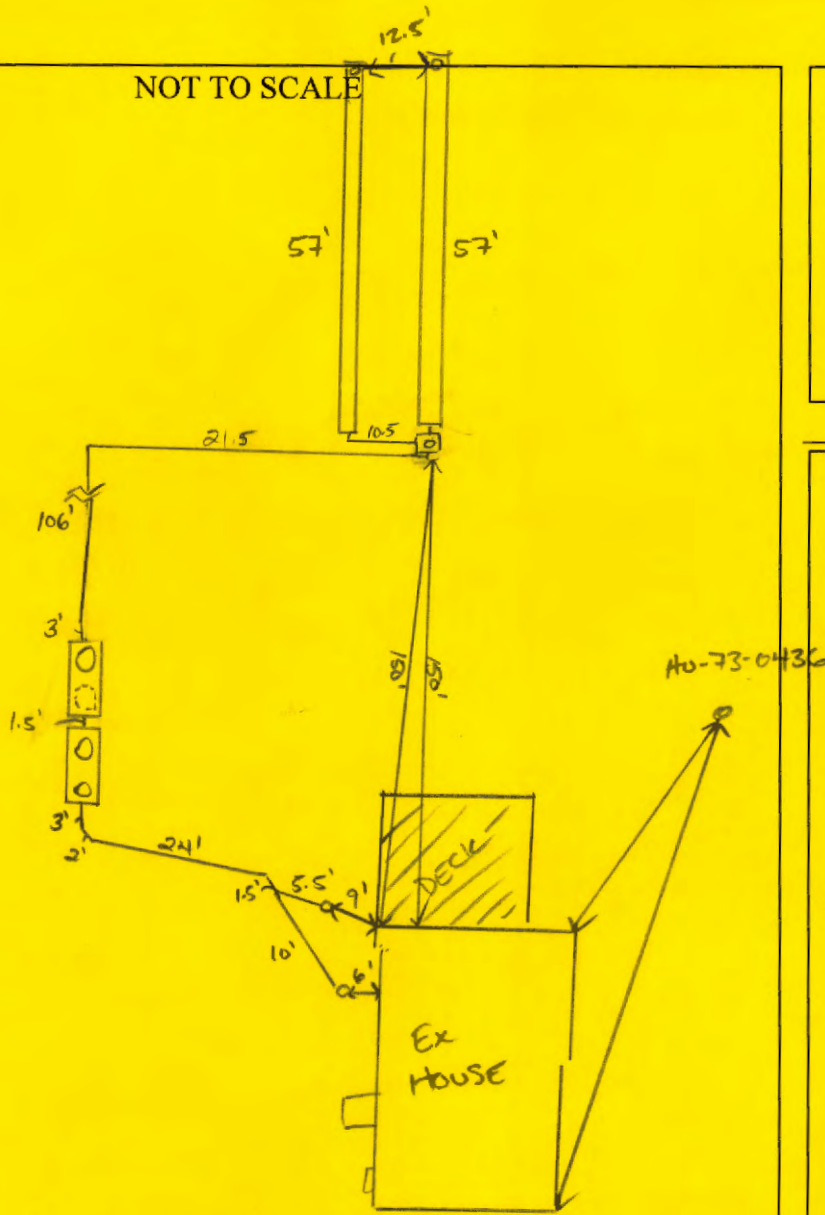
3/27/19 set new S.T. and P.T. outside 100' well radius.  
 Run 2" F.M. up along well arc. between fences. up to new  
 Dbox. Run 2x 52' trenches as staked in field running north  
 along fence line. (KMD)

**INSTALLATION:** 4/1/19 CONTRACTOR NO SHOW. @ 4/2/2019 TANK AND SOME  
 TRENCH DIG. REINSP TANK, F.M. AND TRENCHES. @ 4/3/2019  
 TANKS SET AND UPPER TRENCH DURING CONST. TO SPEC. REINSP TRENCH  
 AND F.M. @ 4/4/2019 FORCE MAIN AND LOWER TRENCH COMPLETE. REINSP  
 P/A. @ 4/10/2019 ALARM OK. PUMP OK. WATER CONFIRMED TO D BOX.  
 TWO SEPERATE CIRCUITS 20A PUMP. 15A CONTROL CIRCUIT. OK TO COMPLETE. (KMD)

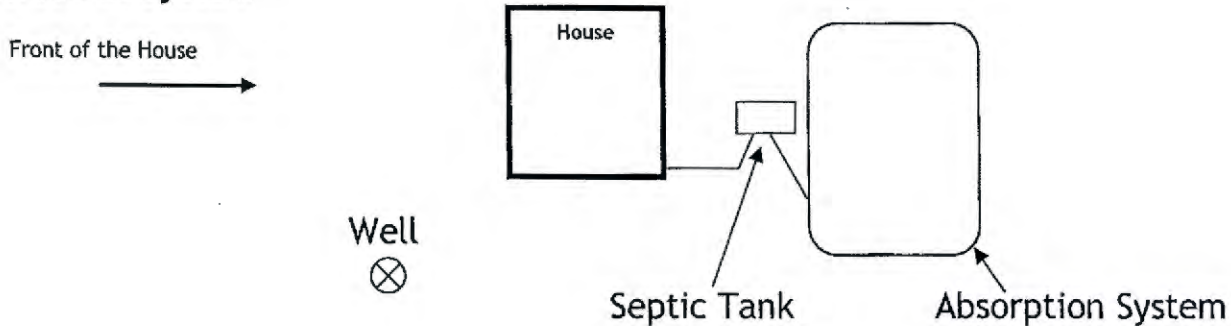
### Sketch of System

<input type="checkbox"/> Other:		Tank Size: Unknown		<input type="checkbox"/> Unknown: _____	
<b>System Component</b>		<b>Condition</b>		<b>Comments</b>	
<b>Septic Tank</b>		<input type="checkbox"/> Acceptable <input checked="" type="checkbox"/> Unacceptable <input type="checkbox"/> Needs Further Evaluation		The septic tank appears to be composed of cinderblock. Access consists of a 6" PVC cleanout at grade over the front corner of the tank. The back baffle is in place and is composed of terracotta. Upon arrival the liquid level in the septic tank was observed to be below normal at ~4'. This suggests that the septic tank may not be water-tight. The septic tank will need to be replaced by a licensed contractor as cinderblock tanks are prone to not being watertight and structural integrity issues.	
<b>Absorption System</b>		<input type="checkbox"/> Acceptable <input type="checkbox"/> Unacceptable <input checked="" type="checkbox"/> Needs Further Evaluation		Per the seller the absorption system is believed to consist of drainfields. The area above where the absorption system is believed to be located was probed and no abnormal moisture was observed. Due to the low liquid level in the tank a hydraulic load test could not be performed during the evaluation. The condition of the absorption system will need to be verified by a licensed contractor at the time that the septic tank is installed.
