INFORMATION FORM - SEPTIC SYSTEM REPAIR/UPGRADE

# HOME LAND

<b>Date:</b> June 3, 2019 <b>Name of Evaluator:</b> Adam Brown <b>Time:</b> 8:00 AM <b>Property Address:</b> 3513 Hipsley Mill Road Woodbine, MD 21797 <b>Recent Weather Conditions:</b> Normal		<b>Ordered By:</b> Margaret Melvin  <b>Buyers:</b> Lisa Davis  <b>Homeowner Interview:</b> The homeowner interview was requested, but was not received prior to the evaluation.		<b>Occupied:</b> <input checked="" type="checkbox"/> Yes <input type="checkbox"/> No <b>Length of Time Vacant:</b> N/A <b># of People Living in Home:</b> 3 <b># of People moving in:</b> 2 <b>Property Age:</b> 1964 <b>System Age:</b> Unknown <b>Last Date of Cleaning:</b> Unknown <b>Recomm'd Pumping Freq:</b> 1-2 Years	
<b>Liquid level in tank is:</b> <input type="checkbox"/> Above Normal <input checked="" type="checkbox"/> Normal <input type="checkbox"/> Below Normal			<b>Bottom Solids Depth:</b> 36 Inches		
<b>Depth of tank:</b> 22 Inches		<b>Type of Tank Access:</b> Lid On Tank		<b>Depth of tank access:</b> 22 Inches

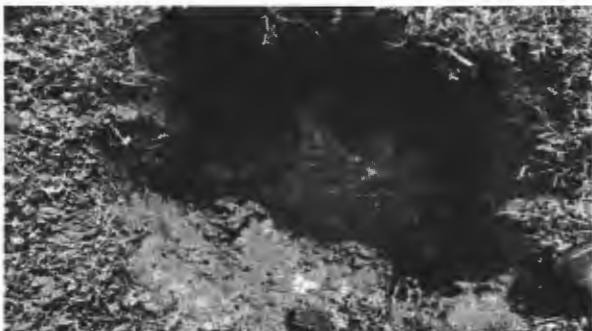
**Picture 3:**

Shows the back of the septic tank was excavated and no access was present. This suggests that the septic tank is composed of cinderblock.

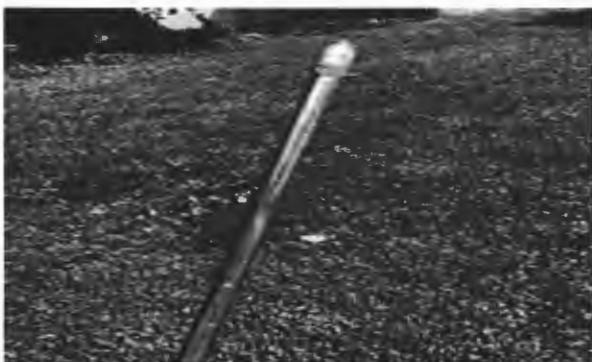
**Picture 4:**

<b>Absorption System</b>		<input type="checkbox"/> Acceptable <input type="checkbox"/> Unacceptable <input checked="" type="checkbox"/> Needs Further Evaluation		During the evaluation 1 drywell was located for the absorption system. No access was observed for the drywell. It is strongly recommended that access at grade be installed in order to monitor the condition of the drywell. The perimeter of the drywell was probed and was observed to be saturated with signs of biomat. (See picture 4) Approximately 150 gallons of water were introduced into the system with no signs of a back-up. Due to time constraints a proper hydraulic load test could not be performed. The condition of the drywell will need to be evaluated by a license contractor at the time that the septic tank is replaced.

Shows the probe to be saturated with signs of biomat after probing the perimeter of the drywell.

*Dry well needs dug up / replaced. 1*

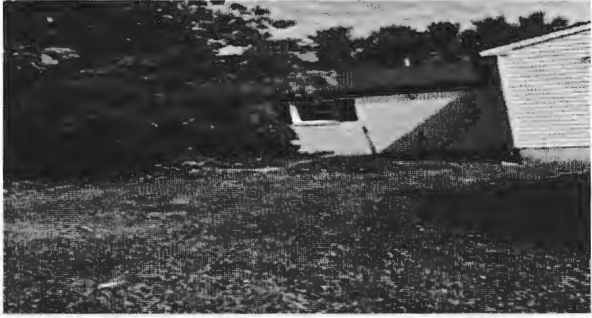
**Picture 5:**

Shows the septic tank to be located in close proximity to the dwelling and trees. This may make future repairs difficult.
