Memorandum

FROM: Howard County Health Department
Well & Septic Program

RE: 14034 Burntwoods Road
Glenelg, MD

DATE: February 20,2020

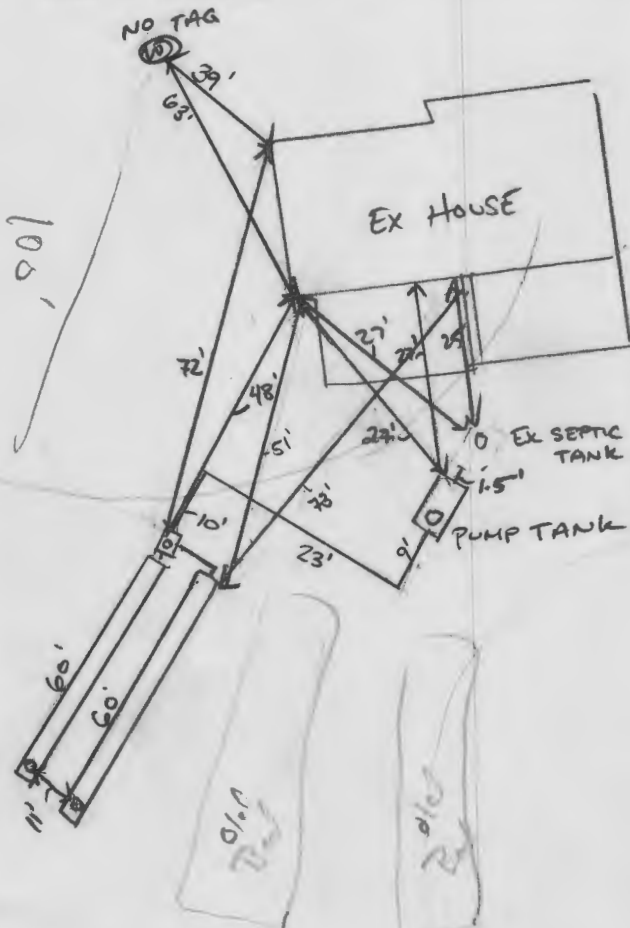
4/24/19 Found location of existing bed, will be more than 10' from it w/ new trenches. set new 1250 p.t. just after ex. ST. shut elevation for new 2x68' trenches as flagged in field, on four drops slightly more @ ends. (KMD)

INSTALLATION: 4/25/2019 RISER INSTALLED ON EX ST. OUTLET BAFFLE INSTALLED. PUMP TANK SET. FORCE MAINS INSTALLED TO D BOX. OK TO BACKFILL. @ 4/29/2019 TRENCHES COMPLETE. D Box FM TURN DOWN TO BAFFLE. OK TO BACKFILL. @ 5/3/19 P/A test OK. Did not make site visit (workload too busy). Contractor confirmed both working (KMD) 5/6/19 Did make it to site w/ contractor to perform P/A test. 'OK' (KMD)

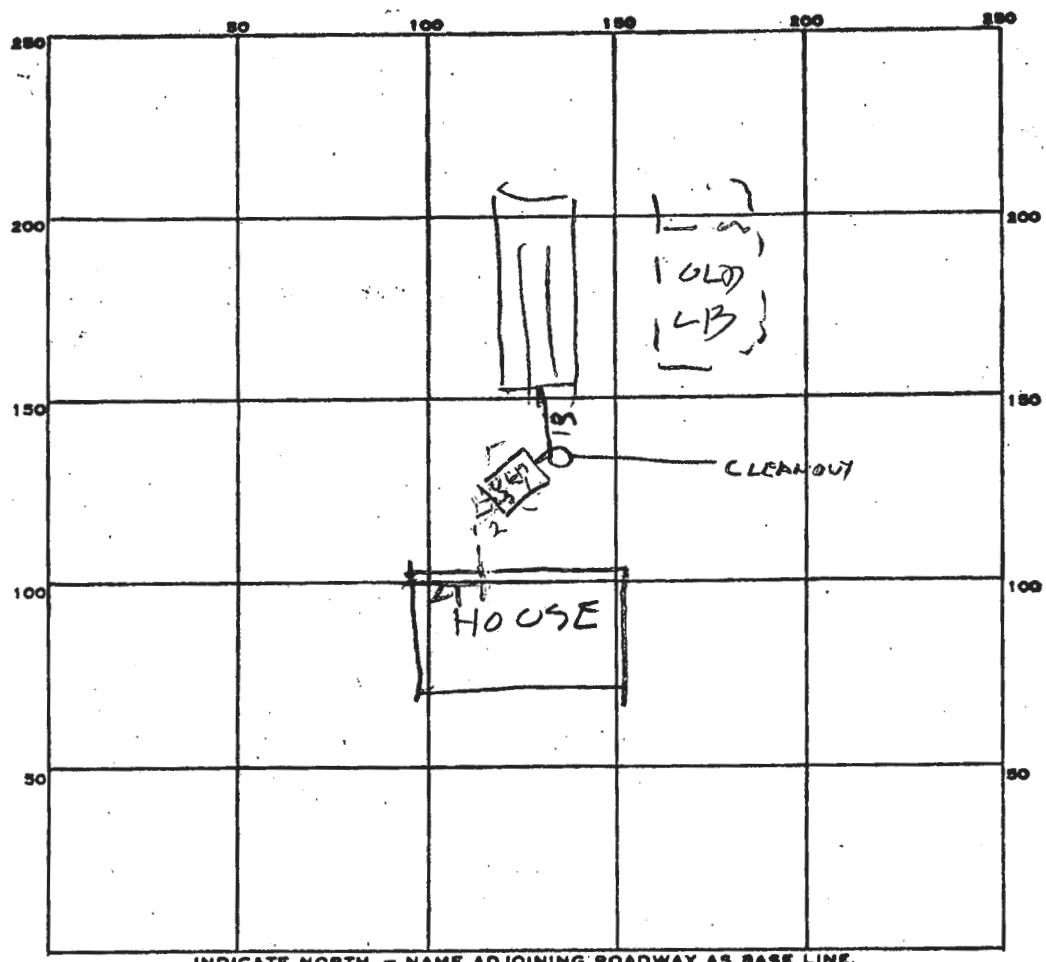
REMARKS 5/13/86 ^{160N} OLD LB INSTALLED 1969
MOST OF BED DUG. VISUAL HOLE DUG
FINISH DIGGING BED & ADD STONE
5/13/86 ^{1130 AM} BED DUG LONGER STONE
ADDED RH

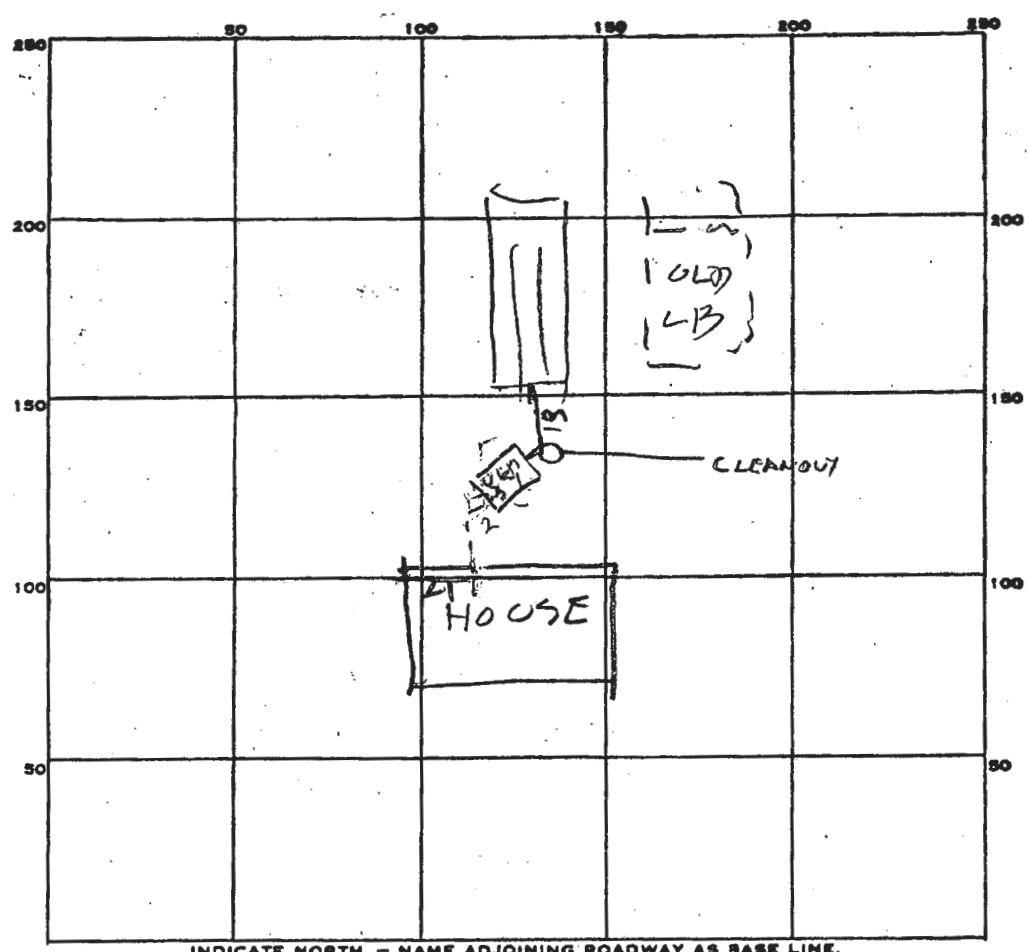
REMARKS 5/13/86^{100N} OLD LB INSTALLED 1969
MOST OF BED DUG. VISUAL HOLE DUG
FINISH DIGGING BED & ADD STONE
5/13/86^{1130 AM} BED = DUG LONGER STONE
ADDED RH

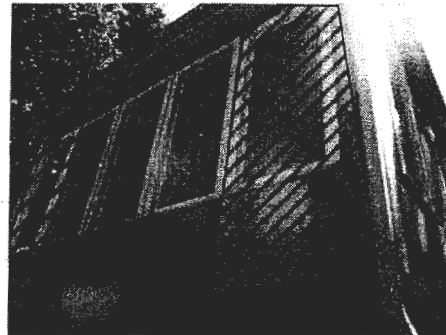
- The rear wall of the sunroom has very little solid wall area compared to the area of window openings. We feel that there are two options for addressing/remedying the wind-bracing requirements:

1. It *might* be possible to retain the current configuration of the windows and still meet wind-bracing requirements. We feel that a pair of pre-engineered elements can be 'inserted' in the wall at each end. A Simpson SSW12x8 Steel Strong Wall can be installed at each corner of the rear wall. This would necessitate: removing the trim, removing the exterior finish, temporarily supporting the sunroom structure, removing the plywood, cutting out the wall studs, and 'sliding' the steel wall panels into the wall cavity. This would also necessitate constructing a pair of 16"x16" CMU piers at the outside corners of the sunroom (these Steel Strong Wall panels must be fastened to a foundation element), which would also necessitate new footings. We recommend discussing this option with a contractor for better information on feasibility and pricing.

2. The simplest solution, in our opinion, would be to abandon the left and right windows on the rear wall. In short, the exterior trim and finishes would need to be removed, the windows at the corners would need to be removed, and the existing plywood wall sheathing would need to be removed. New infill wall studs would need to be provided to close the window openings, and new 1/2" plywood sheathing (with fasteners at 6" on center at plywood edges and 12" on center at all intermediate studs) be provided. This would satisfy the code wind-bracing requirements at this wall, in our opinion.
