RECEIPT DATE: 11/7/19 **ONSITE SEWAGE DISPOSAL SYSTEM** P 566446

APPROVAL DATE: 11/15/2019 **PERMIT: MINOR REPAIR** A Repair

PROPERTY ADDRESS: 11501 Crows Nest Road

Date: October 26, 2019 Name of Evaluator: Matthew Riehl Time: 11:30 AM Property Address: 11501 Crows Nest Road Clarksville, MD 21029 Recent Weather Conditions: Normal		Ordered By: Well Water Solutions Buyers: Homeowner Interview: The homeowner interview was but not received prior to the evaluation.	Occupied: <input checked="" type="checkbox"/> Yes <input type="checkbox"/> No Length of Time Vacant: N/A # of People Living in Home: Unknown # of People moving in: 8 Property Age: 1960 System Age: 1969 & 2001 Last Date of Cleaning: Unknown Recomm'd Pumping Freq: Annually
Liquid level in tank is: <input type="checkbox"/> Above Normal <input checked="" type="checkbox"/> Normal <input type="checkbox"/> Below Normal		Bottom Solids Depth: 14"	
Depth of tank: 21" Front & 16" Back		Type of Tank Access: 6" Cleanout	
Maintenance appears: <input type="checkbox"/> Good <input checked="" type="checkbox"/> Fair <input type="checkbox"/> Poor		Depth of tank access: At grade

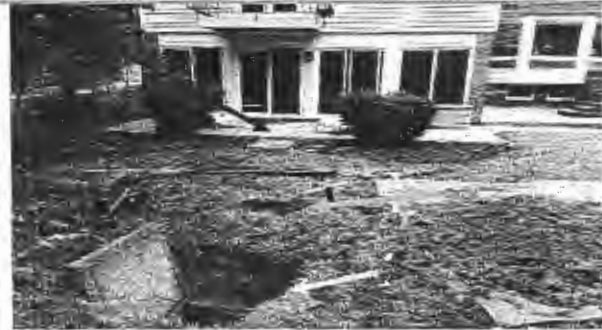
Picture 1:

In the picture each part of the septic system is seen. The red arrow points to the 6" cleanout at grade. The orange arrow points at the back end of the tank.

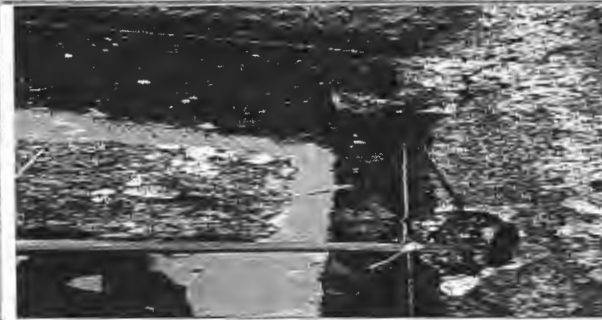
Picture 2:

The hole in the distribution box with a probe inserted.

The back end of the tank was excavated, and the camera was introduced into the back line. The back line appears to be unlevel and has standing water in the line. The distribution box was excavated and opened. Upon inspection a large hole was found in the distribution box that prevents water from reaching the drainfields. There are 2 drainfields to this system. The camera was introduced into drainfield A and was advanced until an obstruction was hit. This obstruction prevented further access to the drainfield and will need to be remediated as it caused a back up during the hydraulic load test. The camera was introduced into drainfield B and advanced forward. An obstruction was also hit in drainfield B. It appears the line has either been compressed or crushed; Water is still flowing through however the camera is unable to be advanced any further. Refer to video and pictures for more information. This is a subjective and visual inspection only, based upon many unknown and unseen factors. This report does not WARRANT nor Guarantee continued functional septic system operations. Payment and/or use of this evaluation signify understanding and acceptances of the above clauses.

NOTES: **Contractor to replace distribution box and minor piping. Call for inspection**

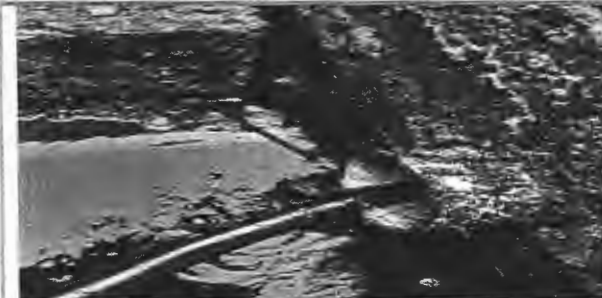
Picture 3:

Drainfield A with water flowing back out of the pipe within a minute of inserting the hose.

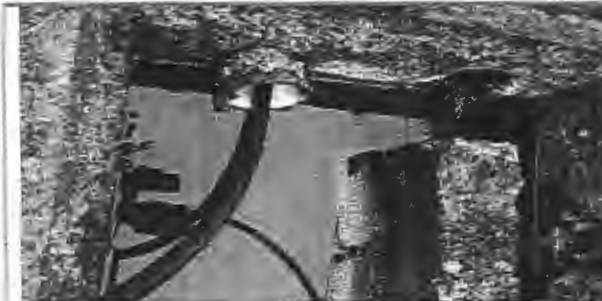
Picture 4:

Drainfield B accepted the water introduced directly into the line.

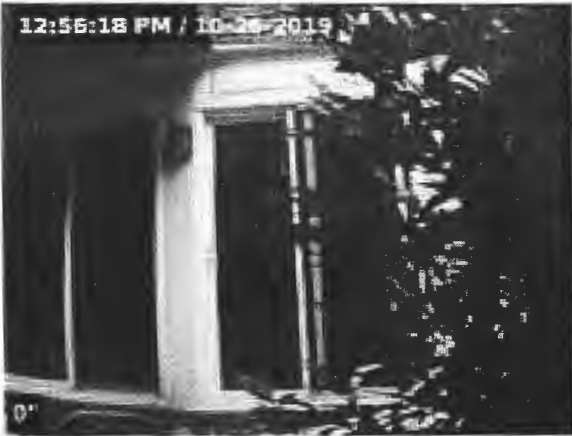
Beginning of the video and identifying the property.

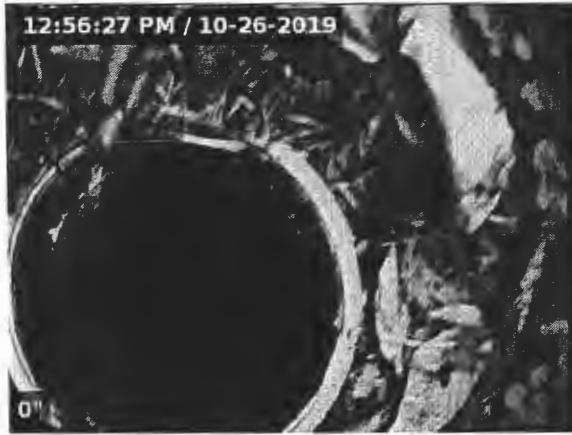
The 6" cleanout on the front end of the septic tank.

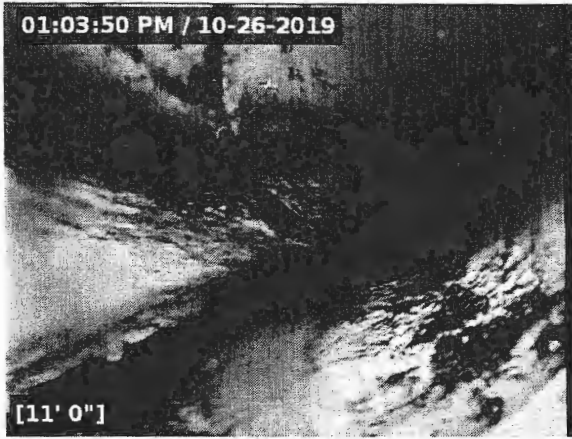
The camera has reached the house.

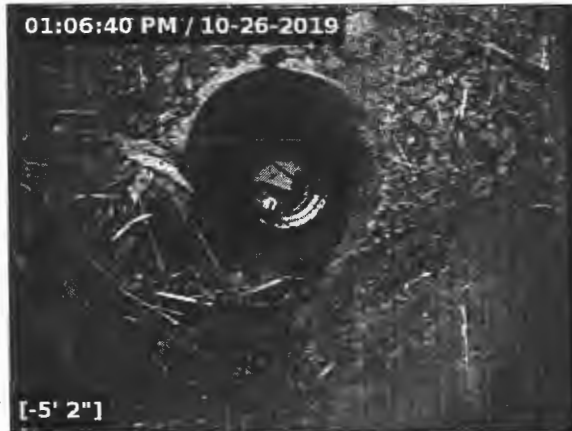
The back end of the septic tank was excavated.

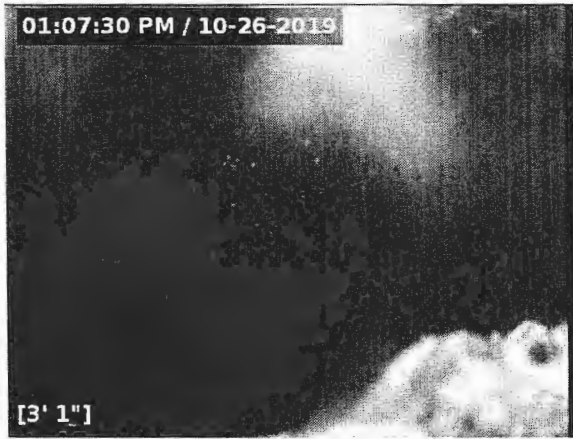
The distribution box is reached.

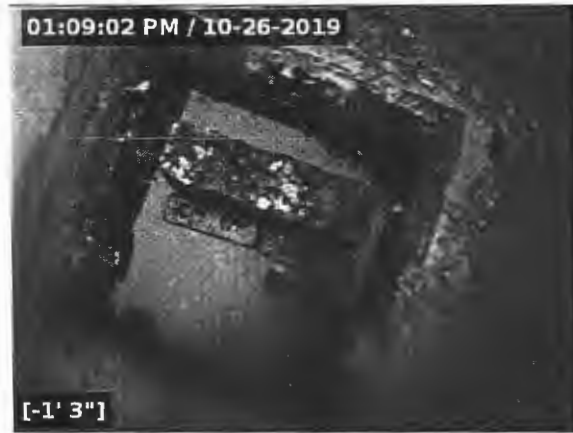
The distribution box is excavated. Drainfield A is to the bottom right and Drainfield B is to the bottom left.

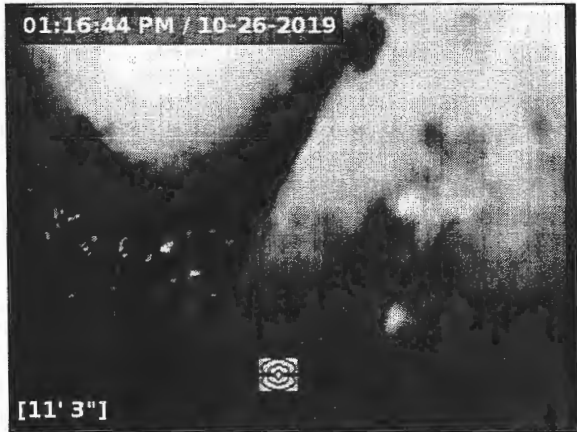
The pipe is observed to be cracked and debris has blocked the drainfield.

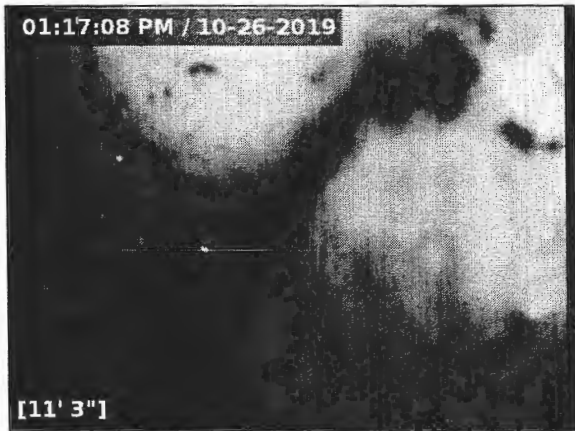
Another photo of the damaged pipe.

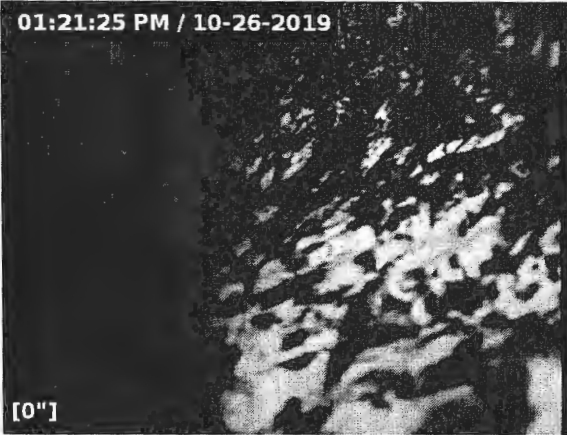
The camera is introduced into drainfield B and zeroed. There is an immediate left turn in the pipe.
