RECEIPT DATE: 5/15/19 **ONSITE SEWAGE DISPOSAL SYSTEM** P 565492

APPROVAL DATE: 9/4/19 **PERMIT: REPAIR** A _____

PROPERTY ADDRESS: 15269 Bucks Run Drive

Date: May 11, 2019 Name of Evaluator: David Vincent Time: 9:00 AM Property Address: 15269 Bucks Run Drive Woodbine, MD 21797 Recent Weather Conditions: Rain	Ordered By: Debbie Jones Buyers: Jennifer Peguero Homeowner Interview: The homeowner interview was requested and was received prior to the evaluation.	Occupied: <input checked="" type="checkbox"/> Yes <input type="checkbox"/> No Length of Time Vacant: N/A # of People Living in Home: 5 # of People moving in: 3 Property Age: 2001 System Age: 2001 Last Date of Cleaning: 2 Years Recomm'd Pumping Freq: 2-3 Years
Liquid level in tank is: <input type="checkbox"/> Above Normal <input checked="" type="checkbox"/> Normal <input type="checkbox"/> Below Normal		Bottom Solids Depth: 18 Inches
Depth of tank: 10 Inches	Type of Tank Access: 6" Cleanout & Riser	Depth of tank access: At Grade
Maintenance appears: <input type="checkbox"/> Good <input checked="" type="checkbox"/> Fair <input type="checkbox"/> Poor		Depth to Distribution Box: 18 Inches

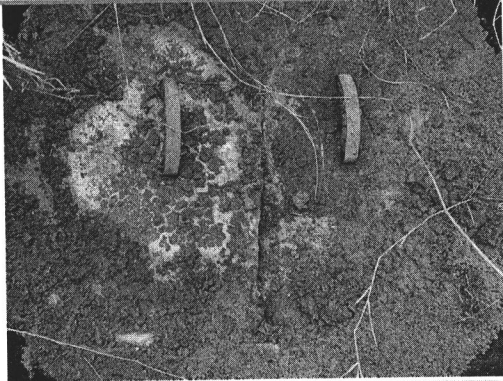
Picture 1:

This picture shows the broken lid on the tank with the riser lid removed. It is recommended that this lid be replaced. The lid was not removed during the evaluation.

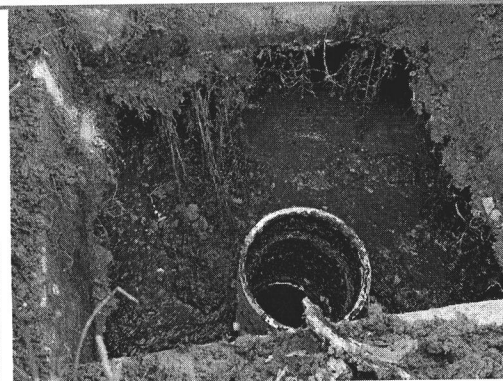
Picture 2:

The back end access of the tank opened, with roots visible in the tank. It is recommended that the roots be removed.

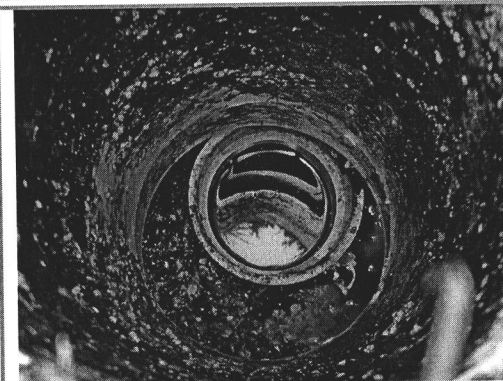
Picture 3:

This picture shows the front line, which was found to be completely submerged upon arrival. The front line will need to be remediated by a licensed contractor, as it is a potential clogging point.

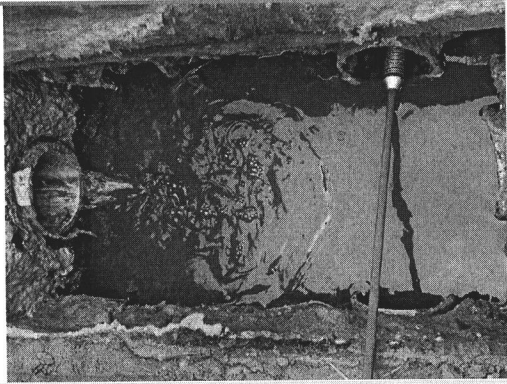
Picture 1:

The distribution box at the beginning of the hydraulic load test.

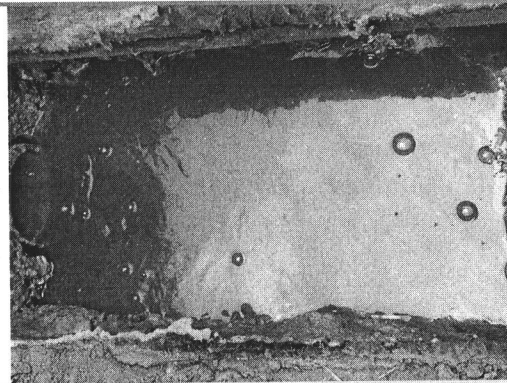
Picture 2:

The distribution box after approximately 200 gallons of water were introduced into the system. All three drainfield lines are completely submerged in effluent, indicating a back-up.
