Bureau of Environmental Health

RECEIPT DATE: 2/26/20 ONSITE SEWAGE DISPOSAL SYSTEM P 567325

APPROVAL DATE: 3/9/2020 PERMIT: REPAIR A

PROPERTY ADDRESS: 6392 Guilford Road

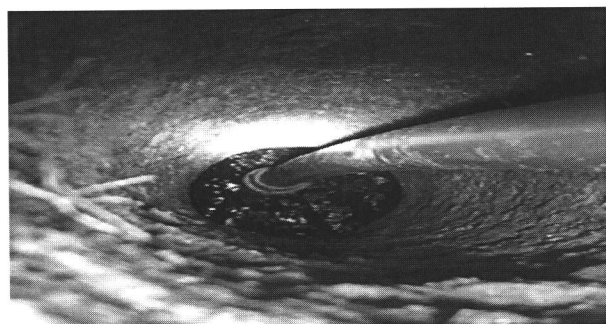
Picture 1:

Shows the liquid level in the septic tank to be below normal, upon arrival for the evaluation. Shows the liquid level in the tank to be at -3.5', upon arrival for the evaluation.

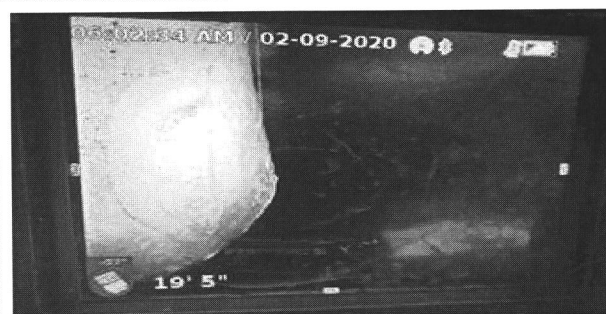
Picture 2:

Shows upon arrival the liquid level in the septic tank was observed to be below normal and below the front terracotta cleanout.

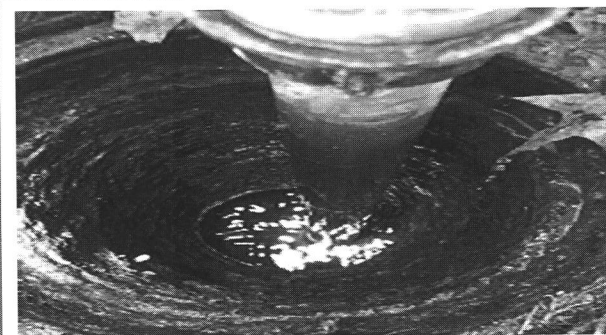
Picture 3:

Shows the liquid level in the tank was returned to the normal operating level during the evaluation.

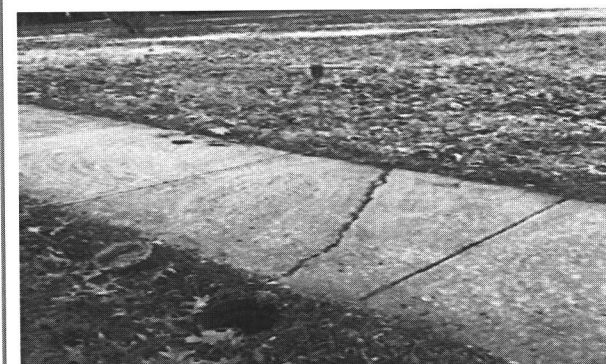
Picture 4:

Shows a portion of the septic tank to be located underneath a concrete walkway. In the event of future repairs, portions of the concrete walkway may need to be removed.

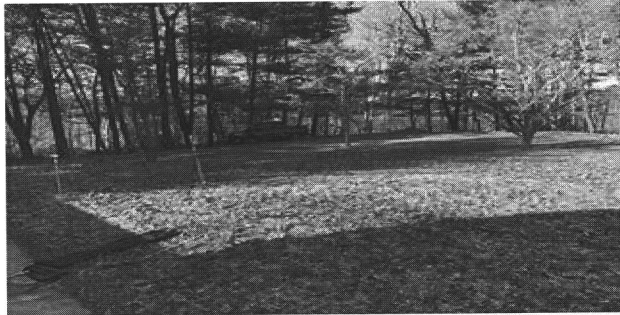
Picture 5:

Shows the approximate area for the absorption system. Shows the absorption system to be located in close proximity to a paved driveway. In the event of future repairs, portions of the paved driveway may need to be removed.

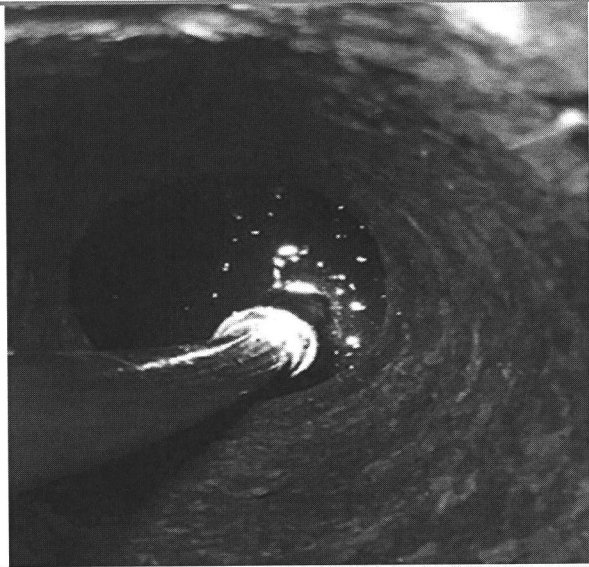
Picture 9:

Shows upon arrival for the re-inspection the liquid level in the septic tank was observed to have returned to a below normal level. Shows the liquid level in the tank to be at ~3.5', upon arrival for the re-inspection. This indicates that the septic tank is currently leaking.

<input type="checkbox"/> Other:	Tank Size: 1,500 gallons	<input type="checkbox"/> Unknown:	_____
System Component	Condition	Comments	
Septic Tank	<input type="checkbox"/> Acceptable	Access consists of a 6" cast iron cleanout at grade over the front of the tank; the tank is located 28" below grade. The front and back baffles are in place and are composed of terracotta. Upon arrival for the initial evaluation the liquid level in the tank was observed to be below normal. (See pictures 1 & 2) The liquid level in the tank was returned to the normal operating level during the initial evaluation. (See picture 3) A re-inspection was conducted and the liquid level in the tank was observed to have returned to a below normal level. (See picture 9) This indicates that the tank is currently leaking. The liquid level in the tank was observed to be at -3.5', upon arrival for the re-inspection. This indicates that the tank has leaked ~500 gallons of liquid prior to the re-inspection. The septic tank will need to be replaced by a license contractor, once the proper permits are issued by the county health department.
