**APPLICATION  
FOR PERCOLATION TESTING AND SITE EVALUATION**

SUBDIVISION/PROPERTY NAME BRAEBURN S-1  
 PROPERTY ADDRESS 10869 BRAEBURN RD. COLUMBIA, MD 21044  
STREET TOWN ZIP

<b>Date:</b> May 4, 2021 <b>Name of Evaluator:</b> Nicholas Riehl <b>Time:</b> 10:30 AM <b>Property Address:</b> 10869 Braeburn Road Columbia, MD 21044 <b>Recent Weather Conditions:</b> Normal		<b>Ordered By:</b> Chris Nelson  <b>Buyers:</b>  <b>Homeowner Interview:</b> The homeowner interview was sent but was not received prior to the evaluation.		<b>Occupied:</b> <input type="checkbox"/> Yes <input checked="" type="checkbox"/> No <b>Length of Time Vacant:</b> 1-2 <b># of People Living in Home:</b> N/A <b># of People moving in:</b> 2 <b>Property Age:</b> 1966 <b>System Age:</b> 1966 <b>Last Date of Cleaning:</b> Unknown <b>Recomm'd Pumping Freq:</b> 2-3 years					
<b>Liquid level in tank is:</b> <input type="checkbox"/> Above Normal <input checked="" type="checkbox"/> Normal <input type="checkbox"/> Below Normal		<b>Bottom Solids Depth:</b> 14 Inches		<b>Depth of tank:</b> 10 Inches		<b>Type of Tank Access:</b> Cleanout		<b>Depth of tank access:</b> At Grade

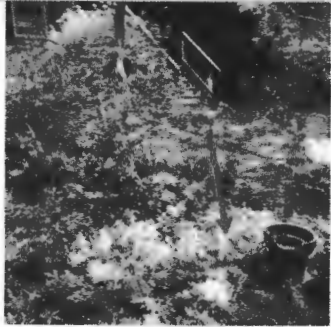
**Picture 1:**

This shows the septic tank in relation to the house.

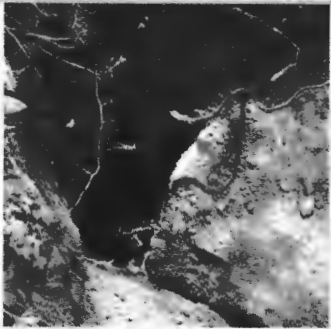
**Picture 2:**

This shows the lid on the back of the septic tank is broken.

<input type="checkbox"/> Aeration System			Tank Size: 750 Gallons			<input type="checkbox"/> Drywell (Number of: 1) <input type="checkbox"/> Cesspool			
<input type="checkbox"/> Other:			<input type="checkbox"/> Unknown: _____						
<b>System Component</b>			<b>Condition</b>			<b>Comments</b>			
<b>Septic Tank</b>			<input type="checkbox"/> Acceptable <input checked="" type="checkbox"/> Unacceptable <input type="checkbox"/> Needs Further Evaluation			The septic tank is composed of concrete and is approximately 750 gallons in total capacity. The septic tank is accessible via a cleanout at grade. The septic tank is 10 inches below grade. The back baffle is in place and composed of terracotta. Currently there are 14 inches of solids in the septic tank. The septic tank is due for cleaning within 1-2 years. The lid on the back of the septic tank is broken. A licensed septic contractor will need to replace the lid. Please refer to page 2 and the camera septic report for further information.

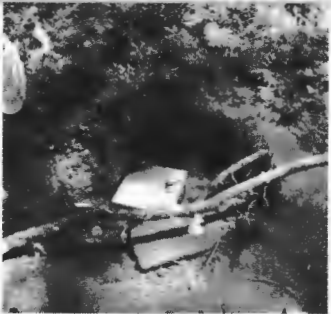
**Picture 3:**

This shows a paver was placed above the opening of the broken lid on the septic tank.

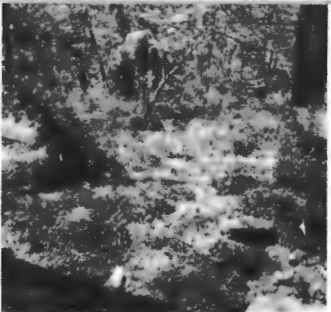
**Picture 4:**

This shows the drainfields in relation to the distribution box. White flags were left above the trenches.

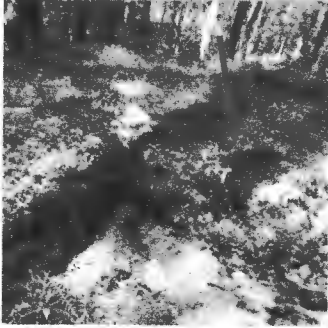
**Picture 5:**

This shows the drainfields in relation to the distribution box. White flags were left above the trenches.

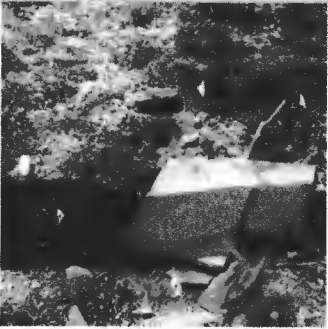
**Picture 6:**

The area above the distribution box was marked and the broken lid was covered with the pavers.
