RECEIPT DATE: 11/25/20 **ONSITE SEWAGE DISPOSAL SYSTEM** P 572874

APPROVAL DATE: 12/16/2020 **PERMIT: REPAIR** A \_\_\_\_\_

PROPERTY ADDRESS: 15521 Cattail Oaks

RE: **15521 Cattail Oaks Septic Repair Installation – P572874**

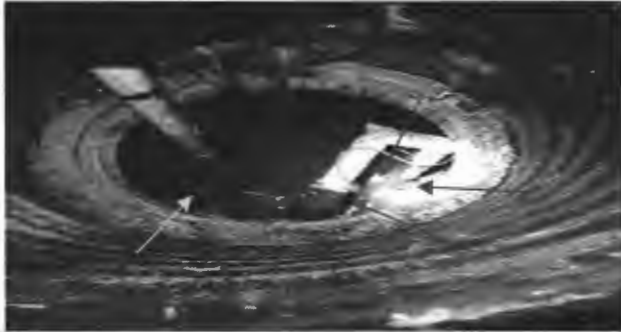
**Picture 1:**

Shows the floats that were located in the pump chamber. Two floats in the pump chamber appear to be not currently in use. (Yellow arrow points to the pump float; red arrow points to the highwater alarm float; blue arrows point to the floats appearing to be not currently in use.)

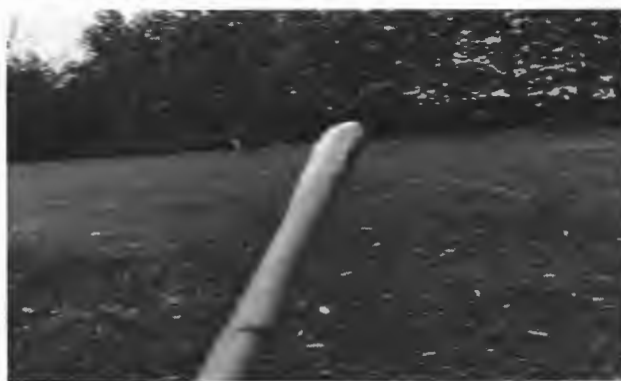
**Picture 4:**

Shows the probe to be wet after probing each drainfield.

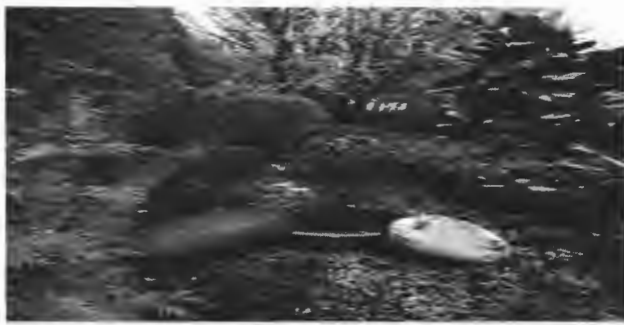
**Picture 6:**

Shows the location of the septic tank and pump chamber on the property. Shows the septic tank and pump chamber to be located underneath of landscaping. In the event of future repairs, portions of the landscaping may need to be removed.

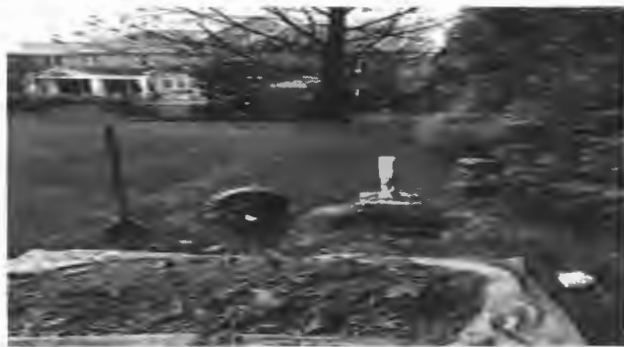
**Picture 7:**

Shows the location of the distribution box on the property. Shows access for the distribution box to consist of a 4" PVC observation port at grade.
