**Howard County
Health Department**

**PERMIT
MINOR REPAIR**

PROPERTY ADDRESS: 13559 Triadelphia Road

Date: January 8, 2021 Name of Evaluator: Nicholas Riehl Time: 10:15 AM Property Address: 13559 Triadelphia Road Ellicott City, MD 21042 Recent Weather Conditions: Normal	Ordered By: Victoria Erbe Buyers: Richard Oh Homeowner Interview: The homeowner interview was sent but was not received prior to the evaluation.	Occupied: <input type="checkbox"/> Yes <input checked="" type="checkbox"/> No Length of Time Vacant: Unknown # of People Living in Home: N/A # of People moving in: 4 Property Age: 1962 System Age: 1962 Last Date of Cleaning: Unknown Recomm'd Pumping Freq: 3-4 Years
Liquid level in tank is: <input type="checkbox"/> Above Normal <input type="checkbox"/> Normal <input checked="" type="checkbox"/> Below Normal		Bottom Solids Depth: 0 Inches
Depth of tank: 27 Inches	Type of Tank Access: Riser	Depth of tank access: 15 Inches
Maintenance appears: <input type="checkbox"/> Good <input checked="" type="checkbox"/> Fair <input type="checkbox"/> Poor		Depth to Distribution Box: Unknown

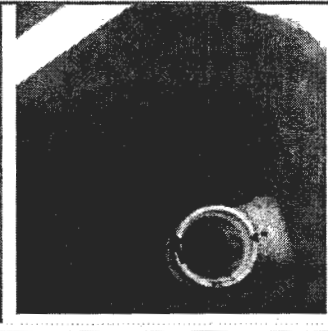
<p>Picture 2:</p> <p>This shows the low liquid level in the septic tank.</p> <p>*This photo was taken during the original inspection.</p>

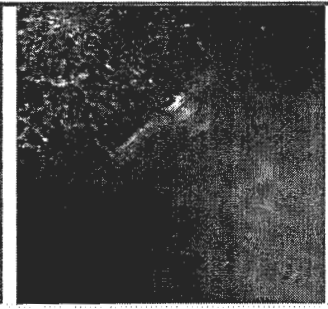
<p>Picture 4:</p> <p>This shows where the liquid level should be vs where the liquid level is.</p>
