INFORMATION FORM - SEPTIC SYSTEM REPAIR/UPGRADE

RECEIPT DATE: 02/26/2020 **ONSITE SEWAGE DISPOSAL SYSTEM** P 568769

SITE INSPECTION SHEET

Date: 1/13/2021 Name of Evaluator: Jon Blevins Time: 12:30 Property Address: 820 Driver Road Marriottsville, MD 21104 Recent Weather Conditions: Normal	Ordered By: Ingrid Lynch Buyers: Christina Moore Homeowner Interview: The homeowner interview was verbally conducted during the evaluation.	Occupied: <input type="checkbox"/> Yes <input checked="" type="checkbox"/> No Length of Time Vacant: ~1.5 years # of People Living in Home: N/A # of People moving in: 1 Property Age: 1953 System Age: 1981* Last Date of Cleaning: ~3 Years Recomm'd Pumping Freq: 4 Years
Liquid level in tank is: <input type="checkbox"/> Above Normal <input type="checkbox"/> Normal <input checked="" type="checkbox"/> Below Normal		Bottom Solids Depth: 10 Inches
Depth of tank: 20 Inches	Type of Tank Access: Manhole Riser	Depth of tank access: At Grade
Maintenance appears: <input type="checkbox"/> Good <input checked="" type="checkbox"/> Fair <input type="checkbox"/> Poor		Depth to Distribution Box: N/A

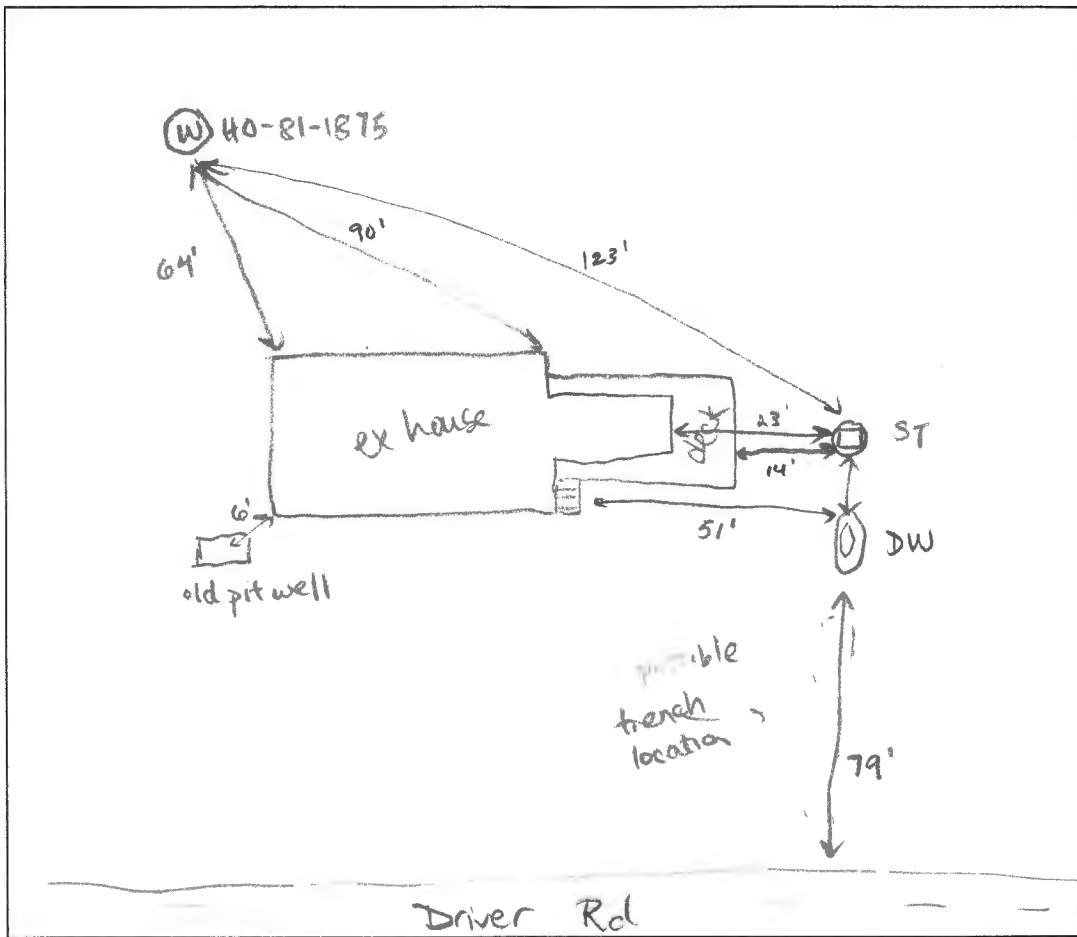
LOCATION DIAGRAM

COMMENTS: Contractor intends to place new 1250 gal (3 bedrooms) tank in same place. Old pit well must be abandoned prior to septic work.

PROPOSAL: Replace leaking block tank with new tank, replace cast iron pipe and reroute sink line to tank

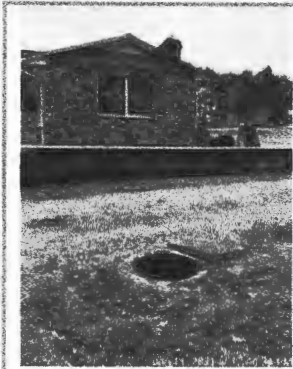
Picture 1: [Picture from original inspection] Showing the septic tank in relation to the house.

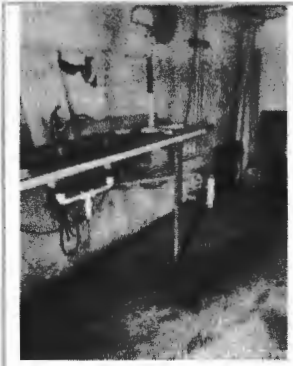
Picture 4: [Picture from original inspection] Showing the sink in the utility room behind the house. This sink must be rerouted to the septic system or be removed.

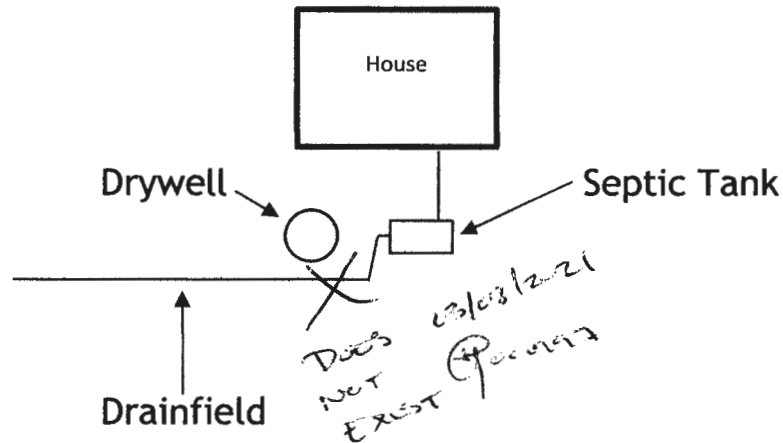
Sketch of System

Absorption System	<input type="checkbox"/> Acceptable <input type="checkbox"/> Unacceptable <input checked="" type="checkbox"/> Needs Further Evaluation	County records state a drainfield was installed in 1981. The drainfield is approximately 4 feet below grade and 50 feet in length. The suspected drainfield location was probed and found to be dry with no signs of biomat present. A drywell with a manhole to grade was located just off the septic tank. This appears to be the original drywell. It was found to be dry to the bottom with a corroded inlet line and no apparent outlet line. A hydraulic load test could not be performed due to a back-up in the septic tank during the inspection.
