INFORMATION FORM - SEPTIC SYSTEM REPAIR/UPGRADE

RECEIPT DATE: 07/20/2021 **ONSITE SEWAGE DISPOSAL SYSTEM** P 569616
 APPROVAL DATE: 08/05/2021 **PERMIT: TANK REPLACEMENT REPAIR** A 569616
 PROPERTY ADDRESS: 14396 Old Frederick Road, Sykesville, MD 21784
 SUBDIVISION: - LOT: - TAX ID: 04-322584
 CONTRACTOR: Legacy Septic EMAIL: _____
 CONTRACTOR ADDRESS: 1538 Manchester Road, Westminster, MD 21157 PHONE: (301) 370-4121
 PROPERTY OWNER: Stack, Kristen EMAIL: _____
 OWNER ADDRESS: 14396 Old Frederick Road, Sykesville, MD 21784 PHONE: _____

Date: June 18, 2021 Name of Evaluator: Nicholas Riehl Time: 12:00 PM Property Address: 14396 Old Frederick Road Sykesville, MD 21784 Recent Weather Conditions: Normal	Ordered By: Well Water Solutions Buyers: Homeowner Interview: The homeowner interview was sent but was not received prior to the evaluation.	Occupied: <input checked="" type="checkbox"/> Yes <input type="checkbox"/> No Length of Time Vacant: N/A # of People Living in Home: 1 # of People moving in: Unknown Property Age: 1917 System Age: Unknown & 1984 Last Date of Cleaning: 2019 Recomm'd Pumping Freq: 2-3 Years
Liquid level in tank is: <input type="checkbox"/> Above Normal <input type

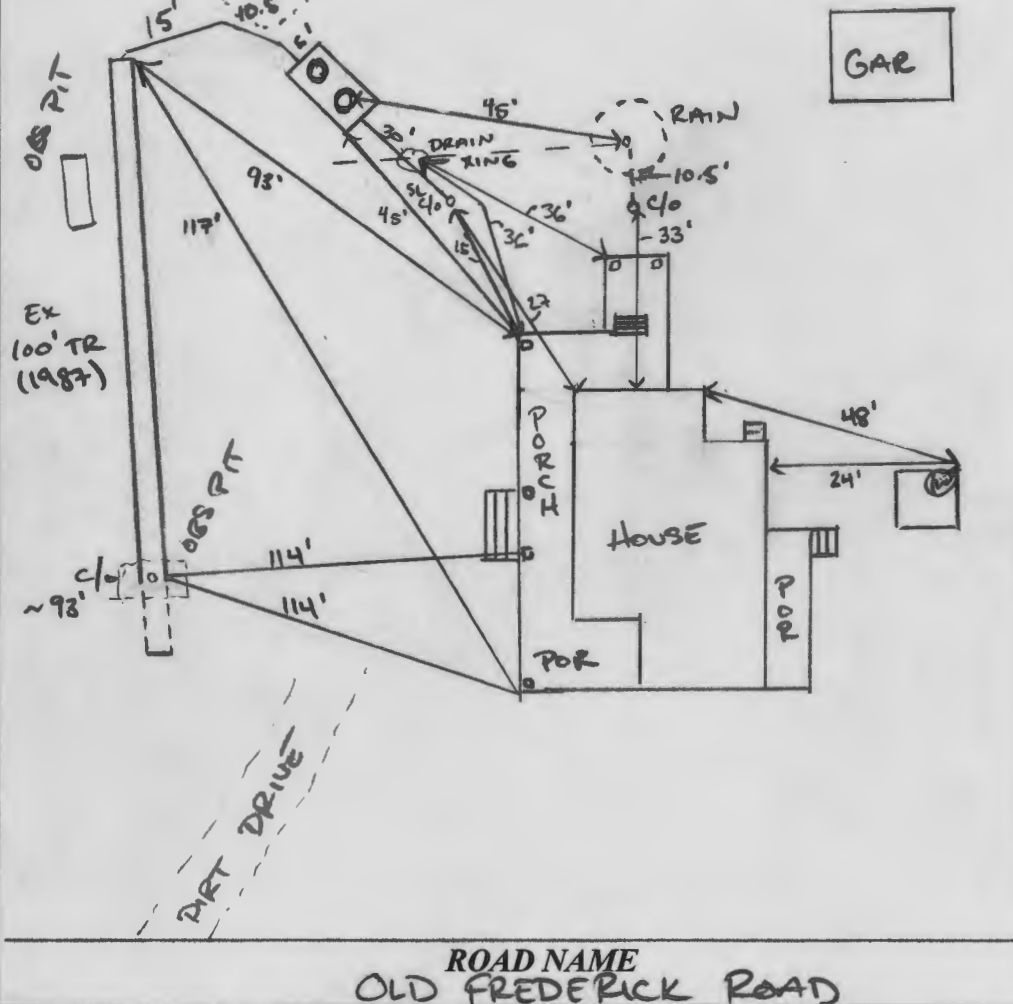
AB CESSPIT
REV RECORDED AS 1250/2000g TANK

PRE-CONSTRUCTION: 08/03/2021 UNCOVERED SEWER LINE AND TANK. TANK WAS CESSPIT. LOCATED EX TRENCH (1987). TRENCH APPEARS CLEAN OF BIOMAT AND COMPLETELY DRY.

* OBS PIT REVEALS HARD BOTTOM AT 10.5'

INSTALLATION: 08/05/2021 INSTALLED OBS PORT 93'-100' AT TRENCH END; SECTION FULL OF FINES. CONT. THOUGHT THEY WERE AT TRENCH END. NOT IDEAL BUT OK. 08/05/2021 (AM) TIE IN TO EX TERRA COTTA SL w/ SWEEP 90 C/O. SET TANK. CRUSHED AND FILLED EX CESSPIT. (PM) EFFLUENT LINE INSTALLED TO EX TR. #

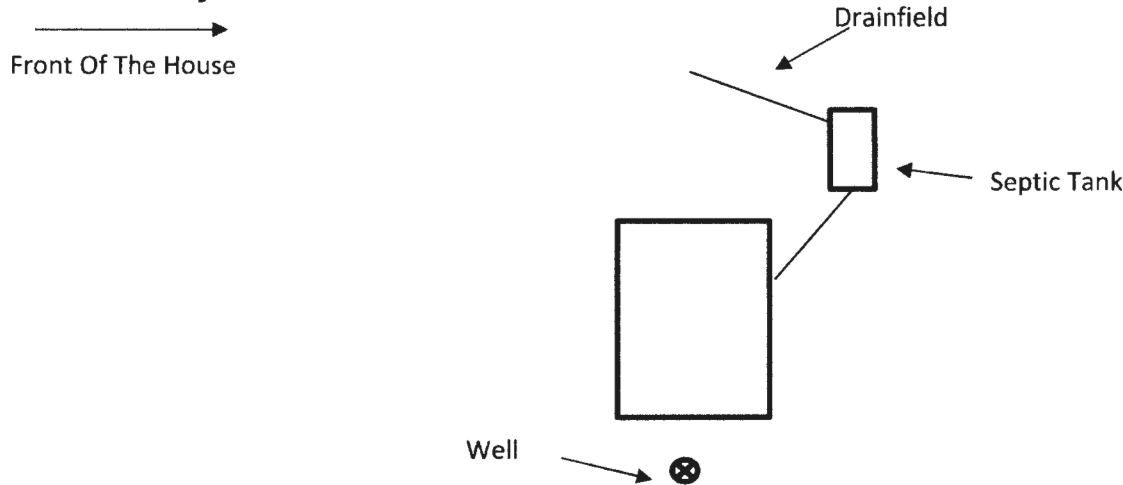
Sketch of System

System Component	Condition	Comments
Septic Tank	<input type="checkbox"/> Acceptable <input checked="" type="checkbox"/> Unacceptable <input type="checkbox"/> Needs Further Evaluation	The septic tank is composed of stone and is approximately 2,000 gallons in total capacity. The septic tank is accessible via a cleanout at grade. The septic tank is 16 inches below grade. The back baffle is in place and composed of PVC. Currently there are 3 inches of solids in the septic tank. Upon arrival, the liquid level was below the normal operating level. The side walls of the septic tank are collapsing into the tank. The septic tank will need to be replaced by a licensed septic contractor after permits have been pulled from the local county health department. Please refer to page 2 for further information.
Pump Present? <input type="checkbox"/> Yes <input checked="" type="checkbox"/> No	<input checked="" type="checkbox"/> Acceptable <input type="checkbox"/> Unacceptable

Absorption System	<input type="checkbox"/> Acceptable <input type="checkbox"/> Unacceptable <input checked="" type="checkbox"/> Needs Further Evaluation	One drainfield was located during the evaluation. The drainfield was probed and found to be dry to a depth of at least 4 inches from the top of the stone. Due to the leaking/collapsing septic tank, a hydraulic load test could not be conducted. When the septic tank is replaced, the absorption system should be re-evaluated to verify its viability.
