RECEIPT DATE: 2/26/21 **ONSITE SEWAGE DISPOSAL SYSTEM** P 568774

APPROVAL DATE: 03/10/2021 **PERMIT: REPAIR** A \_\_\_\_\_

PROPERTY ADDRESS: 17740 Hardy Road

<b>Date:</b> February 8, 2021 <b>Name of Evaluator:</b> David Vincent <b>Time:</b> 9:00 AM <b>Property Address:</b> 17740 Hardy Road Mount Airy, MD 21771 <b>Recent Weather Conditions:</b> Snow		<b>Ordered By:</b> Charlie VanSwol  <b>Buyers:</b> William Van Cleave  <b>Homeowner Interview:</b> The homeowner interview was requested but was not received prior to the evaluation.		<b>Occupied:</b> <input type="checkbox"/> Yes <input checked="" type="checkbox"/> No <b>Length of Time Vacant:</b> ~6 Months <b># of People Living in Home:</b> N/A <b># of People moving in:</b> 4 <b>Property Age:</b> 1975 <b>System Age:</b> Unknown <b>Last Date of Cleaning:</b> Unknown <b>Recomm'd Pumping Freq:</b> 2-3 Years	
<b>Liquid level in tank is:</b> <input type="checkbox"/> Above Normal <input type="checkbox"/> Normal <input checked="" type="checkbox"/> Below Normal		<b>Bottom Solids Depth:</b> 13 Inches			
<b>Depth of tank:</b> 17 Inches		<b>Type of Tank Access:</b> 6" Cleanouts (2)		<b>Depth of tank access:</b> At Grade

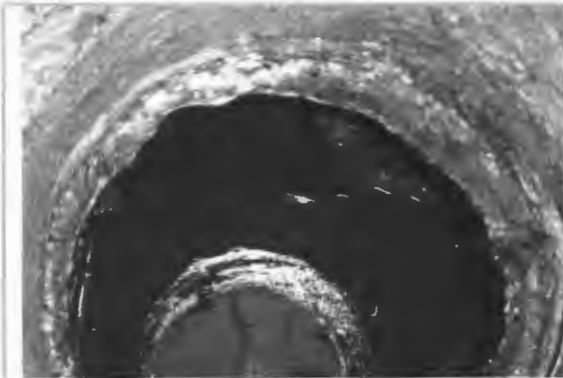
**Picture 1:**

The liquid level in the tank was observed to be below the normal operating level upon arrival. This photo was taken after approximately 150 gallons of water were introduced into the tank to bring the liquid level up to the normal operating level. The liquid level will need to be checked again after at least 24 hours to verify that the tank is watertight and not leaking.

This picture was taken during the initial inspection on 2/4.

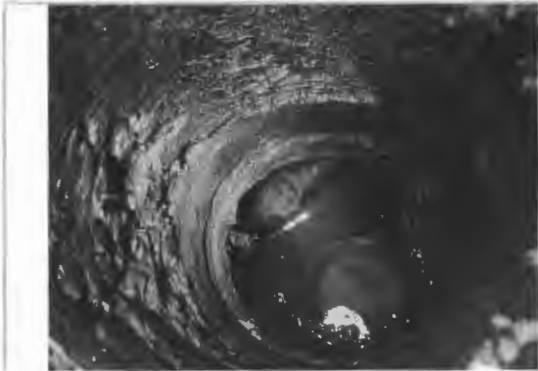
**Picture 2:**

The liquid level in the tank was checked again on 2/8 and was found to have receded approximately 4" below the invert of the outlet line. This indicates that the septic tank is leaking, and will need to be replaced by a licensed contractor.

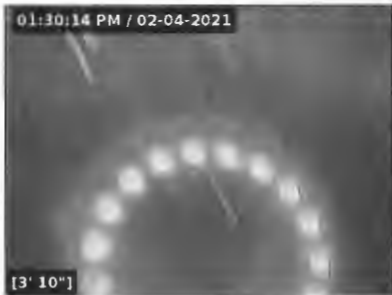
The drywell was found to have approximately 3' of total liquid depth, with approximately 2.5' of liquid depth remaining.

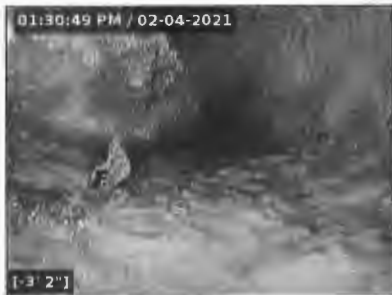
The front and back lines are composed of concrete, and show signs of moderate pitting. Cast Iron pipe- typically last 40-50 years. Is prone to pitting. Pitting is corrosion of metal that can cause holes and or deterioration to develop over time. Heavy pitting can cause clogging points.

The camera is within the back line; moderate pitting of the cast iron pipe is observed.

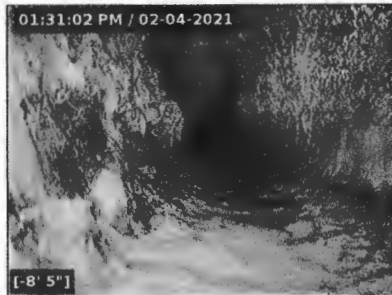
Additional pitting in the line.

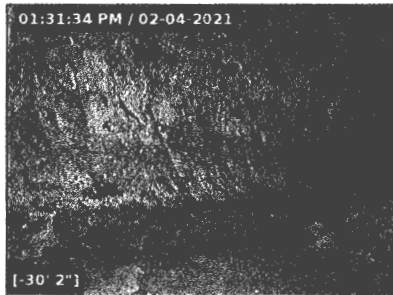
There is a right turn.

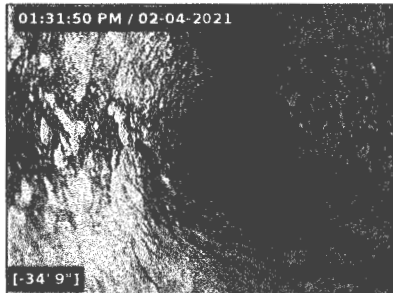
Additional pitting of the line.

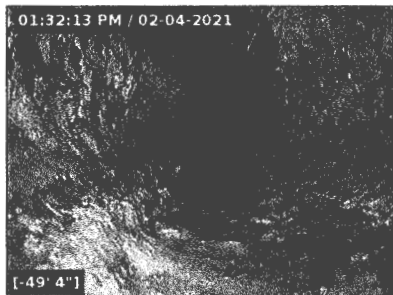
Additional pitting of the line.

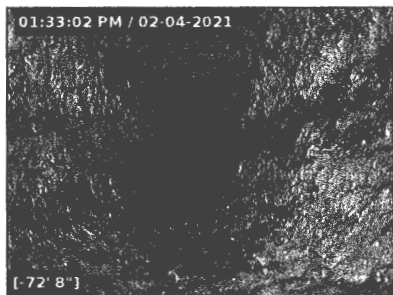
Additional pitting of the line.

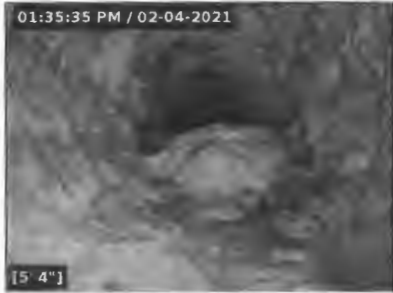
There is a major dip in the front line; this is a potential clogging point. Toilet paper was observed to be accumulating at this dip. The front line will need to be remediated by a licensed contractor, which may include replacement.

Toilet paper observed accumulating in the line at the beginning of the dip.

03/09/2021 REPLACED FRONT LINE W/ SCH 40 PVC AND ADDED CLEANOUT.
