SITE INSPECTION SHEET

OWNER: Christopher Hayes & Gina Lewis Living Trusts PHONE #: \_\_\_\_\_  
ADDRESS: 12585 Folly Quarter Rd CONTRACTOR: Legacy Renovations, Inc.  
Ellicott City, md 21042 WELL TAG #: HO-81-0711  
SUBDIVISION: Glenn Manor LOT: 2 COUNTY #: \_\_\_\_\_  
PROPOSAL: Renovation inside existing structure, three deck and adding a  
full bathroom

DATE: 2/25/22 INSPECTOR: R. Rappoport

**Inspector**  
Mike Weaver  
Environmental Inspector

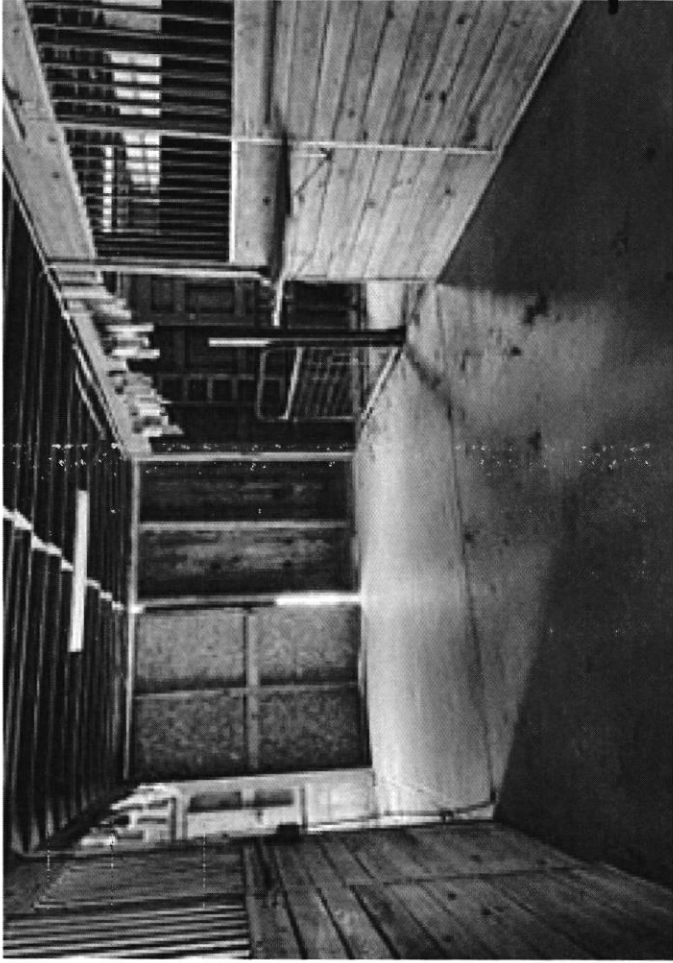
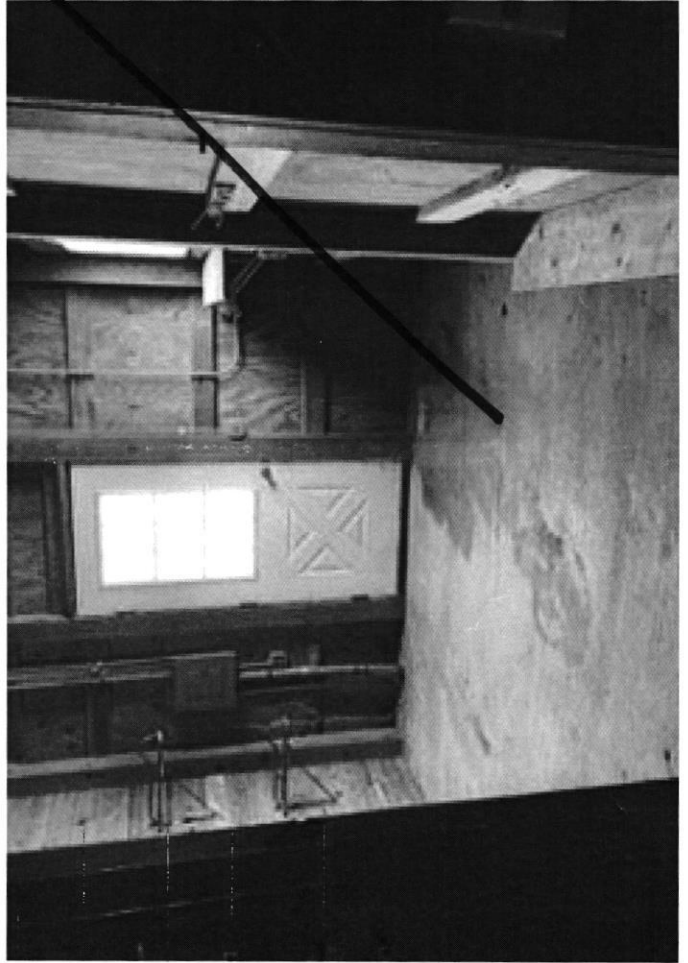
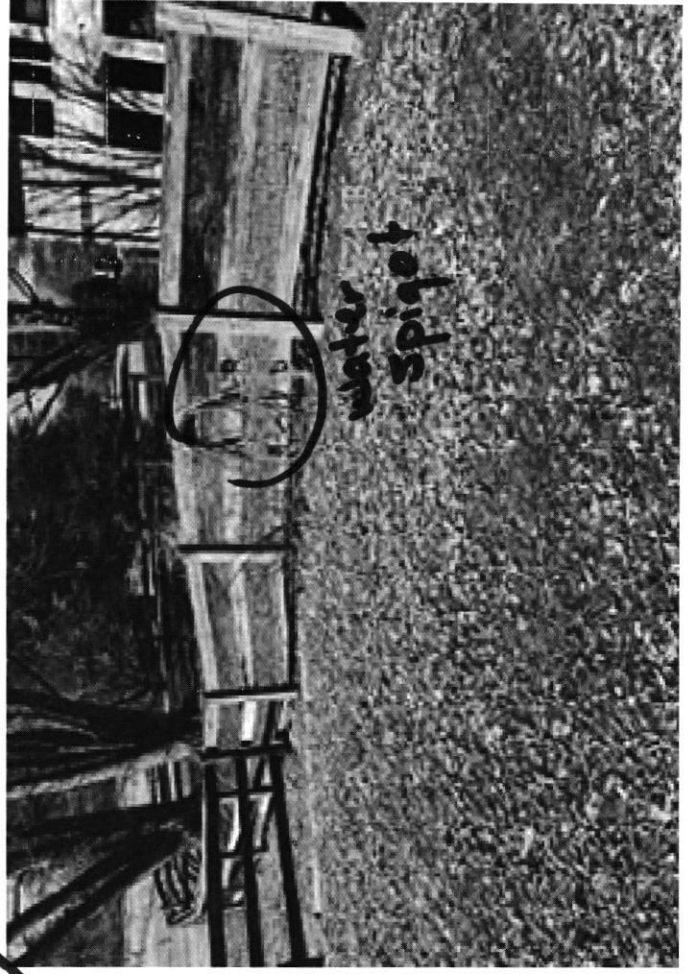
→ concrete slab on top of SDA

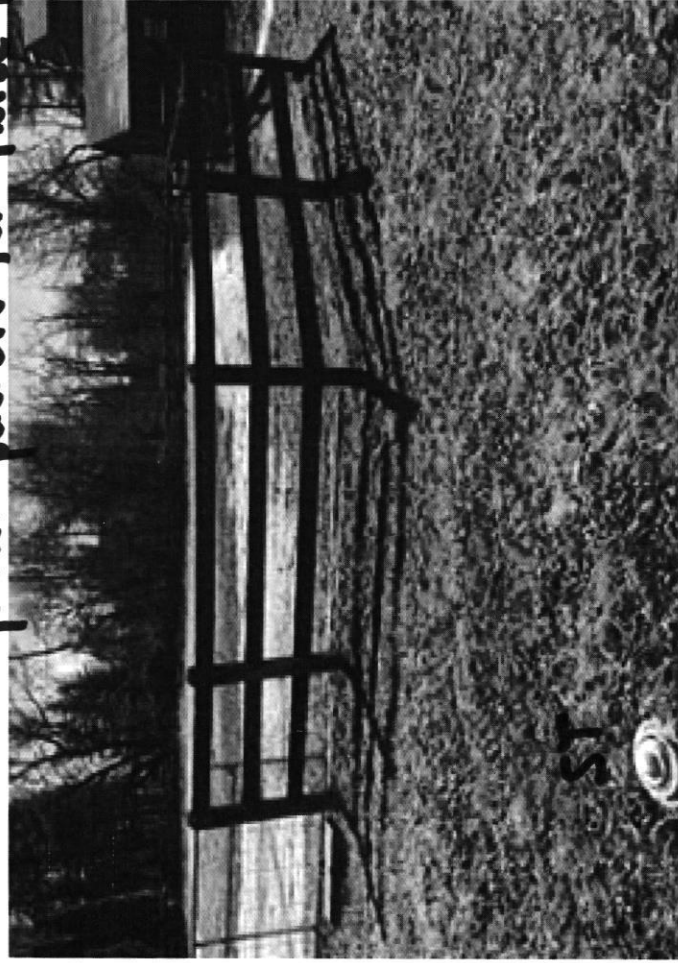
graded pasture for horse training

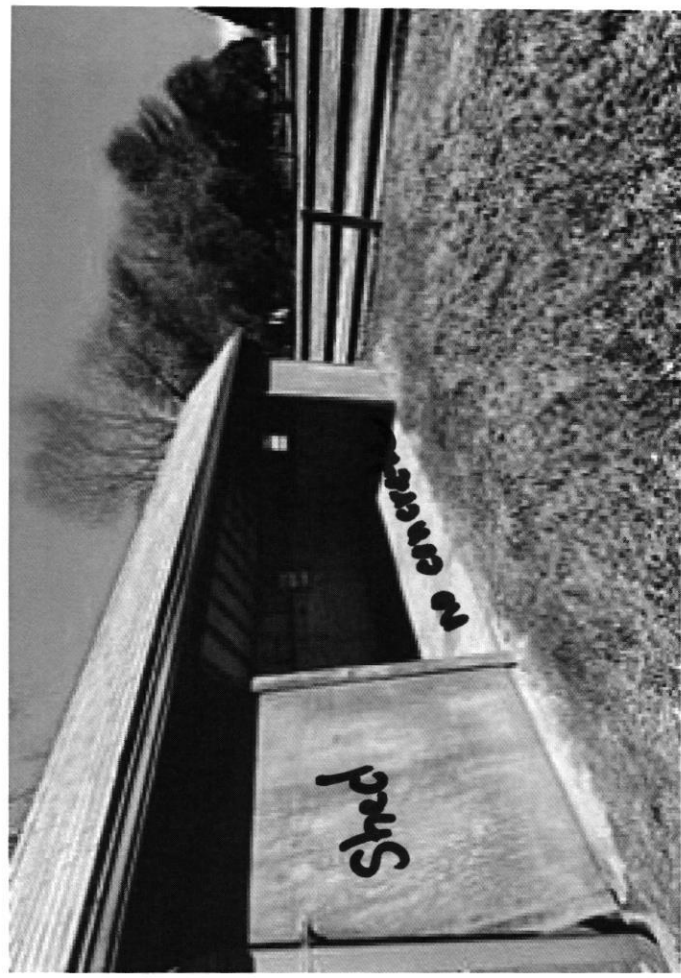
No concrete

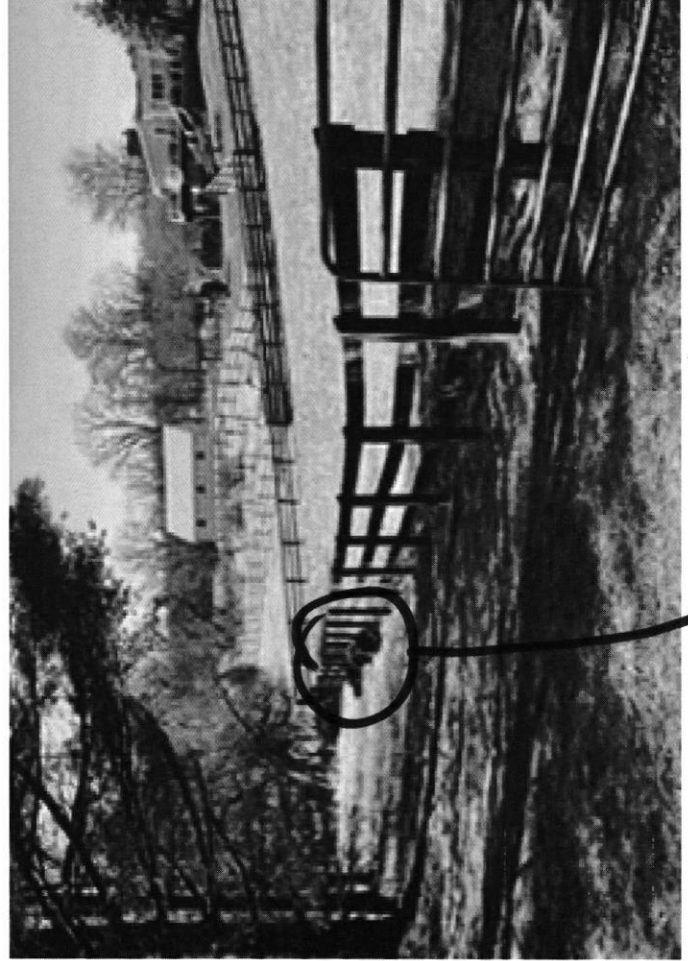
Slab

Unrimmed tires - should be removed.

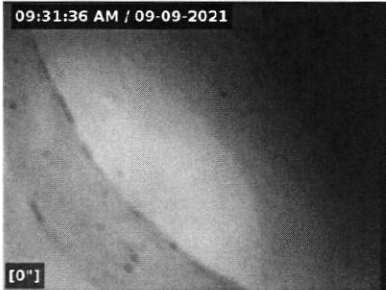
0"

Beginning of front line.

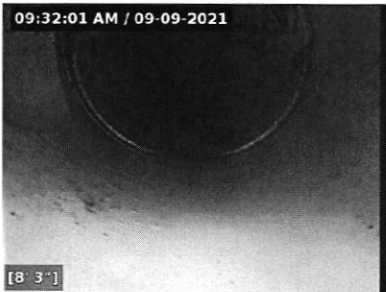
8' 3"

Intersecting line.

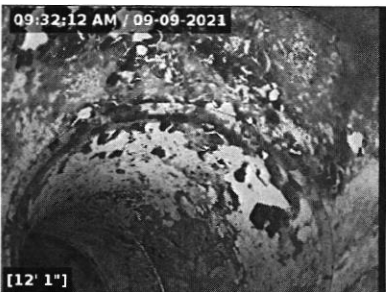
12' 1"

Downward left bend.

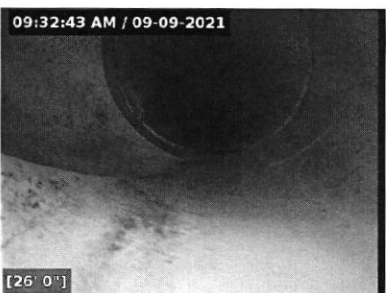
26' 0"

Intersecting line.

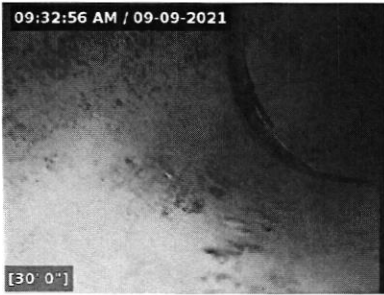
30' 0"

Right bend.

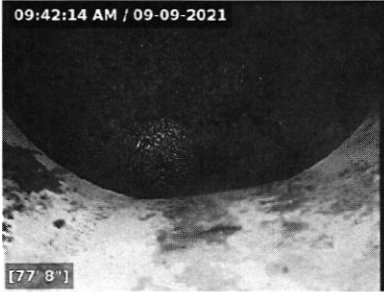
77' 8"

Showing the inside of the front baffle in the septic tank. End of front line.
