RECEIPT DATE: 4/26/2022    **ONSITE SEWAGE DISPOSAL SYSTEM**    P 571515

APPROVAL DATE: 5/5/22    **PERMIT:**    **REPAIR**    A Repair

PROPERTY ADDRESS: 13416 Arada Court

## Onsite Disposal Inspection

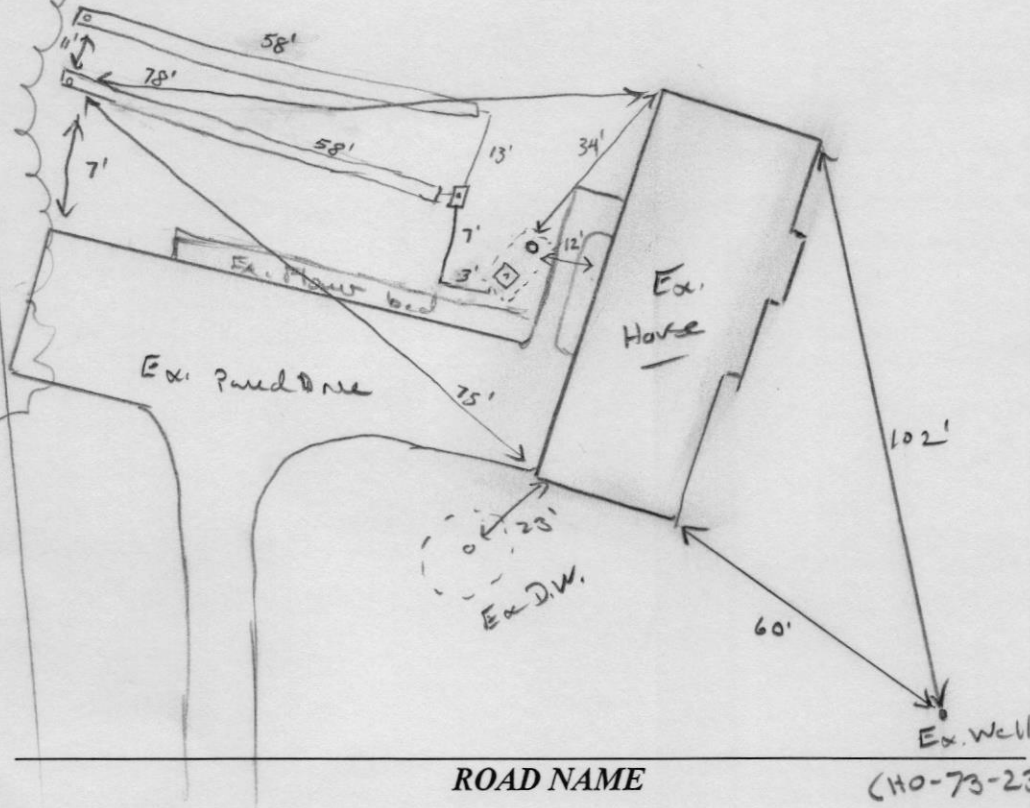
5/5/22 Drywell abandoned. Outlet baffle added to tank. No manhole added to tank because lid is only 6" in ground. 2x 58' trenches installed. D-box level. (ST)

TRENCHES:	LINEAR FEET REQUIRED: <u>116</u>	INLET DEPTH: <u>2</u>
	TRENCH WIDTH: <u>3</u>	MAXIMUM BOTTOM DEPTH: <u>6</u>
	MINIMUM SPACE BETWEEN TRENCHES: <u>11</u>	EFFECTIVE AREA BEGINNING DEPTH: <u>3</u>
LOCATION:	<b>TO BE STAKED BY SANITARIAN DURING PRE-CONSTRUCTION INSPECTION.</b>	
NOTES:	Install 2 x 58 ft trenches on contour just below existing drive. Trenches staked out in field. Pump and collapse existing drywell.

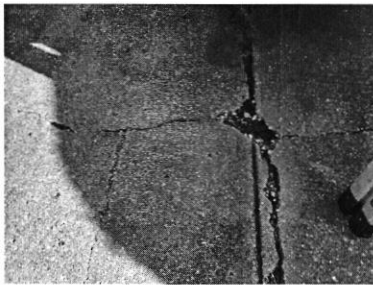
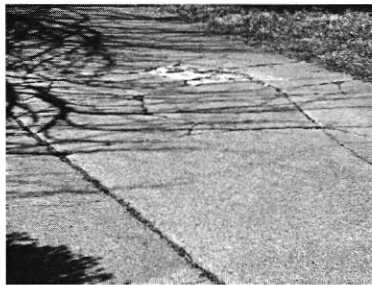
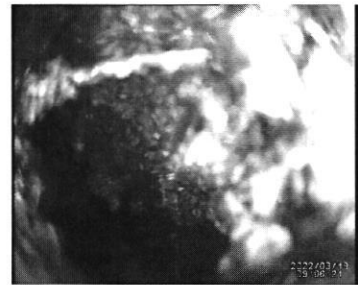
Damaged observed to driveway in the same areas the drain pipes from the septic run. Damage was observed to pipe between septic and drywell. There is no way to access the drain from the drywell to drainfield. Water was still making it to the drywell. Contact a licensed septic company for repairs.

Drain pipe to drywell

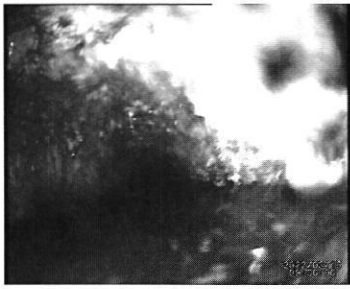
Water sitting in drain pipe to drywell

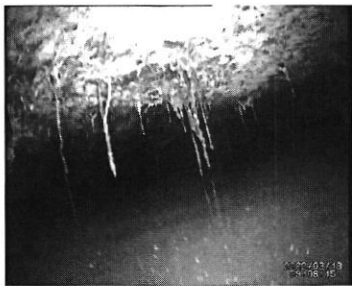
Seepage Pit/Drywell

Seepage pit was filled with water at the beginning of the inspection. It filled up an extra 2 inches before backflowing into the septic tank.

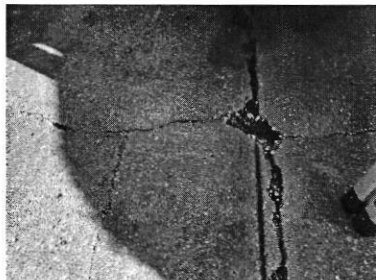
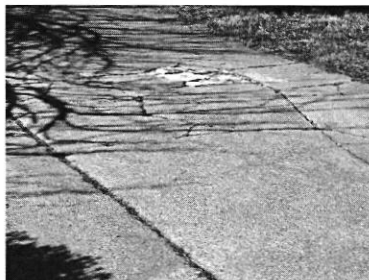
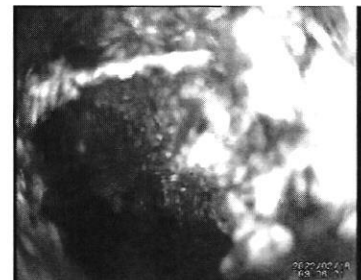
Damaged observed to driveway in the same areas the drain pipes from the septic run. Damage was observed to pipe between septic and drywell. There is no way to access the drain from the drywell to drainfield. Water was still making it to the drywell. Contact a licensed septic company for repairs.

Drain pipe to drywell

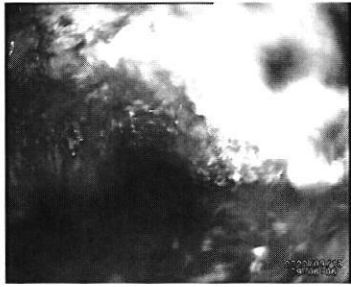
Water sitting in drain pipe to drywell
