**INSPECTION OF THE  
ASBESTOS CONTAINING ACOUSTICAL PLASTER CEILING  
AT THE ABBOTT HOUSE APARTMENT BUILDING  
4539 CEDAR LANE IN COLUMBIA, MARYLAND**

**COLUMBIA RESIDENTIAL MANAGEMENT, INC.  
AND  
COLUMBIA CEDAR LIMITED PARTNERSHIP  
POST OFFICE BOX 1816  
COLUMBIA, MARYLAND 21044-0816**

**ENERGY VENTURES ANALYSIS, INC.  
1901 N. MOORE STREET, SUITE 1200  
ARLINGTON, VIRGINIA 22209-1751**

**AUGUST 1988**

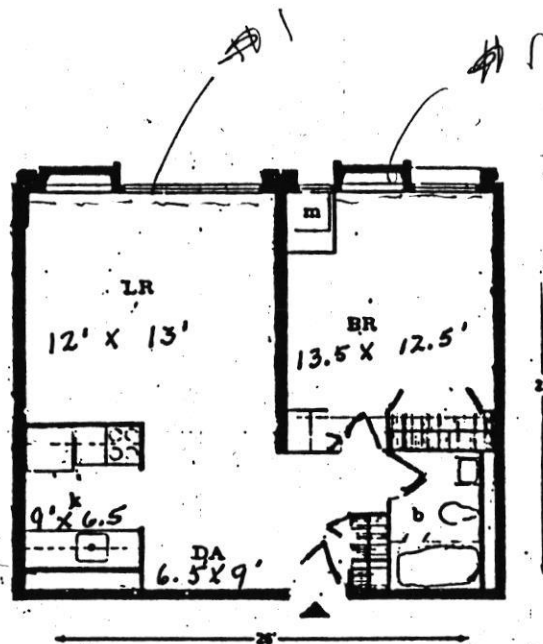
*#1 Stable cond.*

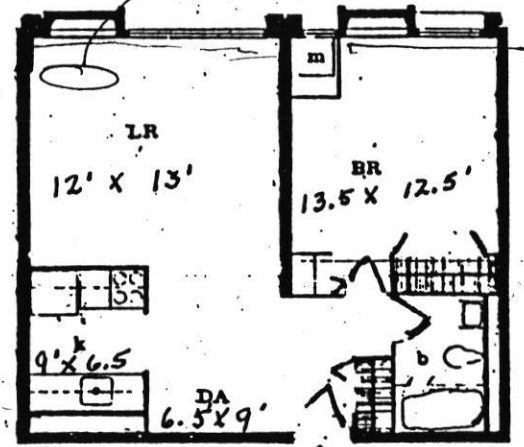
#105

#2  
 Scrape, #2

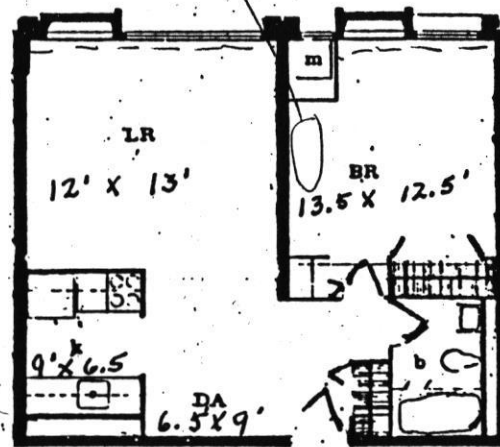
*#502*

*Stained but #1*

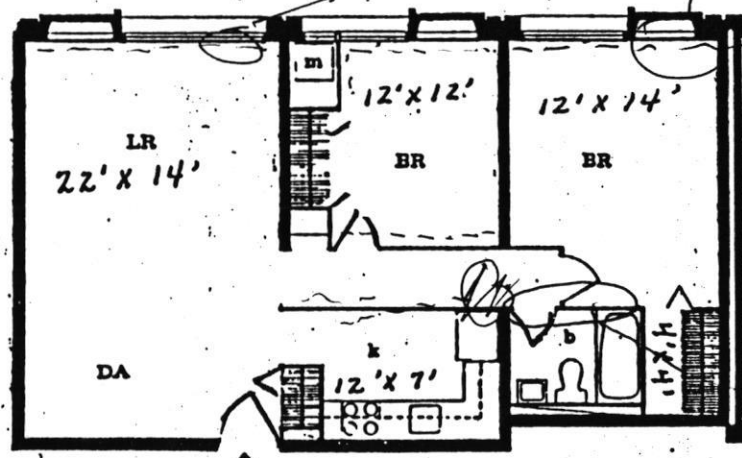
*SIGNS SOME PROCESS MISSING*

*#2*

*Patched & detached*

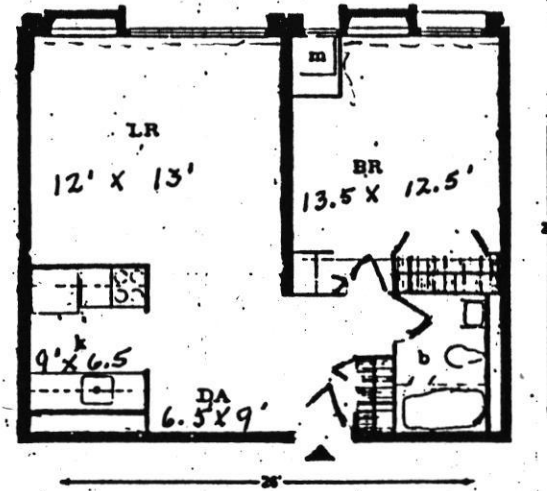
*#505*

*COND #1*

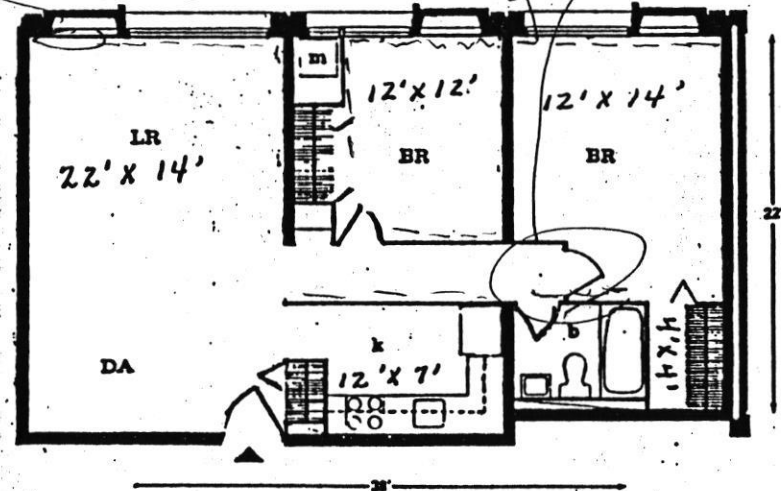
*#503*

*Patch missing*

*Chip missing #2*

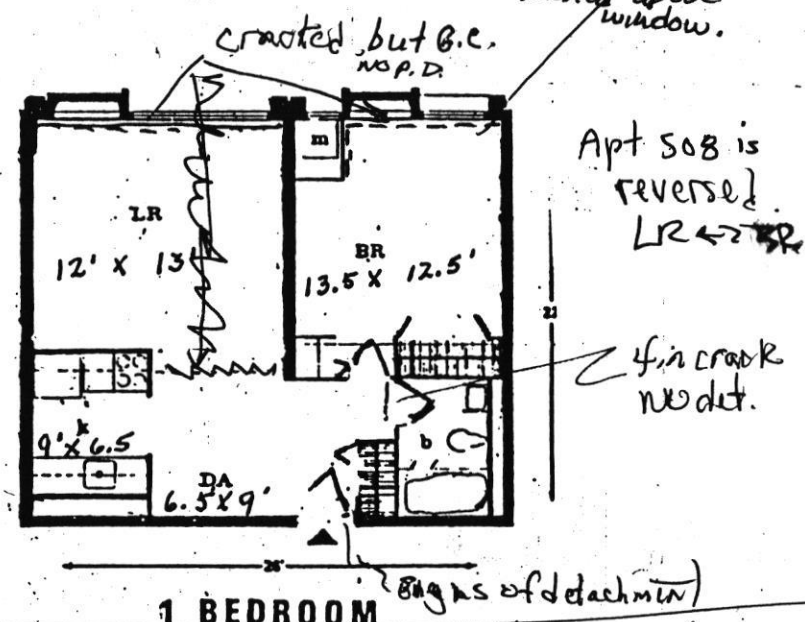
COND. #2

IN bedroom signs along outside wall that some pieces may have been detached above window.

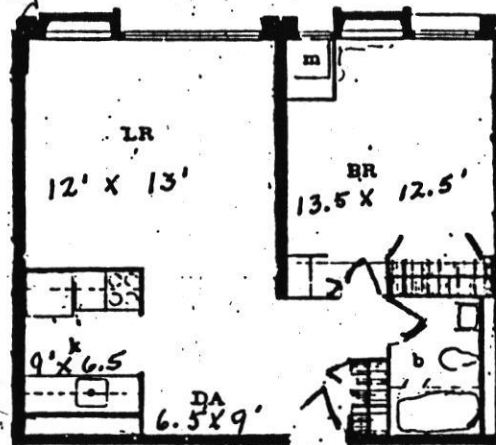
**1 BEDROOM - Apt 511**

*COND #1  
 Good cond stable cracks*

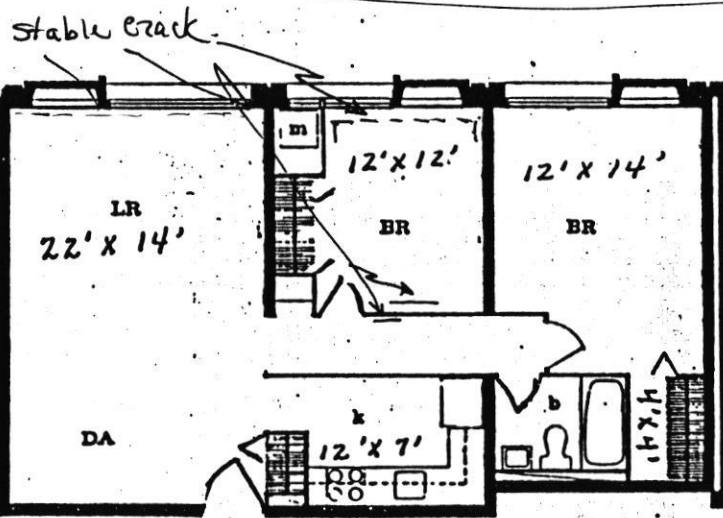
*All Stable  
 Cracks  
 COND #1*

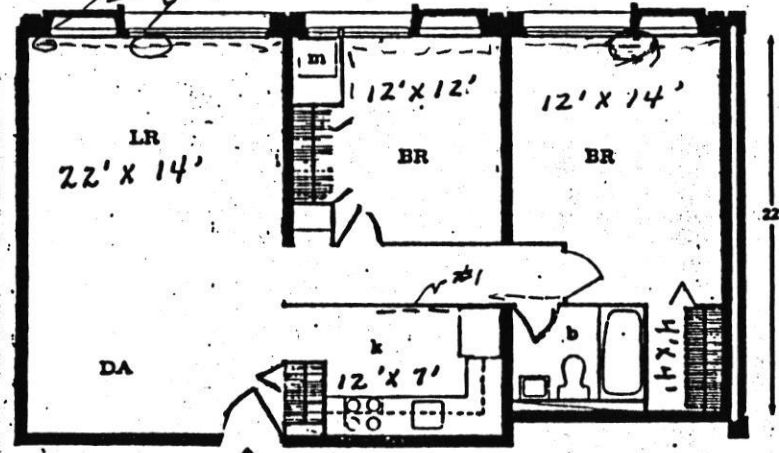
2 BEDROOM - Apt 507

COND #1

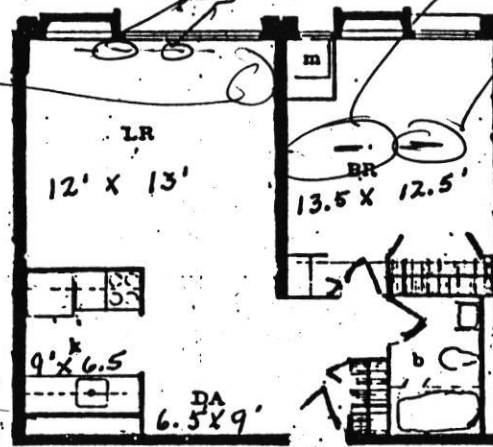
*Appt #612*  
*Some flakes hanging*  
*#2*  
*#2 tape partial dislodged.*

*damaged that was patched*

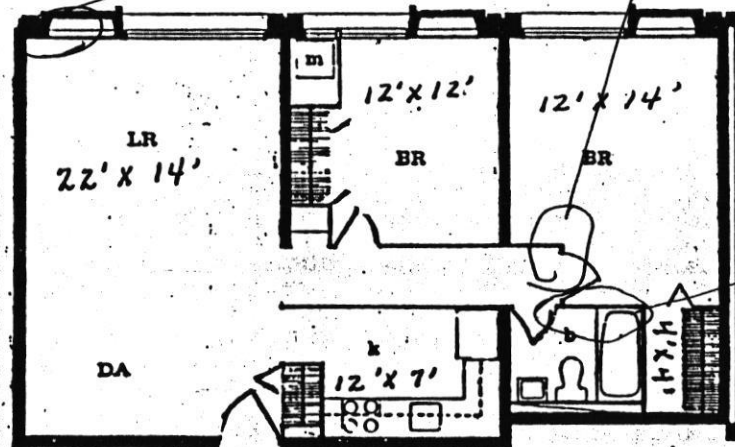
*Appt #606*

*damaged bed cond.*

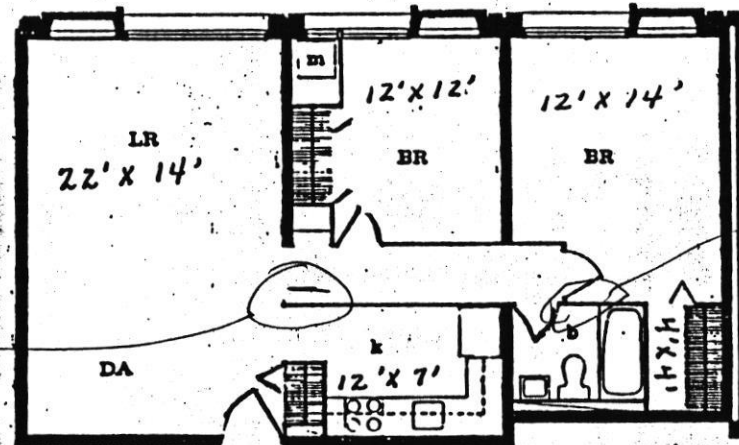
*Handwritten:* Tape Partial detached

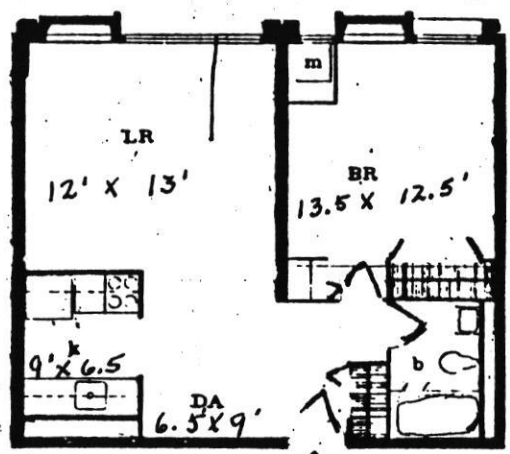
*Apt 701*

701 S	N	Y	paint	Y	1 Y	1ftx8in area detached in bedroom. 6 foot long water damage on outside wall was still wet with history of leaking. Area outside detachment had some large hanging flakes. Outside is immediate area of flaking, ACM appeared stable although discolored. Closet area also leaking but ACM appears stable. Area by window missing piece but no signs of flaking. 2 scraps stable. Air sample showed ambient fiber concentration of 0.001 f/cc which is well below OSHA action level for asbestos of 0.1 f/cc.
801 U	N	N		Y	3 Y	Active water leak in bedroom and closet area. Leak caused detachment of ceiling in bedroom. Water damage extends to 3 sq ft area. Closet area active dripping cause partial detachment but currently condition #2 may turn into condition#3 after drying. Minor cracks elsewhere are stable. Air sample showed no detectable level of fibers in air (<0.001 f/cc) verifying that no asbestos was being or had been released into air at time of test.

*John d 1007*  
*1' x 8" patch in bedroom area -*  
*6' length along outer wall - recent water damage.*  
*2 scrapes - stable.*  
*1 area by window crack - missing patch but no signs of flaking/det.*

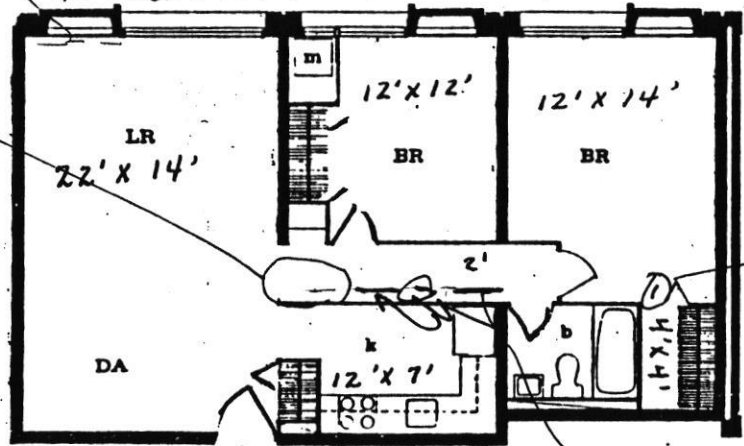
*Apt 704*

*stable minor damage*

*but sig crack stable patched*

*Scrap stable*

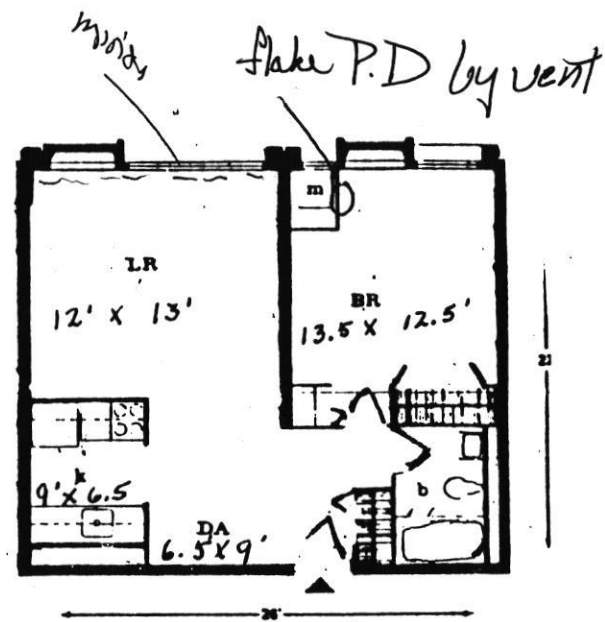
*Apt 702*

702 U	Y		N		Y		1	N	One piece partially detached in bedroom by vent. Otherwise, cracks minor and stable.
704 U	Y		Y1	good	Y		2	N	Tape partially detached in hallway in 3 areas for approx 2-4' in length. Significant crack also in hallway entrance but is stable. Minor crack in Livingroom painted over and stable. Scraps in Bedroom closet door damage are stable. Dust sample showed 25-30% asbestos encased in plaster. Air sample taken verified that no fibers were being or had been released at time of test since concentrations were below detectable limits (<0.001 f/cc).
706 U	N		N		Y		1	N	Partially detached small chips/flakes found in bedroom closet and above smoke detector in hallway. Prescrapped area near Livingroom vent. Minor stable cracks elsewhere. Some discoloration from old water damage evident but ACM stable. Dust sample showed no detectable level of asbestos.
707 U	Y		N		Y		1	N	2 partially detached pieces in large bedroom by vent. Remaining cracks minor, painted and stable. Dust sample showed no detectable level of asbestos.

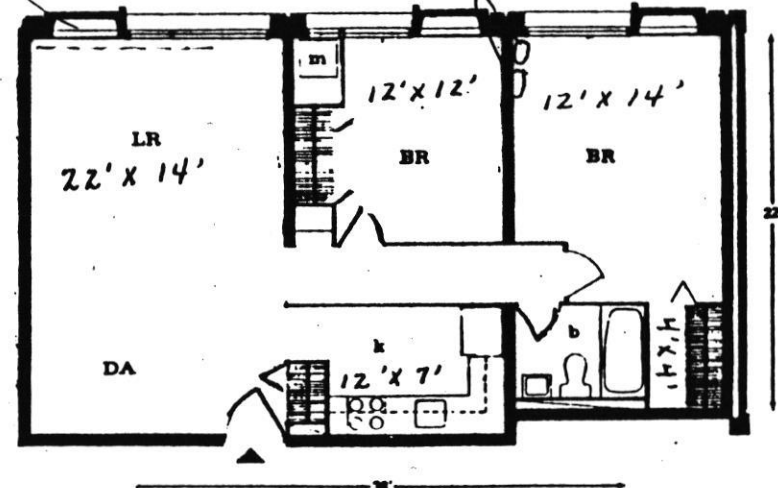
*mirrors painted over.* *2 flakes. P.D. #2*

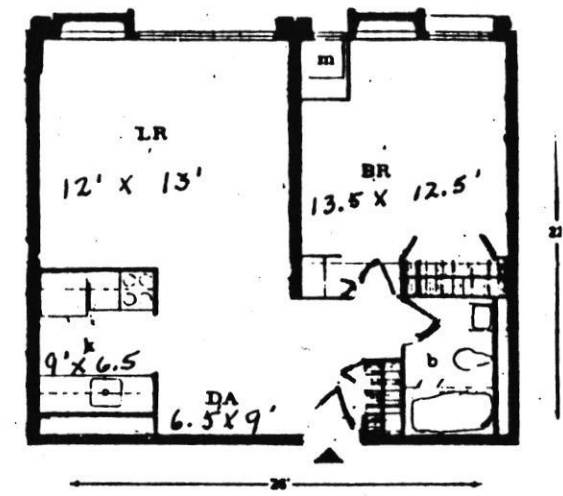
*Apt 709  
 #2*

709 U	N		N		Y		3	N	3' long area by doorway in large bedroom partially detached. One piece partially detached in small bedroom. Significant crack in Livingroom by window is stable. Dust sample showed no detectable level of asbestos.
804 U	Y		N		Y		3	N	Partially detached tape in large bedroom by door. Partially detached chips observed in 2 locations in large bedroom and 1 in livingroom. Missing area of ceiling by vent prescrapped but painted over and stable. Remaining cracks minor and stable. Dust samples showed no detectable levels of asbestos. Living room air sample showed a total fiber level of 0.006 f/cc which is well within OSHA standards.
806 B	Y		N		Y		1	N	Repair patches in livingroom and large bedroom are painted and stable. Cracks painted over and stable except in kitchen where one area partially detached but securely held. Appears to be large pieces of ceiling treatment on top of cabinets but no sign of poor condition of

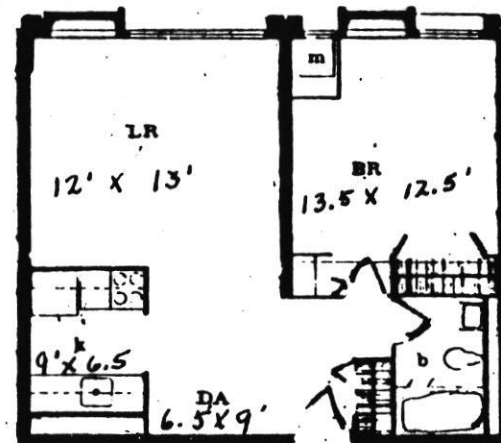
*3ft<sup>2</sup> Detached from water damage  
 Signs of det. in area in BR*

*In closet area - active dripping currently a #2 but may turn into #3*

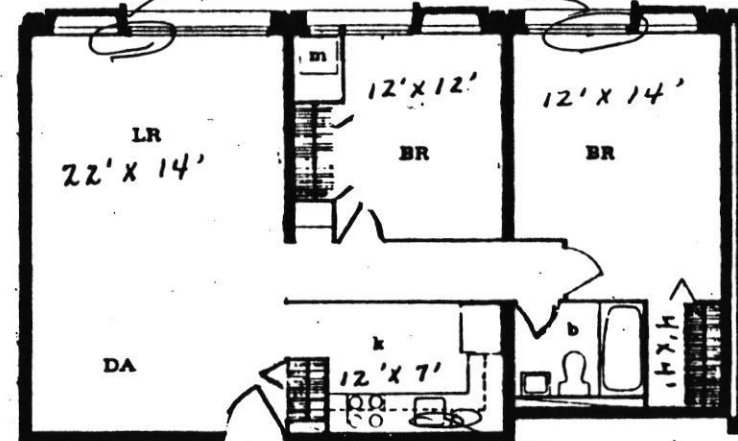
*Patch of painted/repared*

*partial detach*

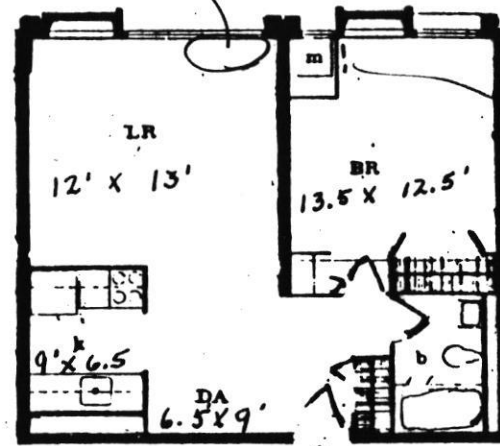
911 U	N	N		Y	2	N		Partially detached area by living room vent measuring 2' by 1' apparently from past water damage. All remaining cracks are minor and stable.

*#2*

*P.D. area by vent 2x1 (maybe water damage)*
