SITE INSPECTION SHEET

PROPOSAL: Site inspection done to verify septic functioning ok.

OWNER: PROP. TRANSFER PHONE #: \_\_\_\_\_  
 ADDRESS: 12203 ETCHINSON CONTRACTOR: HATFIELDS  
ELICOTT CITY WELL TAG #: \_\_\_\_\_  
 SUBDIVISION: \_\_\_\_\_ LOT: \_\_\_\_\_ COUNTY #: (111)  
 PROPOSAL: PROP. TRANSFER; EVALUATING SYSTEM PERC

Subject: Percolation Certification Plan  
Woodmark, Lot 28 Section II, Block B, Csanady Property

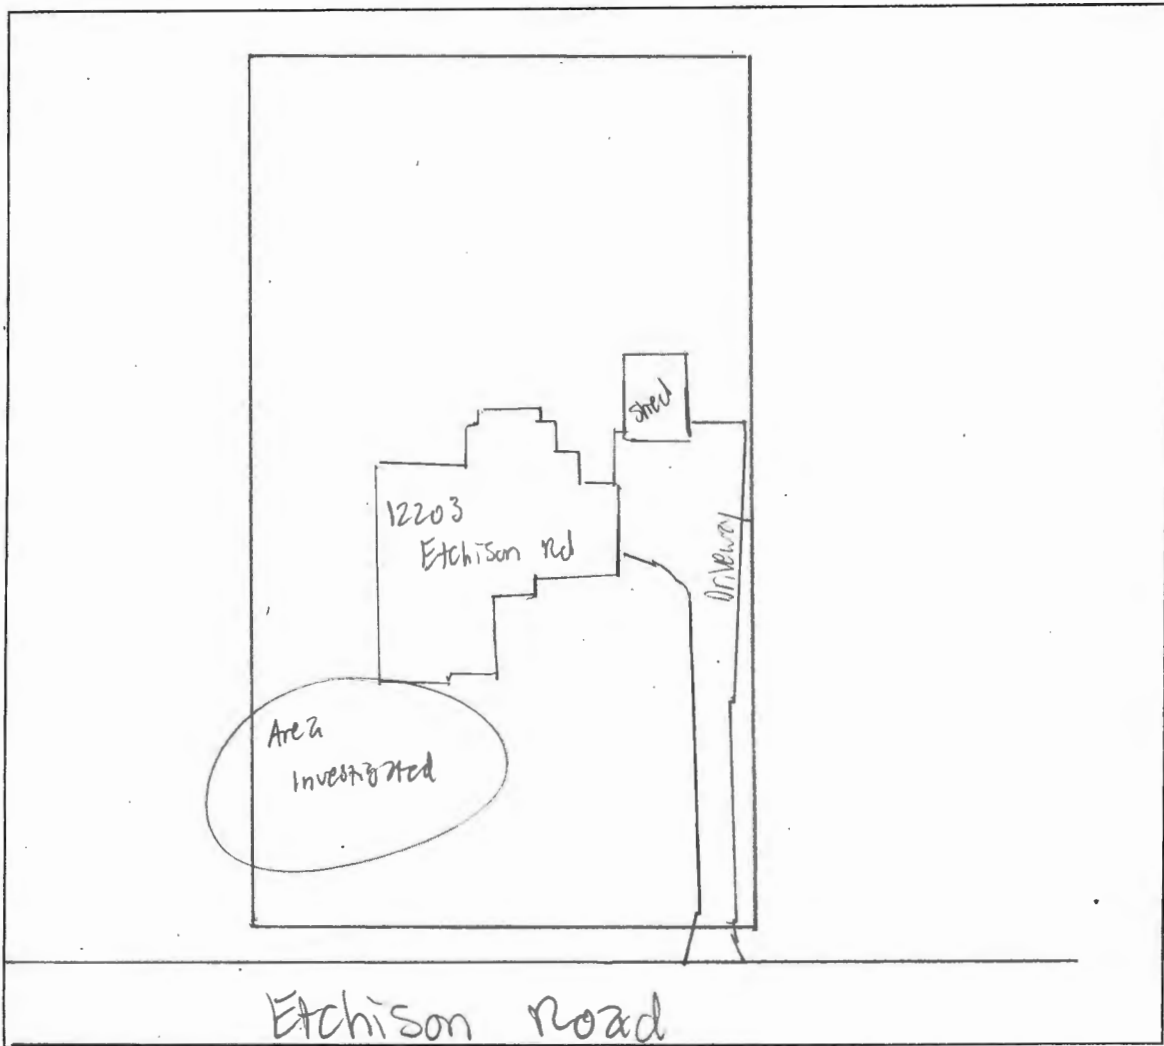
LOCATION DIAGRAM

COMMENTS: On site to verify septic system functioning properly. spoke w/ homeowner & confirmed they're not having problems w/ sewage backing into the home & no sewage smell near drainfield. Walked around drainfield & saw/smelled no signs of a failing system. weather conditions were 45°, cloudy, & raining. (SP)

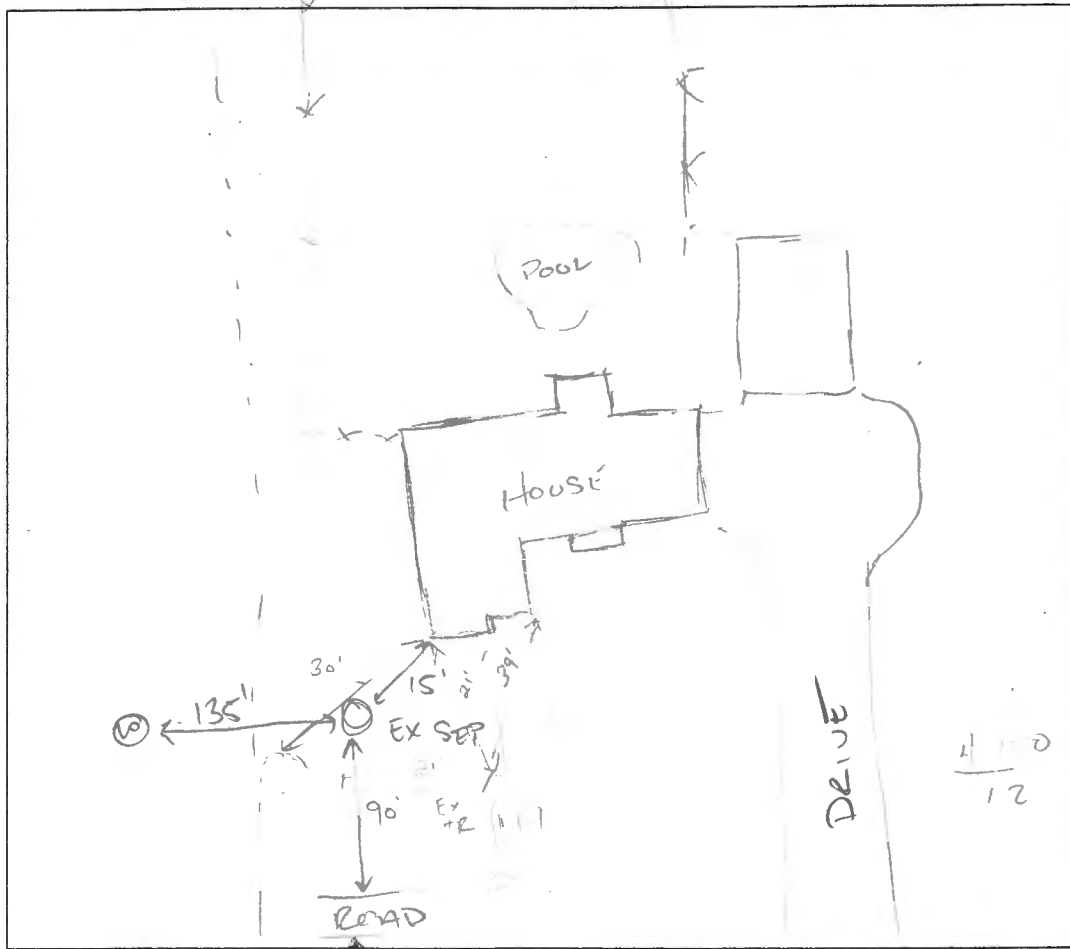
LOCATION DIAGRAM

3  
 8' Bottom  
 5' ECH/ACC  
 < 100'

REPORTED SEPTIC FAIL.

11/24/2020 - SYSTEM IS STILL FUNCTIONING. EX DW IS FULL.  
 23' TRENCH IS STILL FUNCTIONING
