LANGENFELDER
12640 RT. 108
CLARKSVILLE

HOWARD COUNTY HEALTH DEPARTMENT

During the course of the recent septic repair inspection (repair approved, copy of inspection report enclosed), a well construction defect was observed.

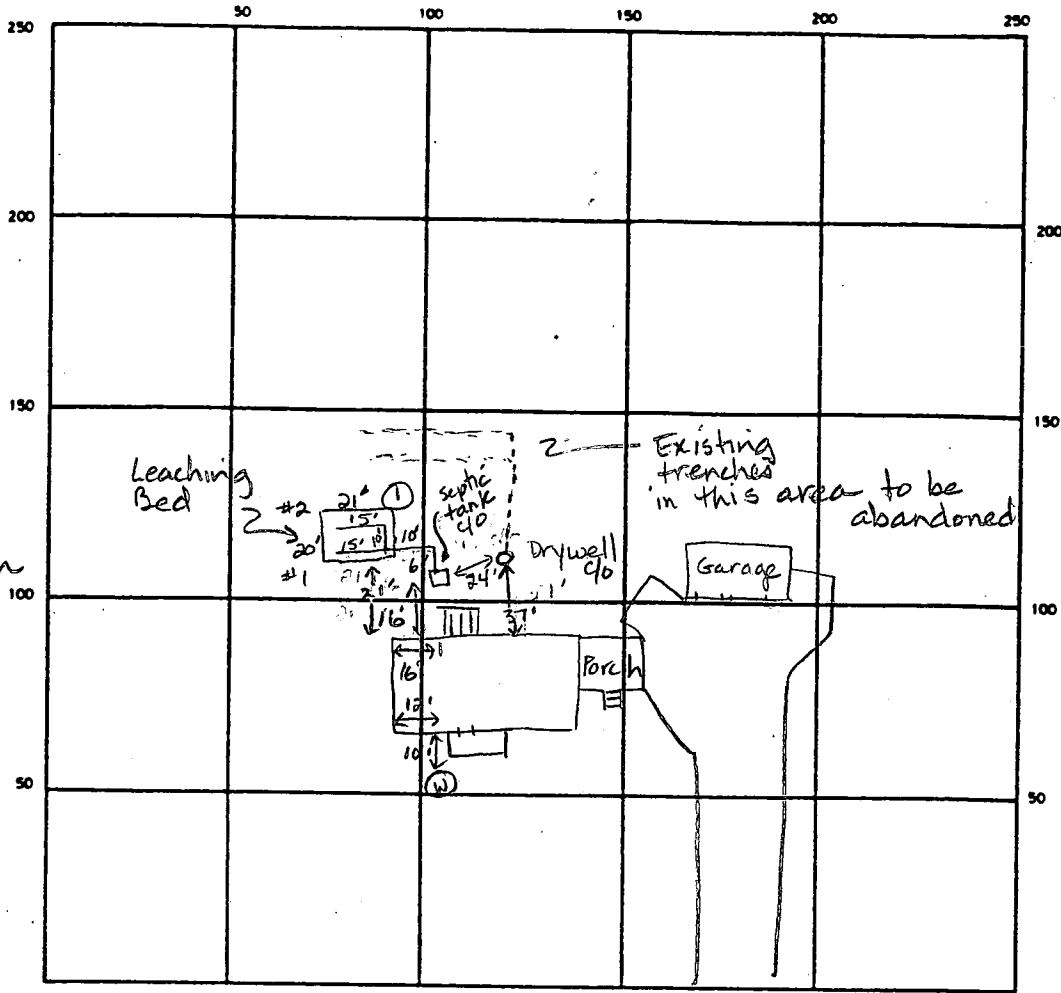
①
Test hole
water at
10.5 ft
5-9-90

5-9-90
Well cap
cracked, flush
w/ ground, open
to contamination
JEN

Leaching Bed ① ② Bed
DRAIN-FIELD/TILE-FIELD DEPTH 6.5 4.5 FT. TRENCH WIDTH 20 x 21 FT. INLET DEPTH 2.5 FT.

REMARKS 5-9-90 Leaching bed 6.5 ft deep at upper end, 4.5 ft deep at lower end. Existing drywell to be abandoned with leaching bed connected to existing septic tank. JEN 6-29-90 Contractor indicated depth to inlet is 2.5 ft from original grade and drywell had been abandoned. JEN

The well casing was observed to be flush with grade and the cap was cracked, leaving the well vulnerable to contamination from surface run-off. Maryland Well Construction Regulation (COMAR 26.04.04.10) specifies that "the well owner is responsible for maintaining the upper terminal at the proper height (not less than 8" above grade) ... and in a condition to conserve and protect the groundwater".

In order to protect your water supply from the threat of contamination and to comply with this regulation, the well casing should be extended to proper height and a secure cap should be placed atop the casing.

This work should be performed by a licensed well driller or plumber and this office (461-9933) should be notified to inspect the work.
