A REPAIR

SEWAGE DISPOSAL SYSTEM
MARYLAND STATE DEPARTMENT OF HEALTH

HOWARD COUNTY
BUREAU OF ENVIRONMENTAL HEALTH

SUBDIVISION _____ ROAD 5946 Montgomery Rd. LOT _____

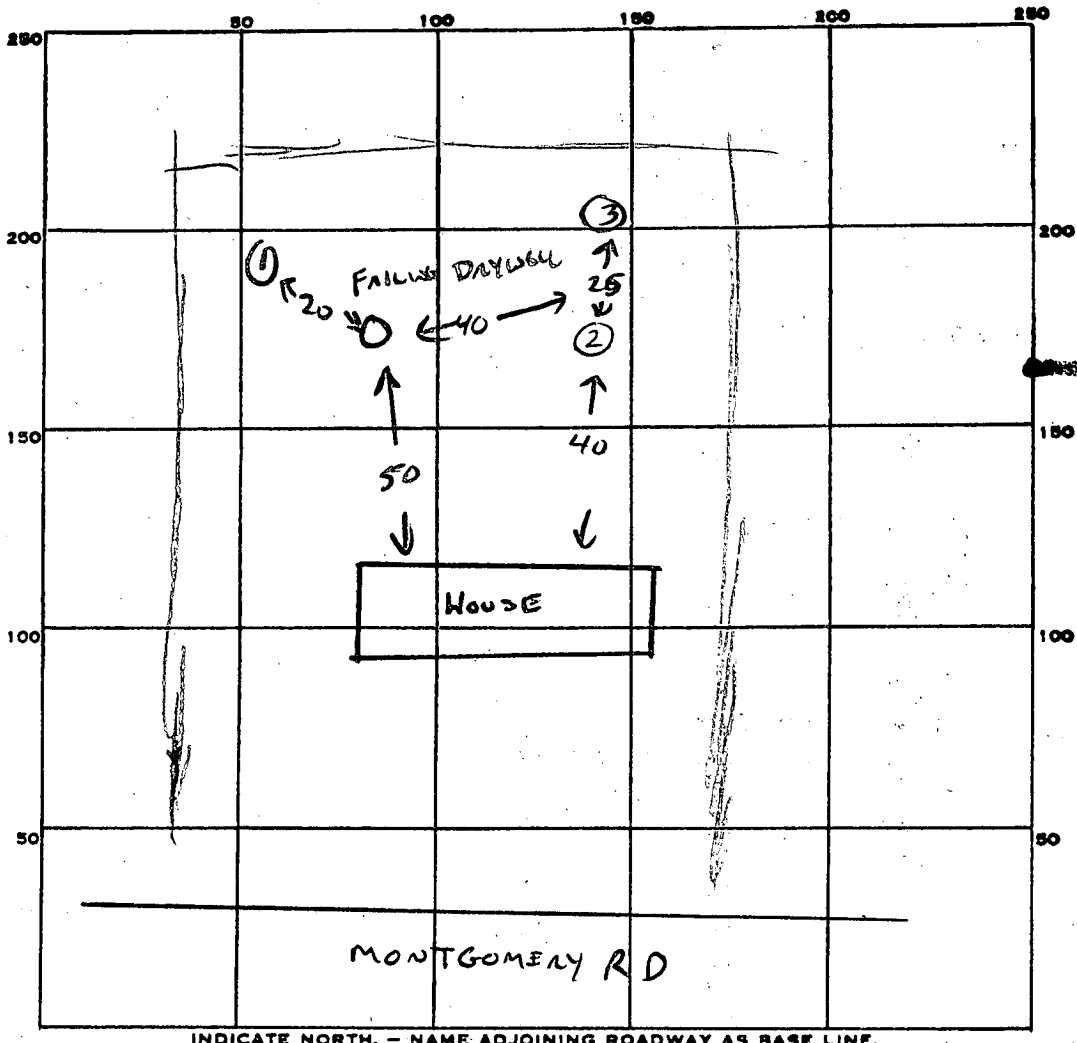
REMARKS EXISTING DAYWELL FOR 25 YEARS SEEMED TO WORK OK. 2 ELDERLY PEOPLE IN HOUSE.
3 HOLES DUG 12' DEEP ALL 3 HAD SANDY CLAY TOP TO BOTTOM.
1 HOLE TESTED - NO PERCOATION IN 2 HOURS.
NO REPAIR FEASIBLE, PUBLIC SEWER ANTICIPATED IN 5 YEARS.
RECOMMEND PUMPING DAYWELL AS NEEDED, IF THAT DOES NOT WORK OUT
THEN RECONSIDER REPAIR POSSIBILITIES.
