PERMIT

SEWAGE DISPOSAL SYSTEM

MARYLAND STATE DEPARTMENT OF HEALTH

SUBDIVISION Evergreen Valley Estates

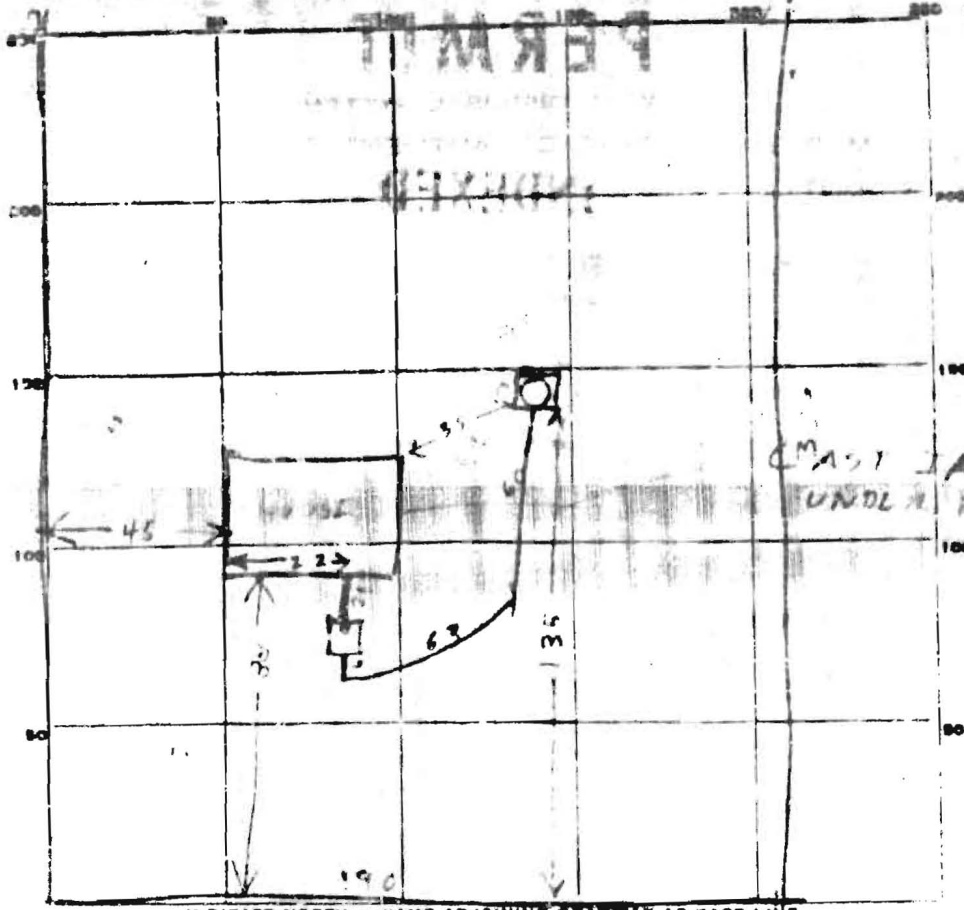
PERMIT CARD

SEPTIC TANK, LEVEL 0.5' above 194' CLEANOUT 0.5'

TILE FIELD, DEPTH 4-6 FT. TRENCH WIDTH 2 FT.

GRAVEL DEPTH 36 IN. TOTAL LENGTH 123 FT.

NUMBER OF TRENCHES _____ TOTAL BOTTOM AREA 260

SEEPAGE PITS, INSIDE DIAMETER 7 1/2 FT. DEPTH BELOW INLET 9 FT.

ABSORBENT AREA 307 SQ. FT. counting slope

REMARKS 9/1/71 - Dry well. Inlet diameter 6 inches. 10 ft. deep.

I see a di. sand line 35' of stone in it.
No water in dry well at the well it caused
water to rise. Water out of it.

DATE SYSTEM APPROVED 9/1/71 INSPECTOR R. Dodge

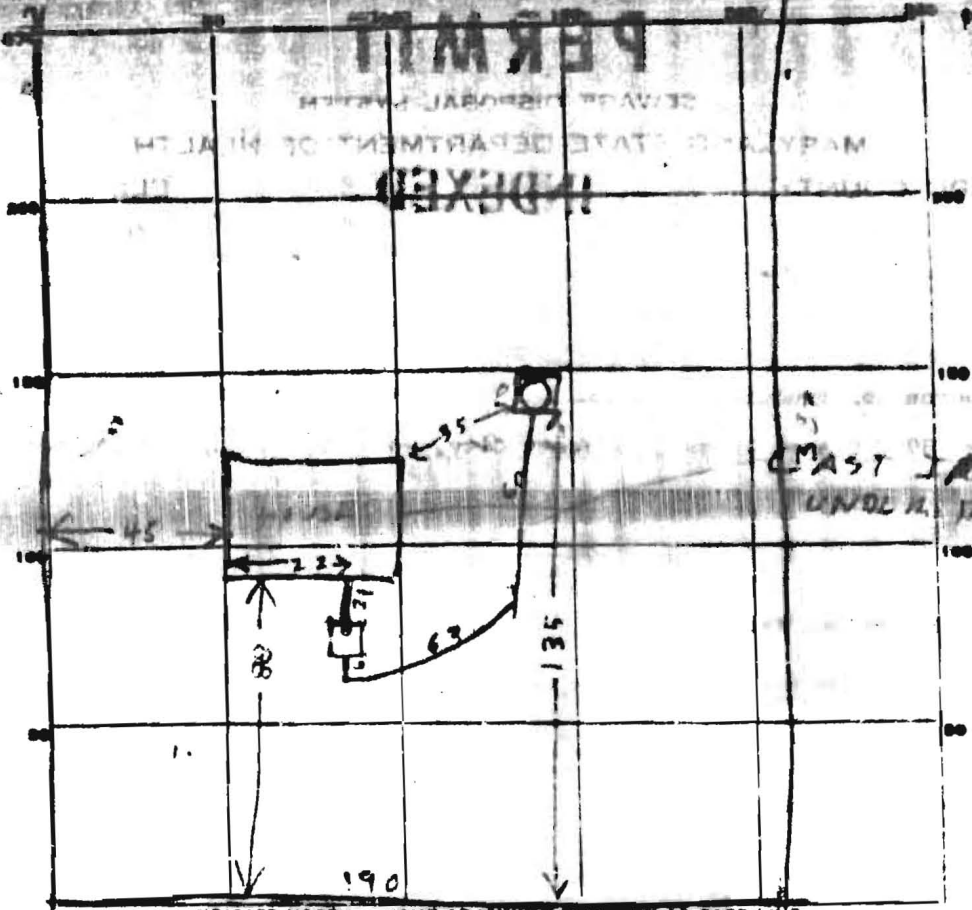
PERMIT CARD

SEPTIC TANK, LEVEL OK ground 16.41 CLEANOUTS 01

TILE FIELD, DEPTH 4-6 FT. TRENCH WIDTH 2 FT.

GRAVEL DEPTH 36 IN. TOTAL LENGTH 123 FT.

NUMBER OF TRENCHES _____ TOTAL BOTTOM AREA 246

SEEPAGE PITS, INSIDE DIAMETER 9 1/2 FT. DEPTH BELOW INLET 9 FT.

ABSORBENT AREA 367 SQ. FT. counting stone

REMARKS 9/2/71 - Dry well located at window side perimeter of dry well
4 FT.

I have also said the tile field has 35% of stone in it
No water in dry well at though it rained
recently. Water well not yet installed

DATE SYSTEM APPROVED 9/2/71 INSPECTOR B. Hodge
