RECEIPT DATE: n/a **ONSITE SEWAGE DISPOSAL SYSTEM** P 533240-A
 INSTALLATION APPROVAL DATE: 9-17-14 **PERMIT** A Repair
 (Signature: KMW)

BRF - REPAIR

File Review:

Breezewood Farms Lot 2 Sec 2
1701 New Hampton Lane

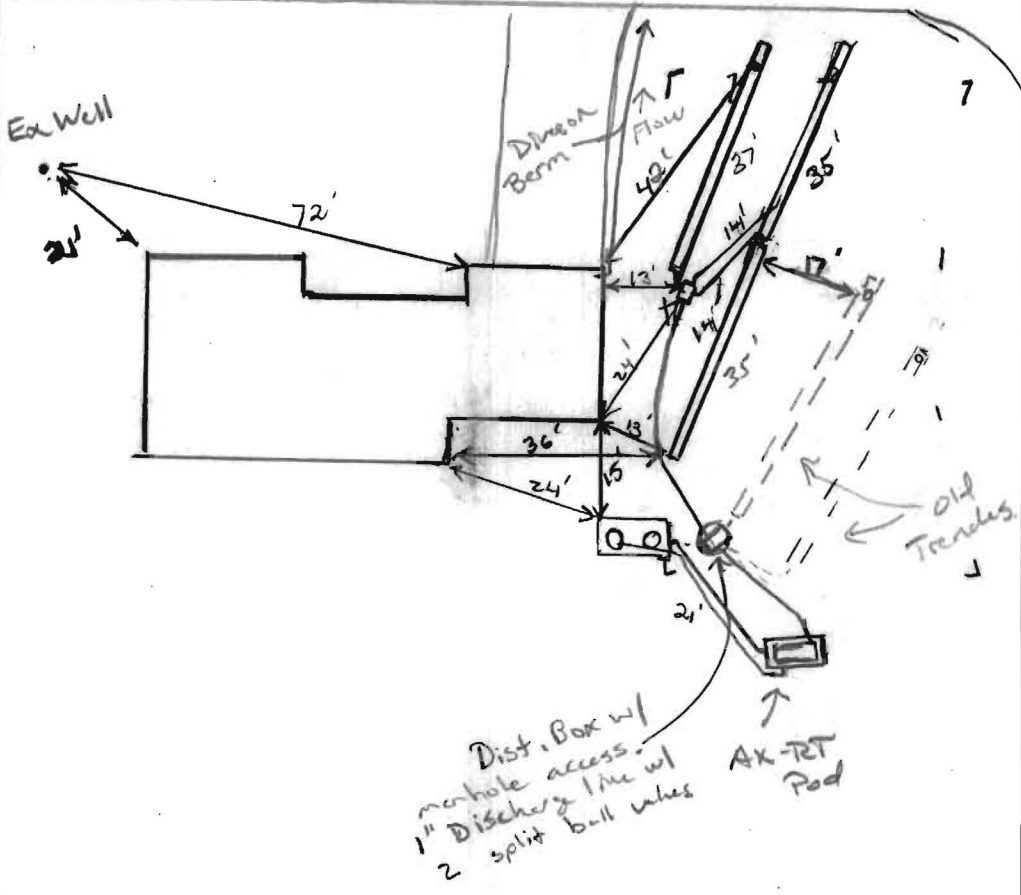
8/28/14 BAT unit installed. No Advantex rep present. Could not start unit, OK to cover work. Need start-up certification from supplier prior to approval (KW)

9/17/14 Met BAT manufacturer in field. start-up performed on system (KW)

8/26/14 Trenches laid out. Set Dbox approx 10' off side corner of house, Run 2x35' trenches towards New Hampton Ln. and 1x35' trench in opp direction. BAT rep. not onsite also word from them as to tank delivery. (KW)

8/26/14 pm Top trench complete. lower trenches partial complete. Need utility marks along New Hampton Lane. No word from Advantex on BAT. tank delivery (KW) 8/27/14 Received call from contractor on-site, tank and Advantex Rep. to be onsite around 9:30 am (KW) 8/27/14 Ernie w/ Atlanta 2 solutions onsite installing RT unit, Trenches complete. Phone call on-site to Bob Johnson w/ Advantex. Asked if it was OK to install 2 ball valves on 1" discharge. OK just not inside unit. OK to cover trenches. Stayed onsite while unit being installed. conversations w/ owner on new system, old system, etc... Will need start-up of unit (KW)

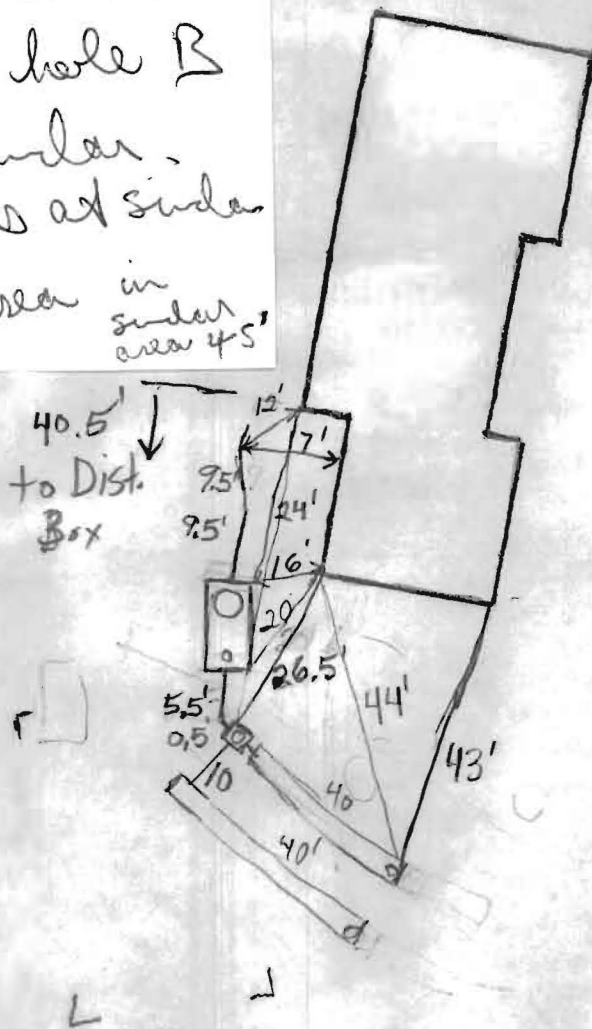
2010 test hole 5
 equivalent to
 2014 test hole B
 Both w/ similar
 perc rates at similar
 depth
 effective area in
 similar area 45'

5/21/10 Tank set 16' from house to keep trenches as far uphill as possible - Not set according to layout
