SEWAGE DISPOSAL TESTING

PROPERTY OWNER Charles C. Puglisi property

PERCOLATION TEST PLAT CHARLES C. RUGLISI PROPERTY		
SCALE 1"=50'	APPROVED BY:	DRAWN BY: <i>[Signature]</i>
DATE 12-20-71		REVISED:
ORIENTON DAM ROAD STA. ELEC. DIS. HOWARD CO. MD.		DRAWING NUMBER WG-1022

PERCOLATION TEST PLAT CHARLES C. PUGLISI PROPERTY		
SCALE: 1"=20'	APPROVED BY:	DRAWN BY: JES
DATE: 12-25-74		REVISED:
STATION DAM ROAD STA. ELEC. DIST. HOWARD COLMES		
		DRAWING NUMBER NO. 1000

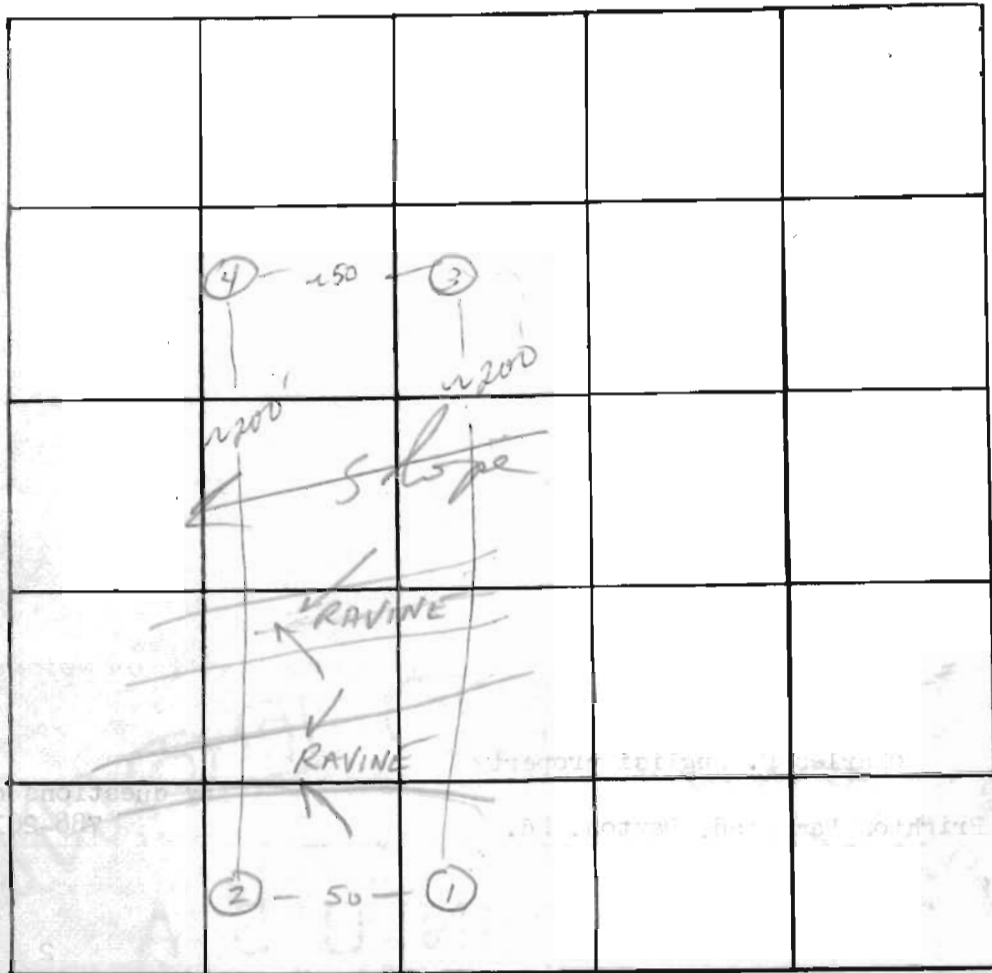
DATE	TEST NO.	DEPTH	PRE-WET		TEST - 1" DROP		TIME
			START	STOP	START	STOP	
1/2/75	1	3	1:14	1:17	1:17	1:25	8
	1-A	11	1:15	1:17	1:17	1:19	2
	2	11	Visual, same as 1		1:17	1:19	-
	3	12'	1:39	1:42	1:42	1:52	10
	3-A	3'	1:39	1:41	1:41	1:53	12
	4	11'	2:00	2:05	2:05	2:16	11
	4A	3'	2:04	2:06	2:06	2:13	7

REMARKS Confirm all holes - locations, lot lines, slopes

TYPE OF SOIL Sandy

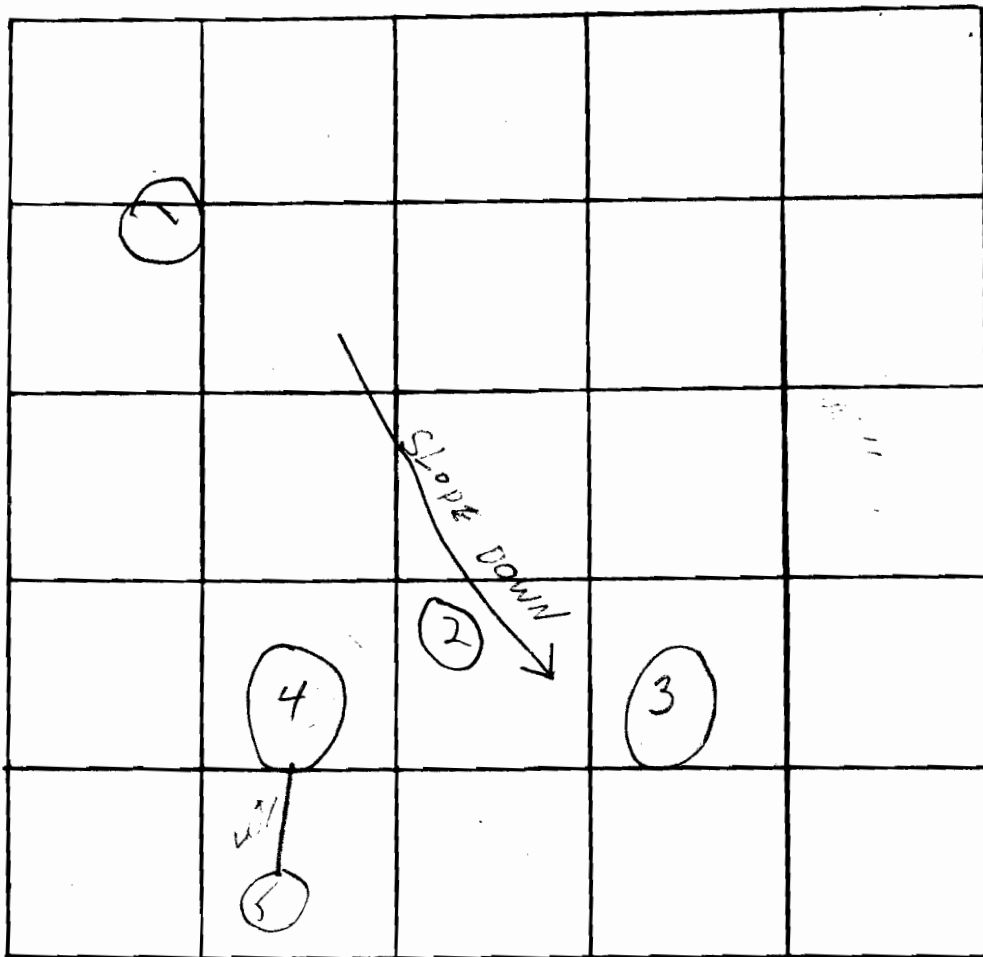
DATE	TEST NO.	DEPTH	PRE-WET		TEST - 1" DROP		TIME
			START	STOP	START	STOP	
	1		NOT	DUG	from north slope		
	1A		- "	"	" "		
	2	12'	VISUAL	SIMILAR TO	3+3A		
			Clay sand-mustard				
	3	12'	235	—	3D NO	MOVEMENT	
	3A	3'	235	237	237	240	3
	4	12'	NO	TEST	wet, rd		
	4A	3'	NO	TEST			
	5	6'	water

REMARKS Centrifuge holes - locations - lot conc. slopes

TYPE OF SOIL Sandy loam

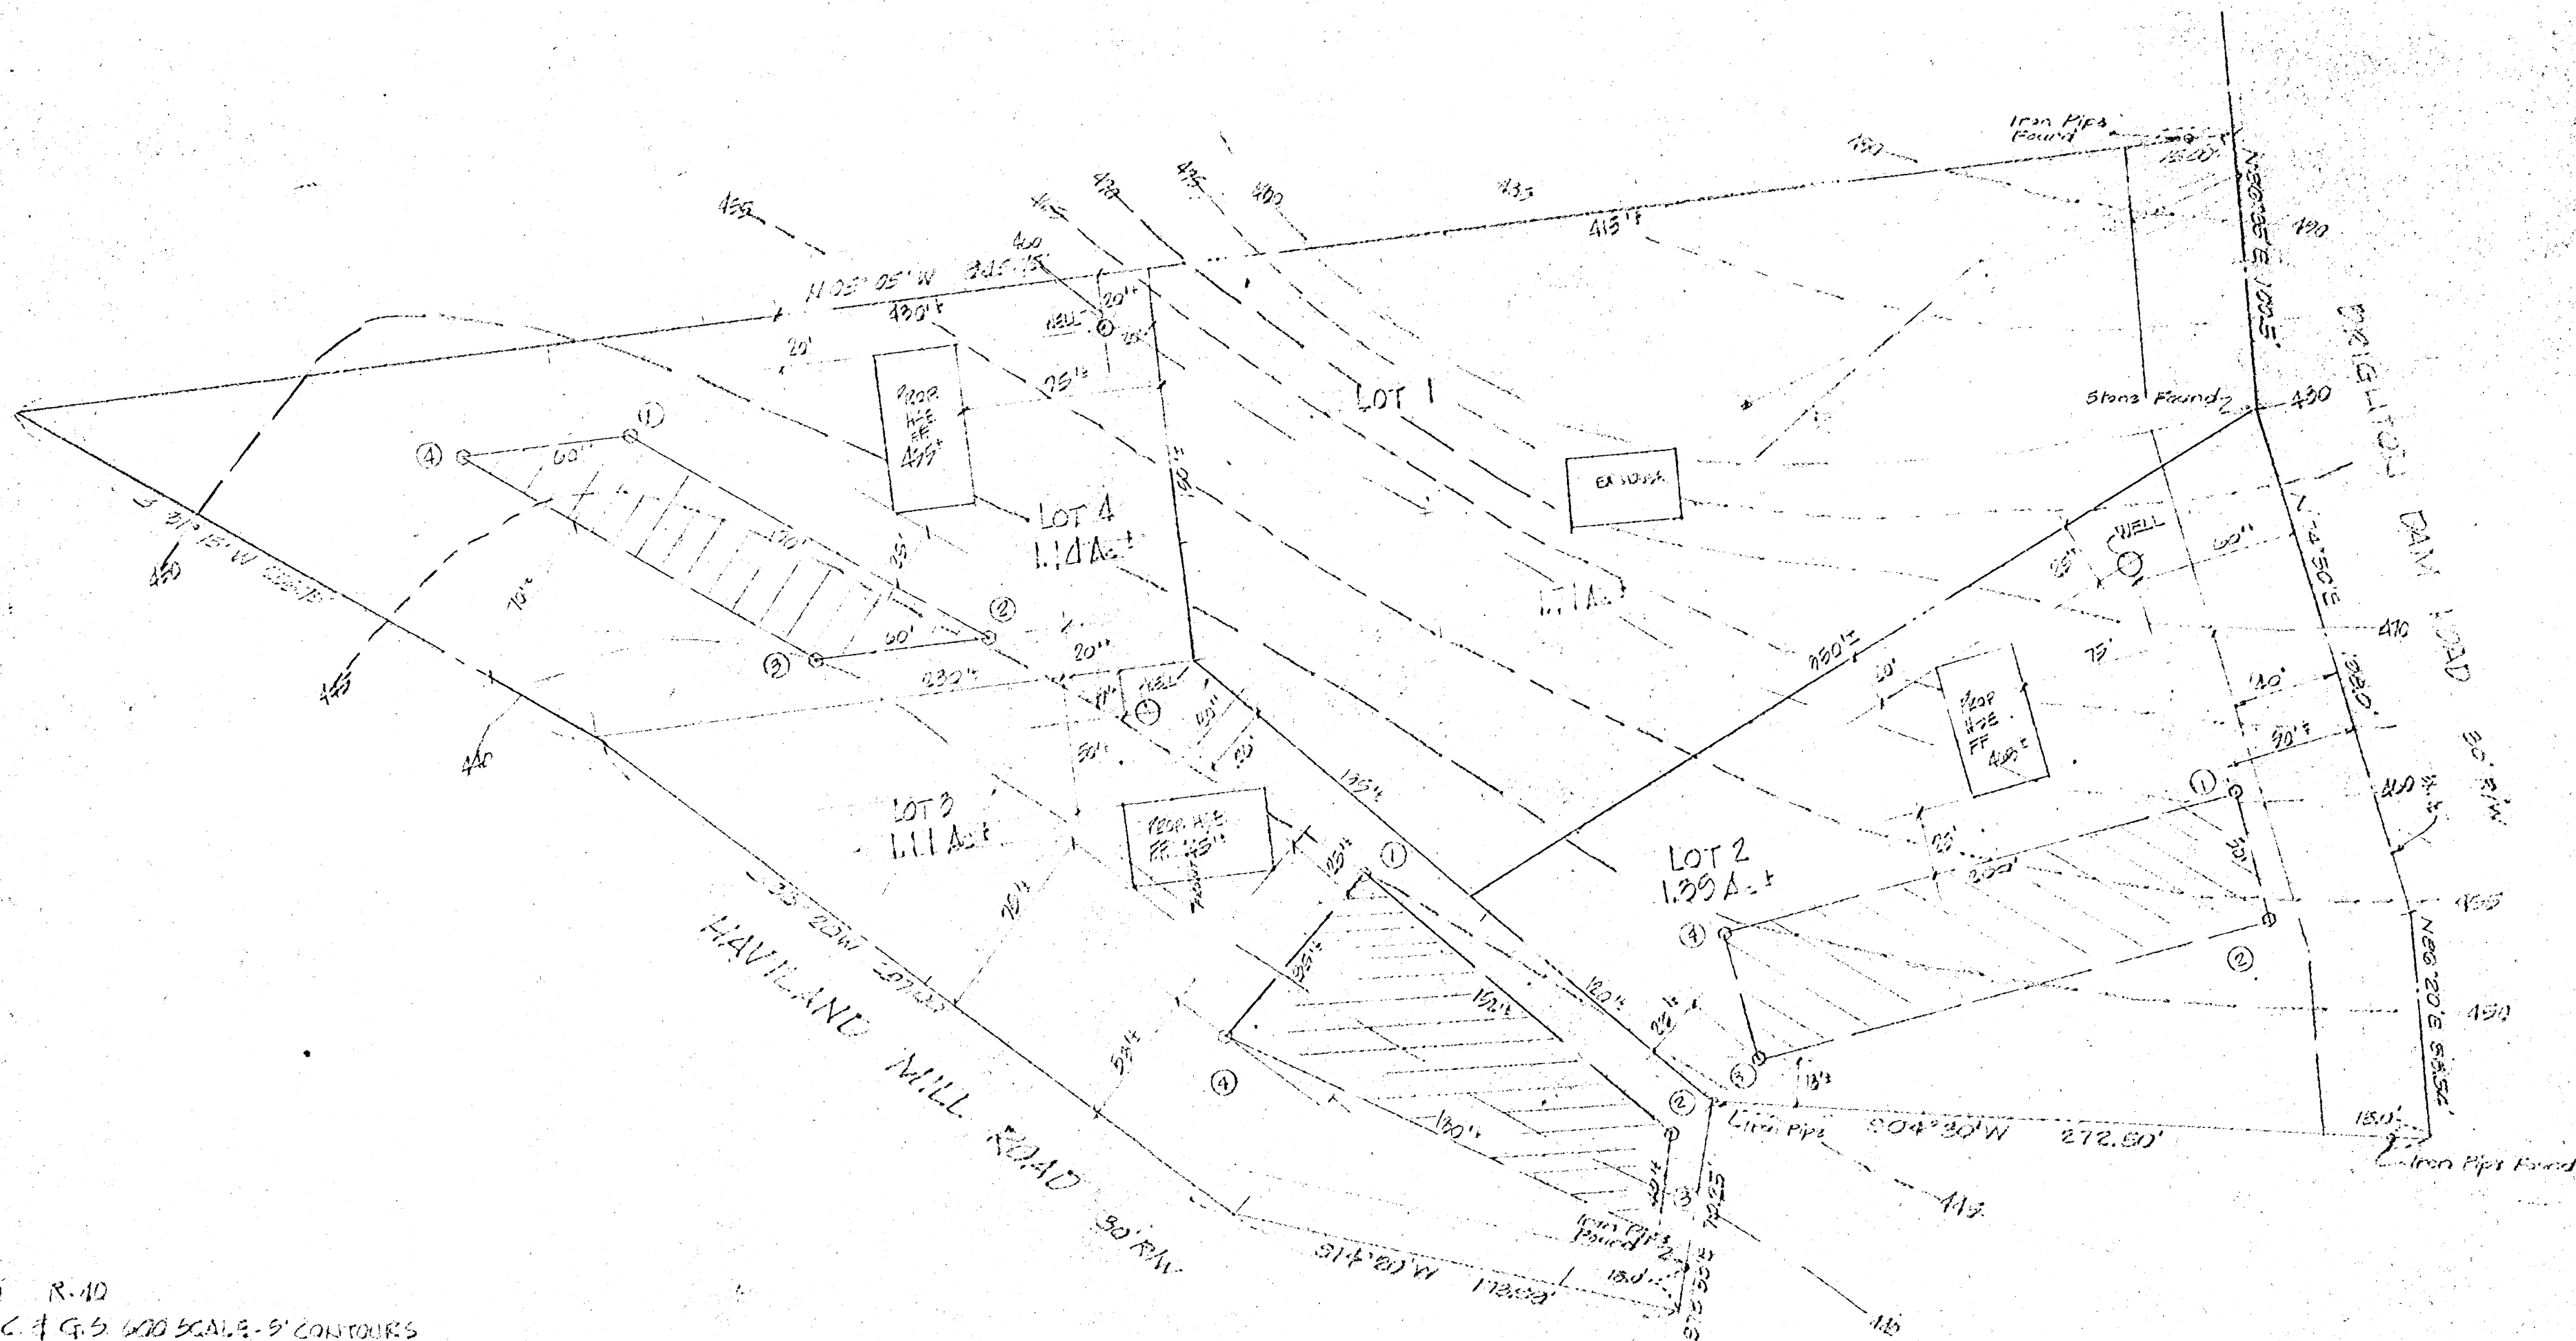
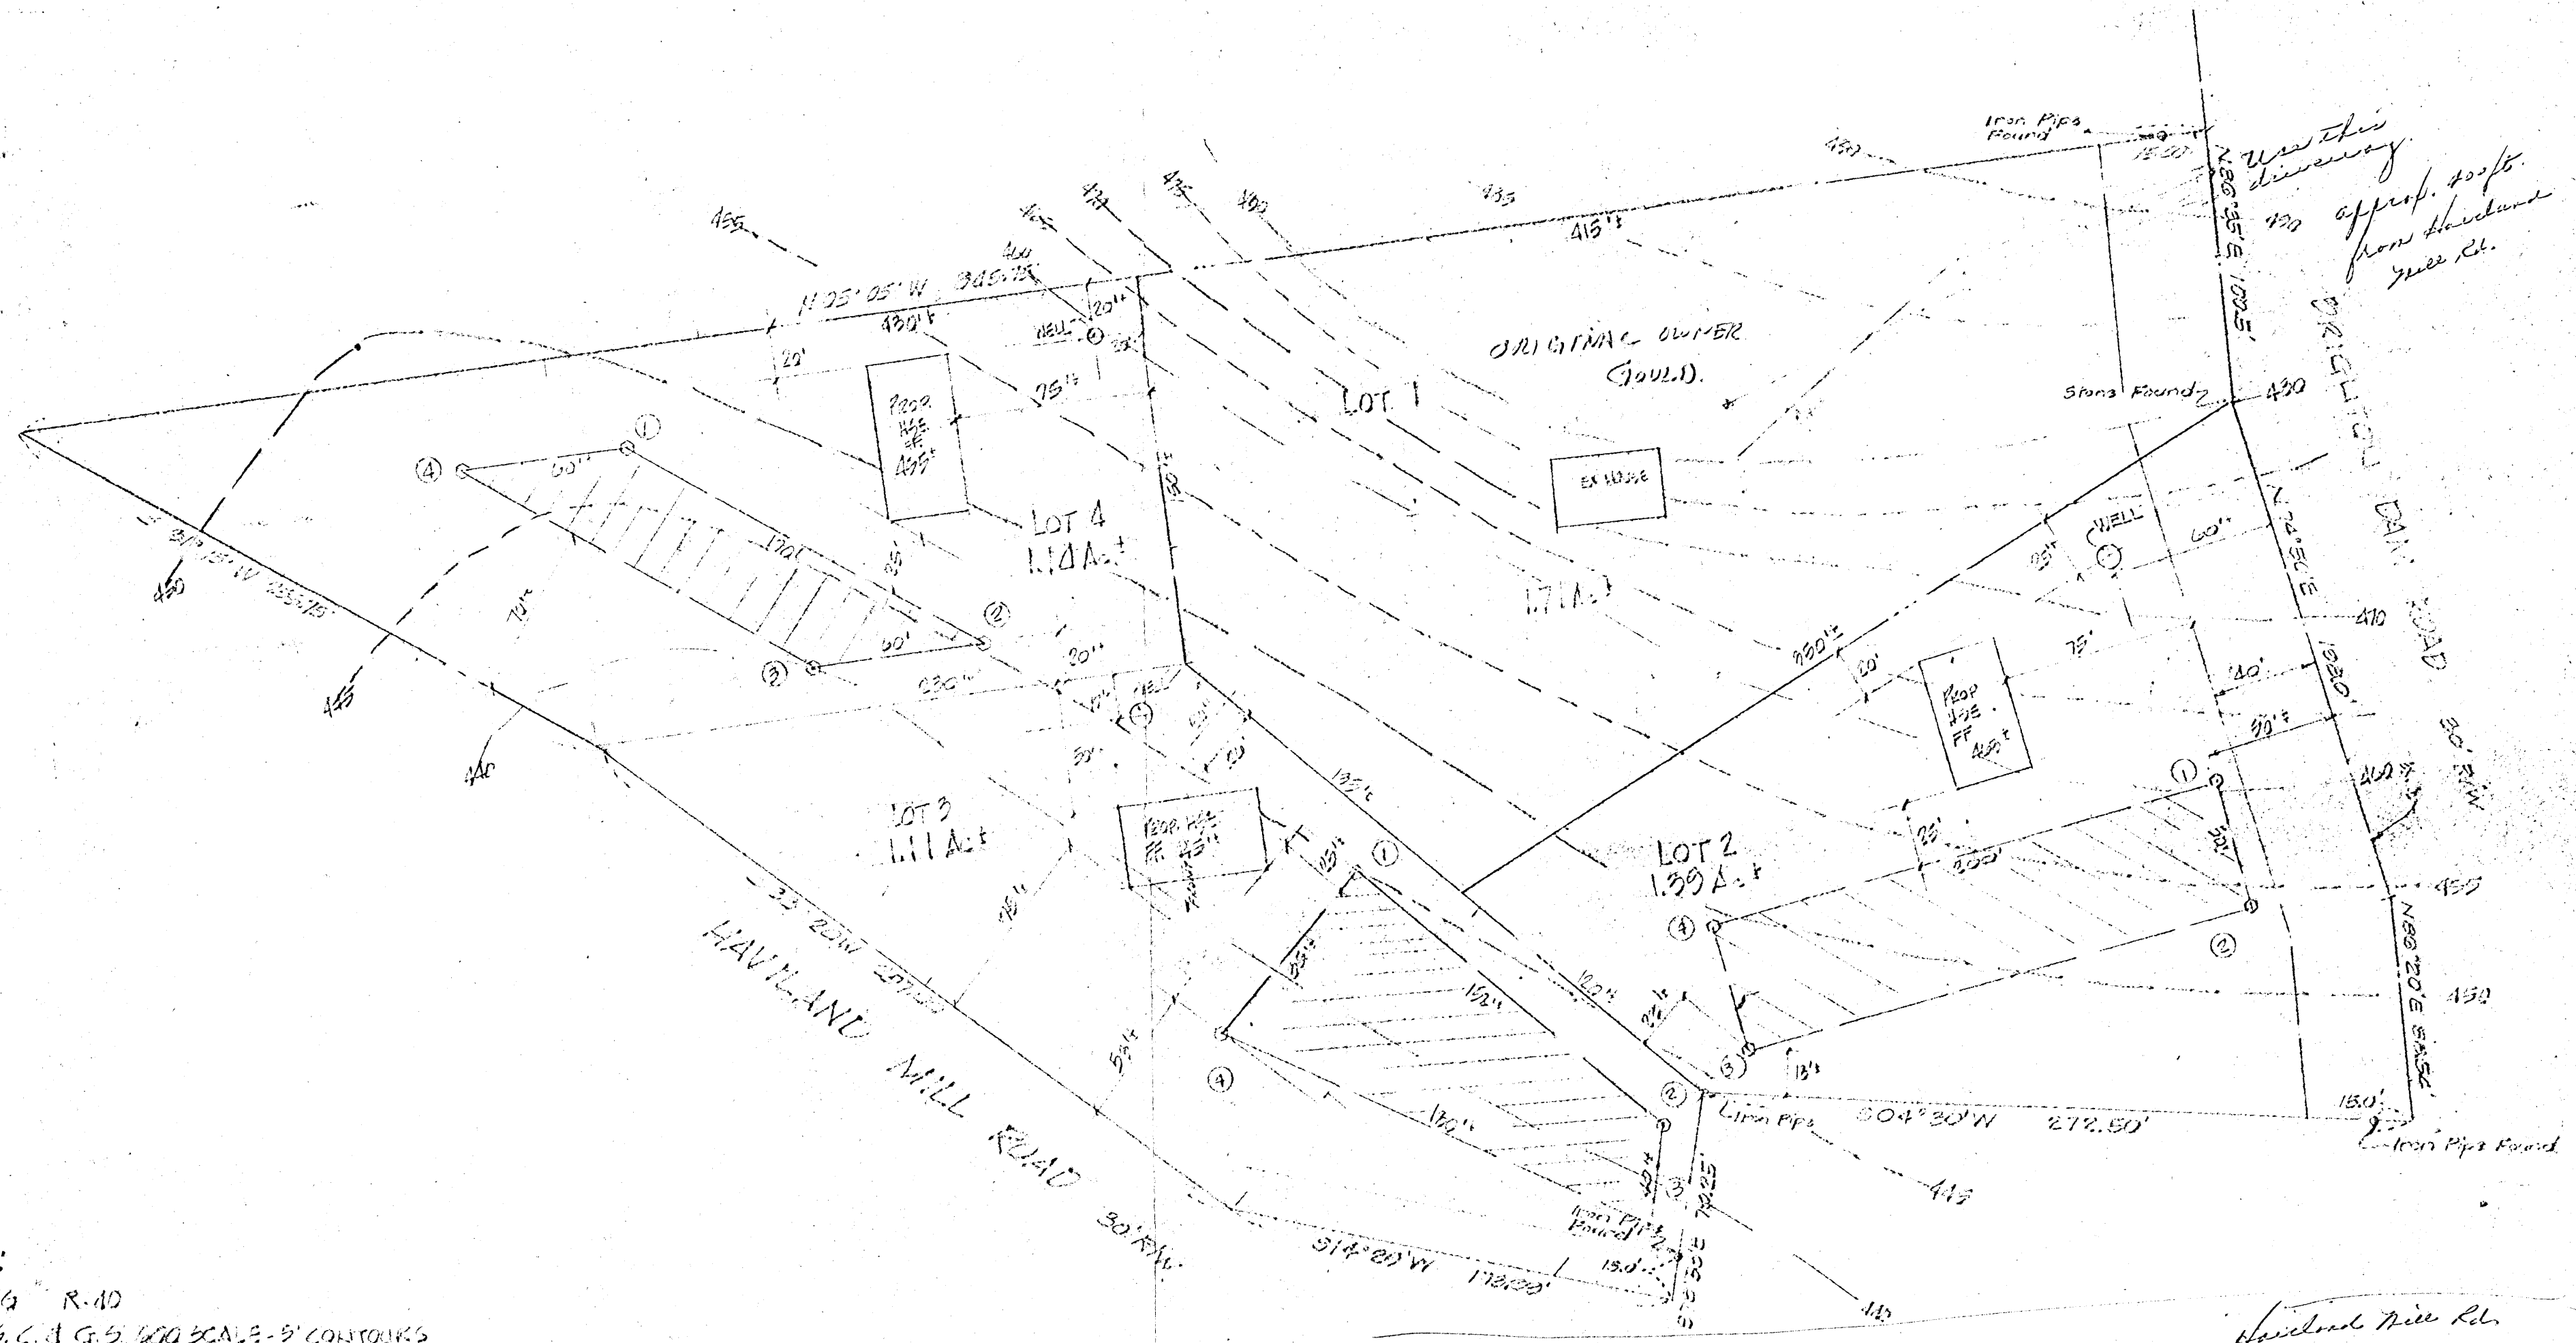
The Charles C. Puglisi property that is a subdivision and located at Brighton Dam & Haviland Mill Roads has been rejected due to the following reasons:

1. Inadequate percolations and high water table on Lot 3.
2. Too steep - slope and ravines (natural erosion) to approve for adequate installation of sewage disposal systems. *This applies to the other lots.*
