RECEIPT DATE: 11/28/2023 **ONSITE SEWAGE DISPOSAL SYSTEM** P 575701

APPROVAL DATE: 11/29/2023 **PERMIT: REPAIR** A _____

PROPERTY ADDRESS: 1188 Day Road

| Date: 9/26/2023 Name of Evaluator: Drew Henderson Time: 14:00 Property Address: 1188 Day Road Sykesville, MD 21784 Recent Weather Conditions: Rain | Ordered By: John Riley Homeowner Interview: The homeowner interview was conducted during the evaluation. | Occupied: <input checked="" type="checkbox"/> Yes <input type="checkbox"/> No Length of Time Vacant: N/A # of People Living in Home: 3 Property Age: 1979 System Age: 1979 Last Date of Cleaning: ~2 Weeks Ago Recomm'd Pumping Freq: 2-3 Years |

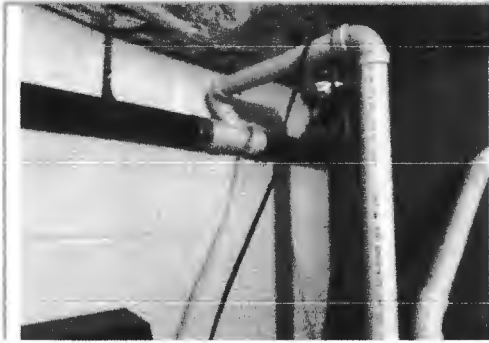
Picture 1:

Showing the sewer line inside the house

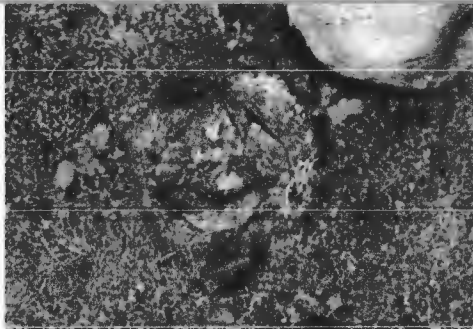
Picture 2:

Showing signs of sewage surfacing previously out of the tank cleanout to grade

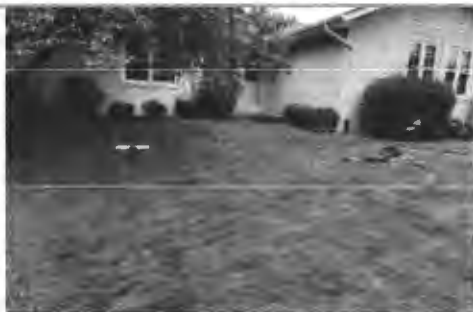
Picture 4:

| Absorption System | <input type="checkbox"/> Acceptable <input checked="" type="checkbox"/> Unacceptable <input type="checkbox"/> Needs Further Evaluation | Per the County records the absorption system is composed of 1 distribution box and 2 drainfields. During the inspection 1 distribution box was located. The drainfields appear to be located underneath the driveway. The tank was pumped 2 weeks ago and is over full with sewage backing up towards the house and surfacing out of the cleanout. This indicates the drainfields are hydraulically loaded and are backing up. A new absorption system needs to be installed by a licensed septic contractor after obtaining permits from the County Health Department. |

Showing location of the distribution box
