APPLICATION
FOR PERCOLATION TESTING AND SITE EVALUATION

SUBDIVISION/PROPERTY NAME
PROPERTY ADDRESS 13715 Triadelphia Mill Rd Clarksville MD 21029
TAX ACCOUNT # 382750 TAX MAP 16003 GRID 191 PARCEL 05377420 LOT NO. 1 LOT SIZE (ACRES) 1
ZONING CATEGORY TIER

Date: September 4, 2024 Name of Evaluator: Tyler Young Time: 8:30 AM Property Address: 13715 Triadelphia Mill Road Clarksville, MD 21029 Recent Weather Conditions: Normal	Ordered By: Andy Bettendorf Buyers: Homeowner Interview: The homeowner interview was sent but not received prior to the evaluation.	Occupied: <input checked="" type="checkbox"/> Yes <input type="checkbox"/> No Length of Time Vacant: N/A # of People Living in Home: 3 # of People moving in: N/A Property Age: 1935 System Age: Unknown Last Date of Cleaning: ~2018 Recomm'd Pumping Freq: 2-3 Years
Liquid level in tank is: <input type="checkbox"/> Above Normal <input checked="" type="checkbox"/> Normal <input type="checkbox"/> Below Normal		Bottom Solids Depth: 12 Inches
Depth of tank: 32 Inches	Type of Tank Access: Manhole Riser	Depth of tank access: At Grade
Maintenance appears: <input type="checkbox"/> Good <input checked="" type="checkbox"/> Fair <input type="chec

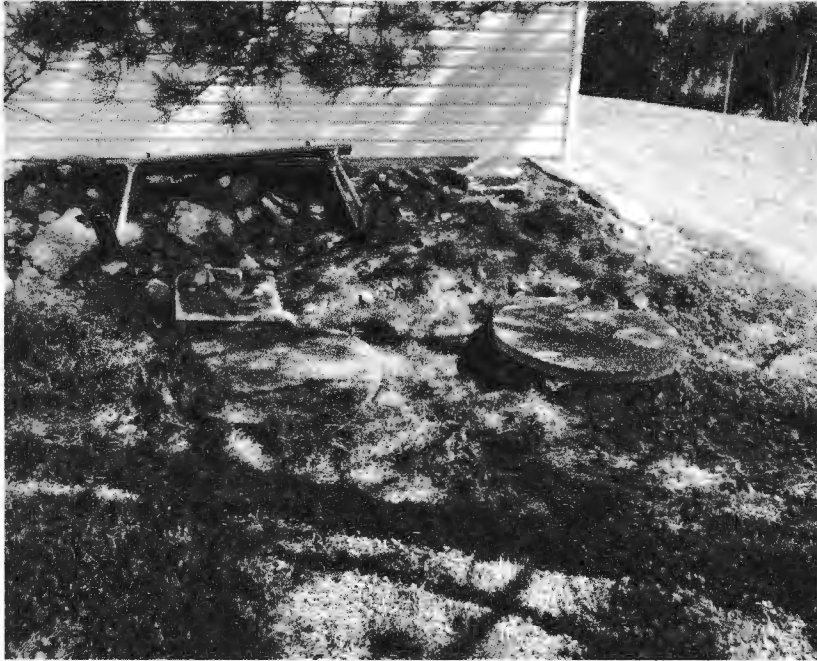
Picture 1:

Showing the location of the septic tank in relation to the nearby garage. The garage is approximately 6 feet from the septic tank.

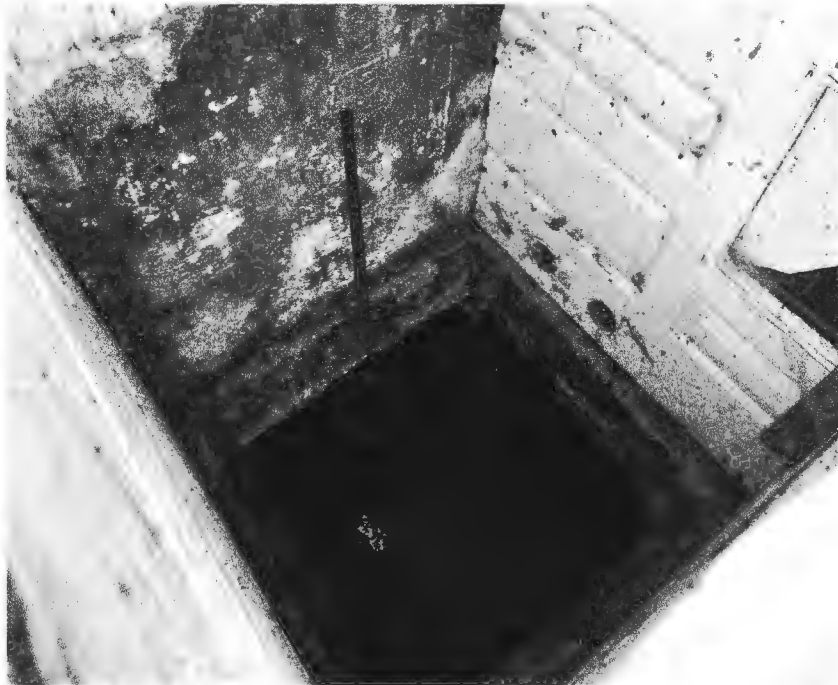
Picture 2:

Showing the homemade back riser of the septic tank and partially missing back baffle (red arrow). The homemade riser should be removed or replaced with a watertight riser. The back baffle will need to be replaced. It is suggested an effluent filter be installed in the new baffle, to extend the life of the drywell, and a riser access be installed to grade, to allow future cleaning of the effluent filter. Effluent filters need to be cleaned on a regular basis to prevent backups.

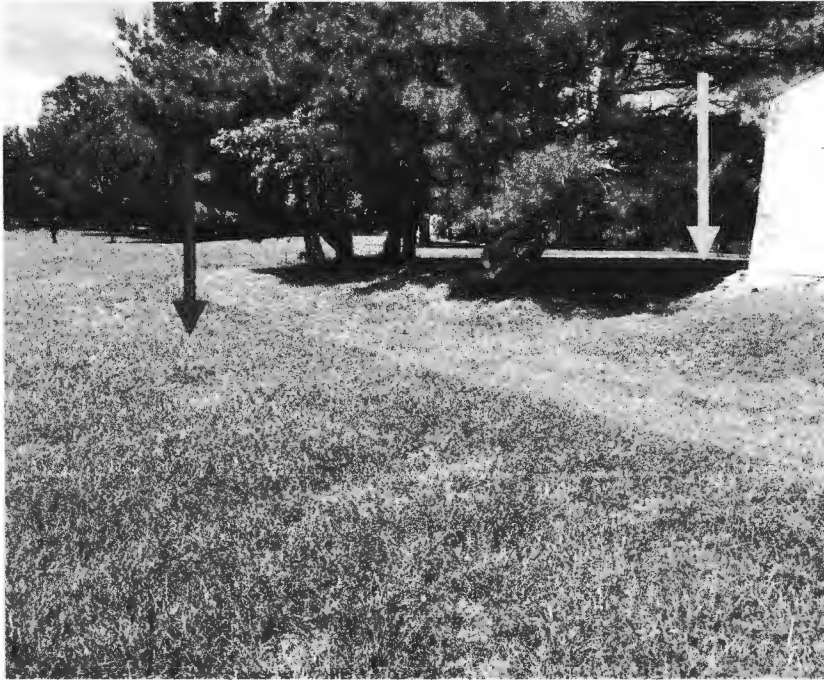
Picture 3:

Showing the locations of the drywell (red arrow) and septic tank (yellow arrow).

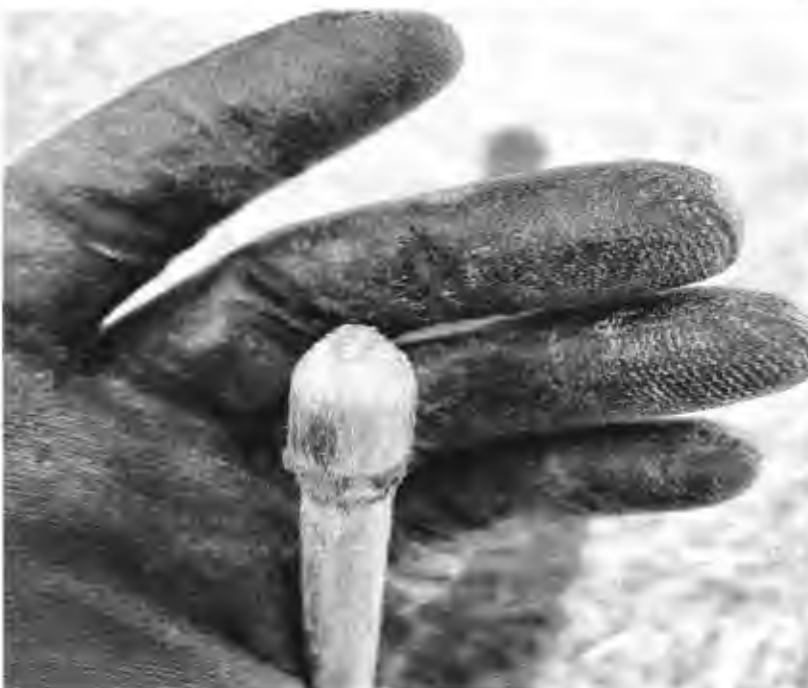
Picture 4:

Showing stone residue from probing the edges of the located drywell.
