Permit Type Building/Residential/Alteration/SFD Permit Number B24001034 Opened Date 03/26/2024
 Description of Work SFD/ RESTORE TO ORIGINAL CONDITION FORM AUTO INTO STRUCTURE INCIDENT, NO REPORT MADE TO HCFRS**SUBJECT TO FIELD INSPECTION**

Repair damage to house and garage from automobile impact
Repair damage to house and garage walls
Repair damage to 2nd floor interior stairs and railing
Repair damage to interior flooring
Repair drywall and paint damaged areas house and garage

Re: 2565 Mullinix Mill Road
Mount Airy, MD 21771

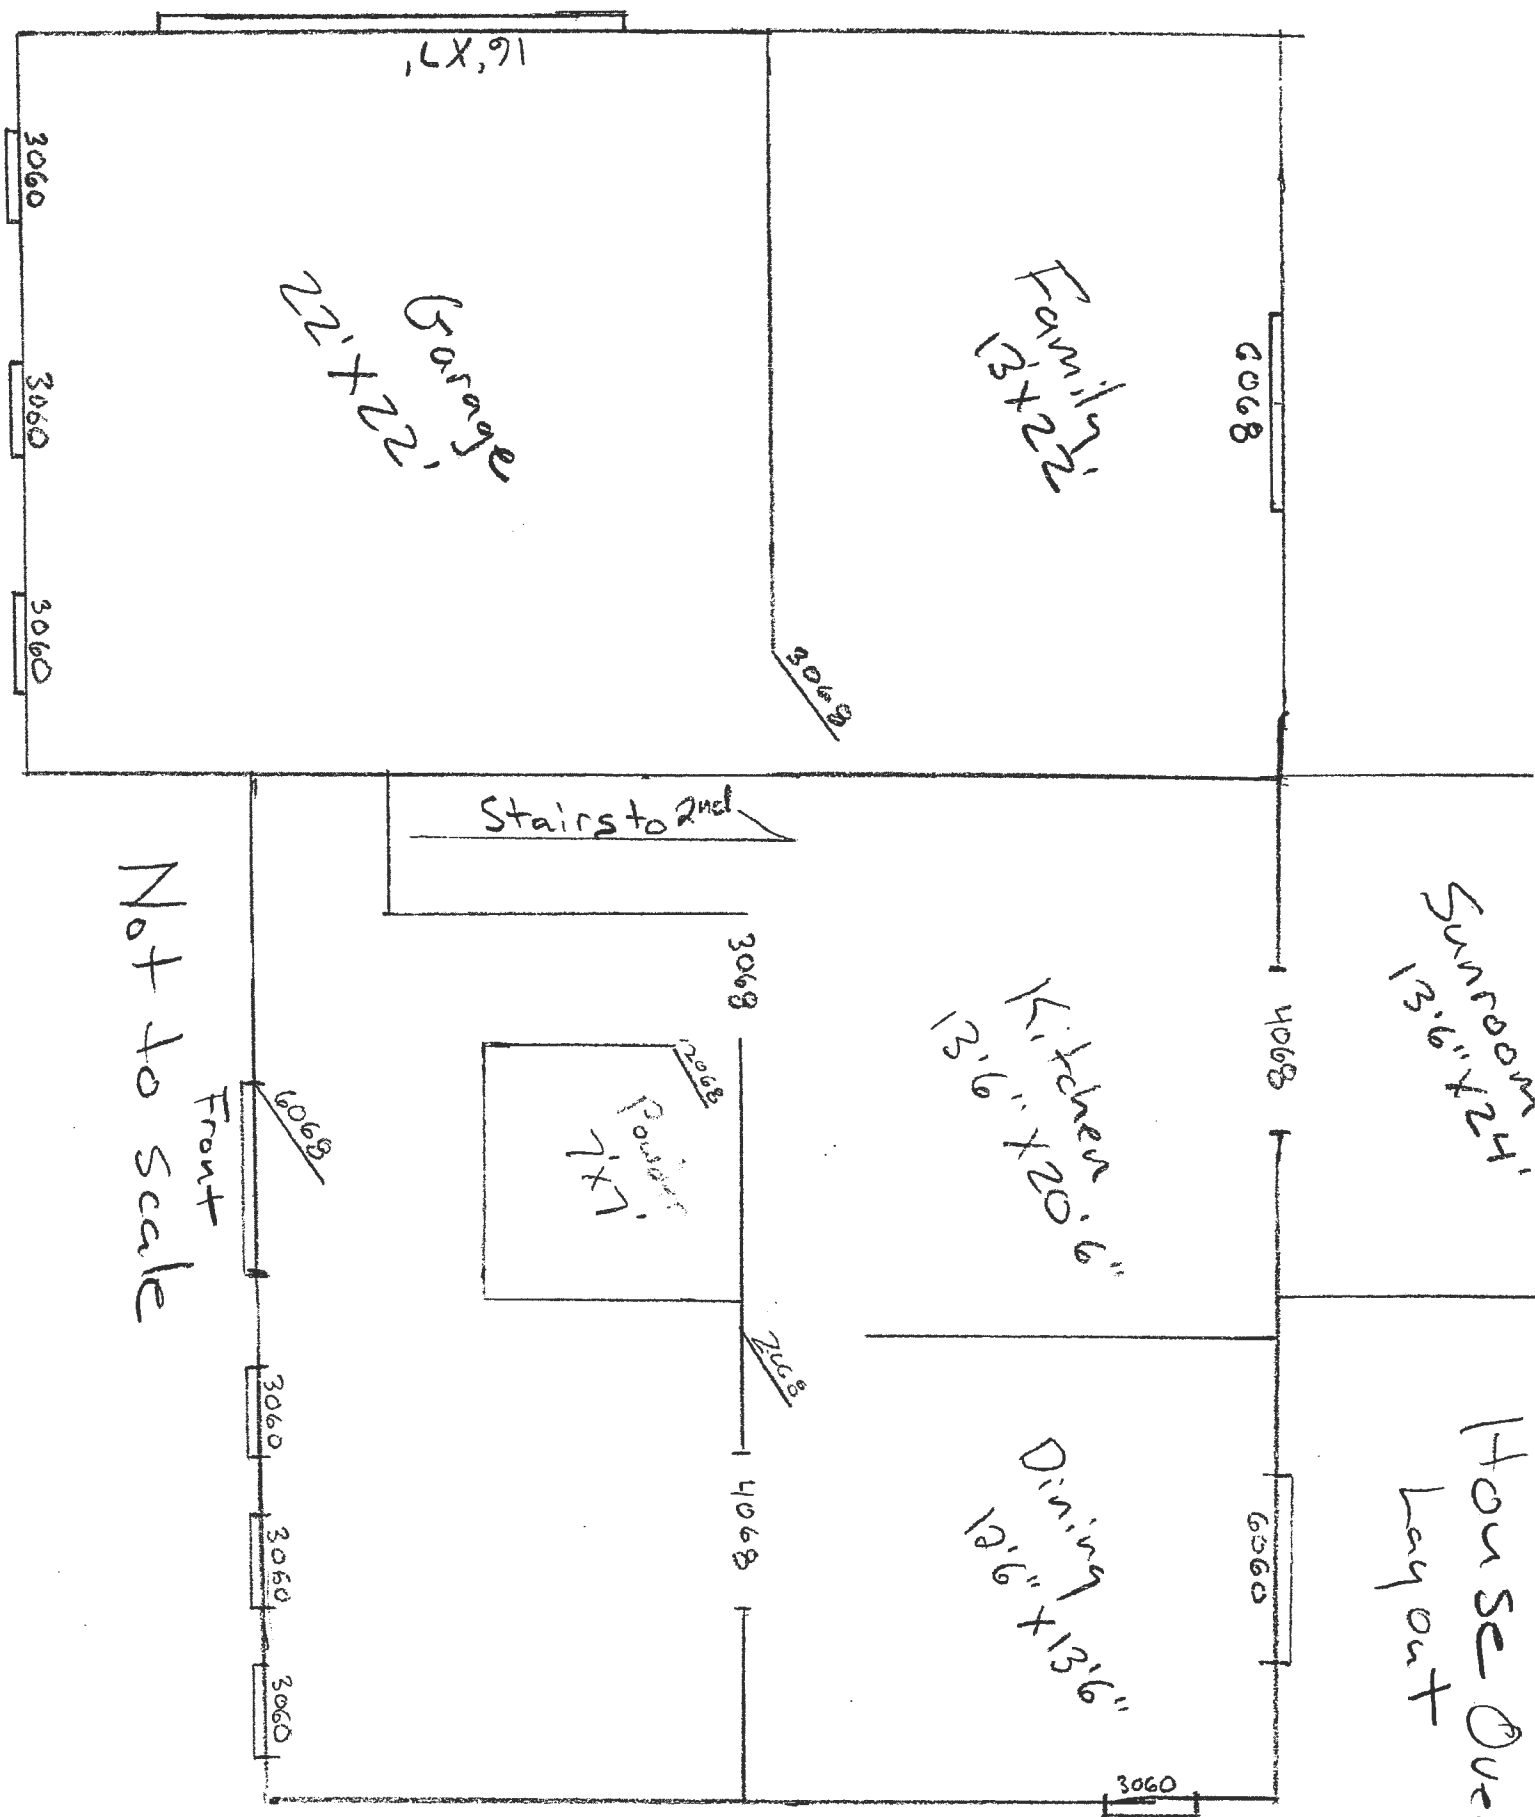
House Overall
Layout

Affected Area
Approx 100 sq. ft.
