DEMOLITION REQUEST FORM

7354 Montevideo Rd
 Property Address

PHASE I ENVIRONMENTAL SITE ASSESSMENT

Wen Property / 7354 Montevideo Road

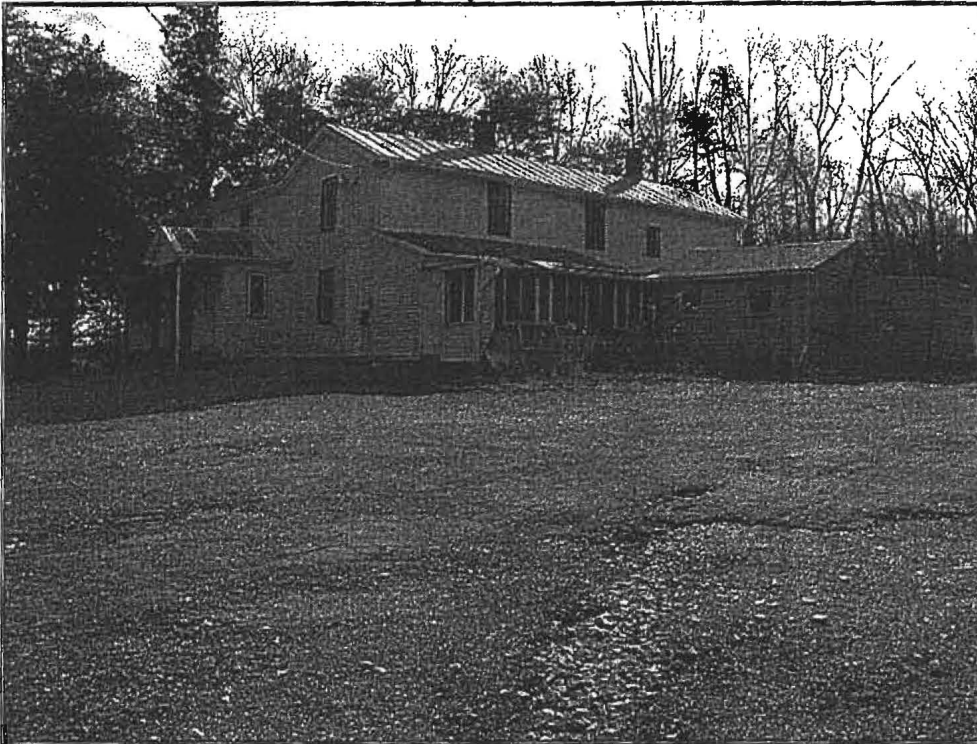
Photograph #1 – View of vacant dwelling on site. The age of the house is unknown.

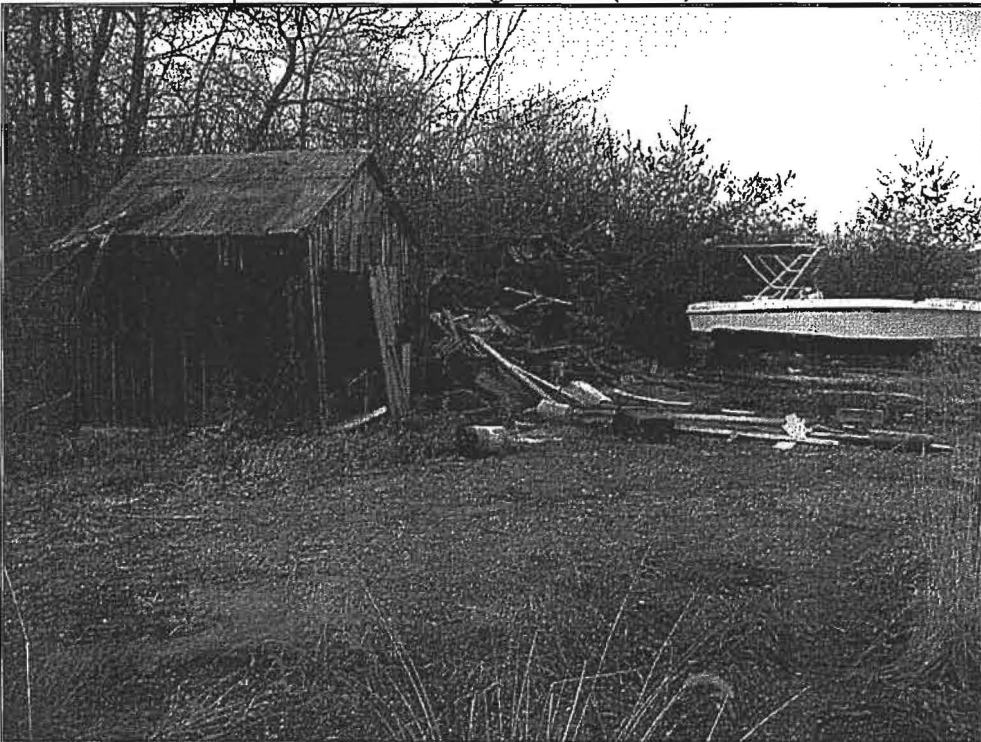
Photograph #4 - Scrap lumber, discarded tires, bricks, trash, and additional debris was observed behind and around the dwelling.

Various Hazardous and Non-Hazardous wastes were located through-out the vacant home and outbuildings. On February 4, 2015, the waste was collected from the residence and various structures and was consolidated for identification and packaging. On February 20, 2015, the Non-Hazardous Waste was removed from the site by ACE. On March 16, 2015, the Hazardous Waste was removed from the site by Clean Ventures, Inc. Please see attached Hazardous and Non-Hazardous Waste Manifests.

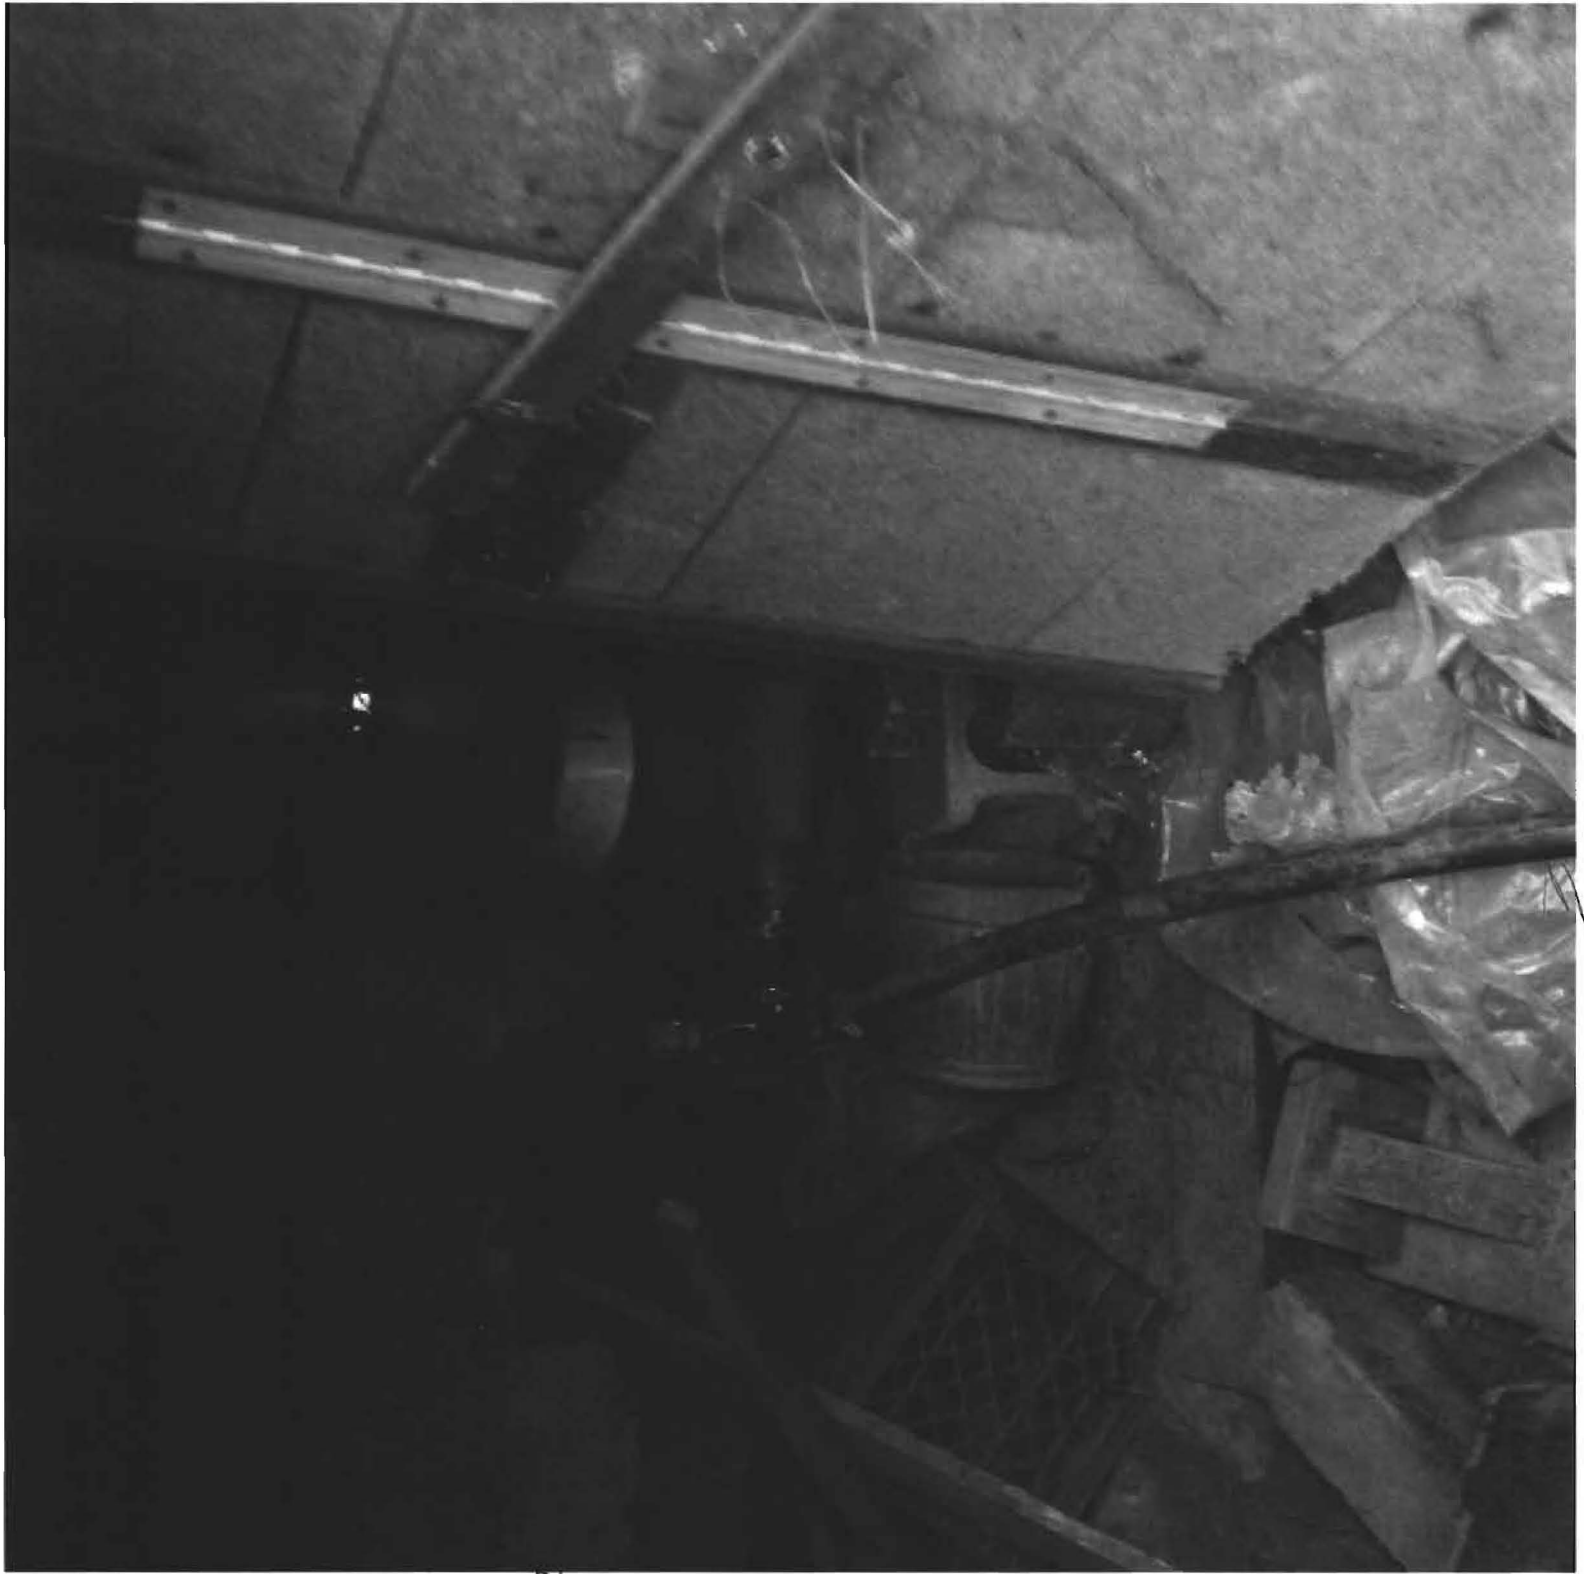
- Dig hole
- Ex - well?
- Spring house?
- May need
conformal
from Plumber
D.M.H.
