SEWAGE DISPOSAL SYSTEM

A REPAIR

ADDRESS 26108 Mullinix Mill Road, Mt. Airy. 21771 PHONE (301)253-5254

REPAIR - PURPOSE - SEPTIC SYSTEM HAD FAILED

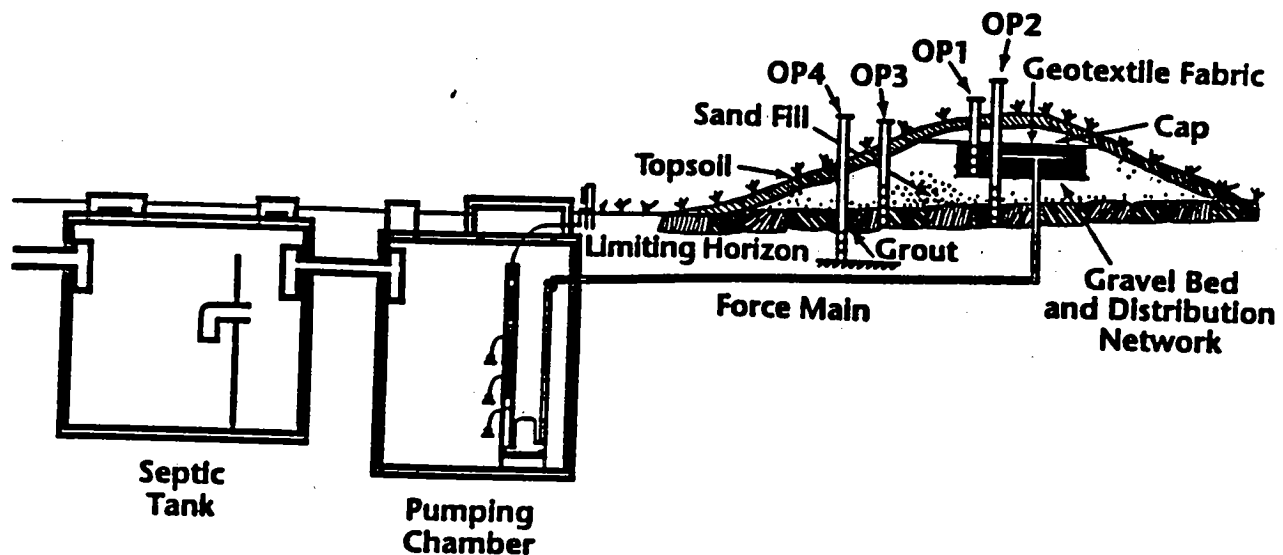
Figure A: Cross Section of Sand Mound Showing Observation Ports

Routine monitoring visits (usually monthly) were made to each system. Visual observations were made of the sand mound and surrounding areas. Flow measurements were calculated from event counters and elapsed time meters installed on each mound's pumping system. Changes in the average pump run time could indicate either clogging in the distribution network or a change in the dose. Observations and measurements of internal ponding were made in observation ports, located and labeled as per fig. A.

A summary of system performance can be found in Table C. Three of the systems had continuous ponding in the bed, two of the systems had intermittent ponding in the bed, and four of the systems had effluent seepage from the mound.

OP1 intermittently ponded after 17 months and continuously ponded after 28 months. After 37 months ponding in the bed caused recycling. Continuous ponding has been observed in OP2 and OP3 after 2 months. After 17 months intermittent seepage began in the wet season. A shallow observation well installed ten feet from the toe of the mound has shown saturated conditions within 8 cm of the surface during the wet season. This soggy can extend 10 meters or more from the toe. Surface water from a puddle 10 meters downslope of the mound was analyzed for fecal coliform and could not be differentiated from normal surface water. This system seeps during the wet season due to poor landscape position; and a shallow limiting horizon and perched water table. Infiltration into the preexisting side-seam septic tank also contributed to the seepage.
