PERMIT

SEWAGE DISPOSAL SYSTEM

HOWARD COUNTY HEALTH DEPARTMENT

PROPERTY OWNER PHILIP QUARRIER

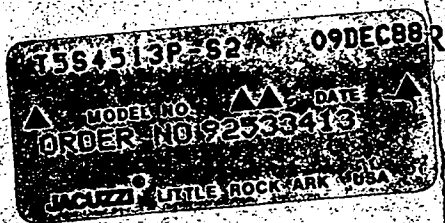
No 7089

- tested all wire connections then pulled well pump, found 1/2 hp well pump had gone bad.

- replaced with new 1/2 hp well pump
