RECEIPT DATE: n/a **ONSITE SEWAGE DISPOSAL SYSTEM** P 533240-A
 INSTALLATION APPROVAL DATE: 9-17-14 **PERMIT** A Repair
 (Signature: KMW)

BRF - REPAIR

File Review:

Breezewood Farms Lot 2 Sec 2
1701 New Hampton Lane

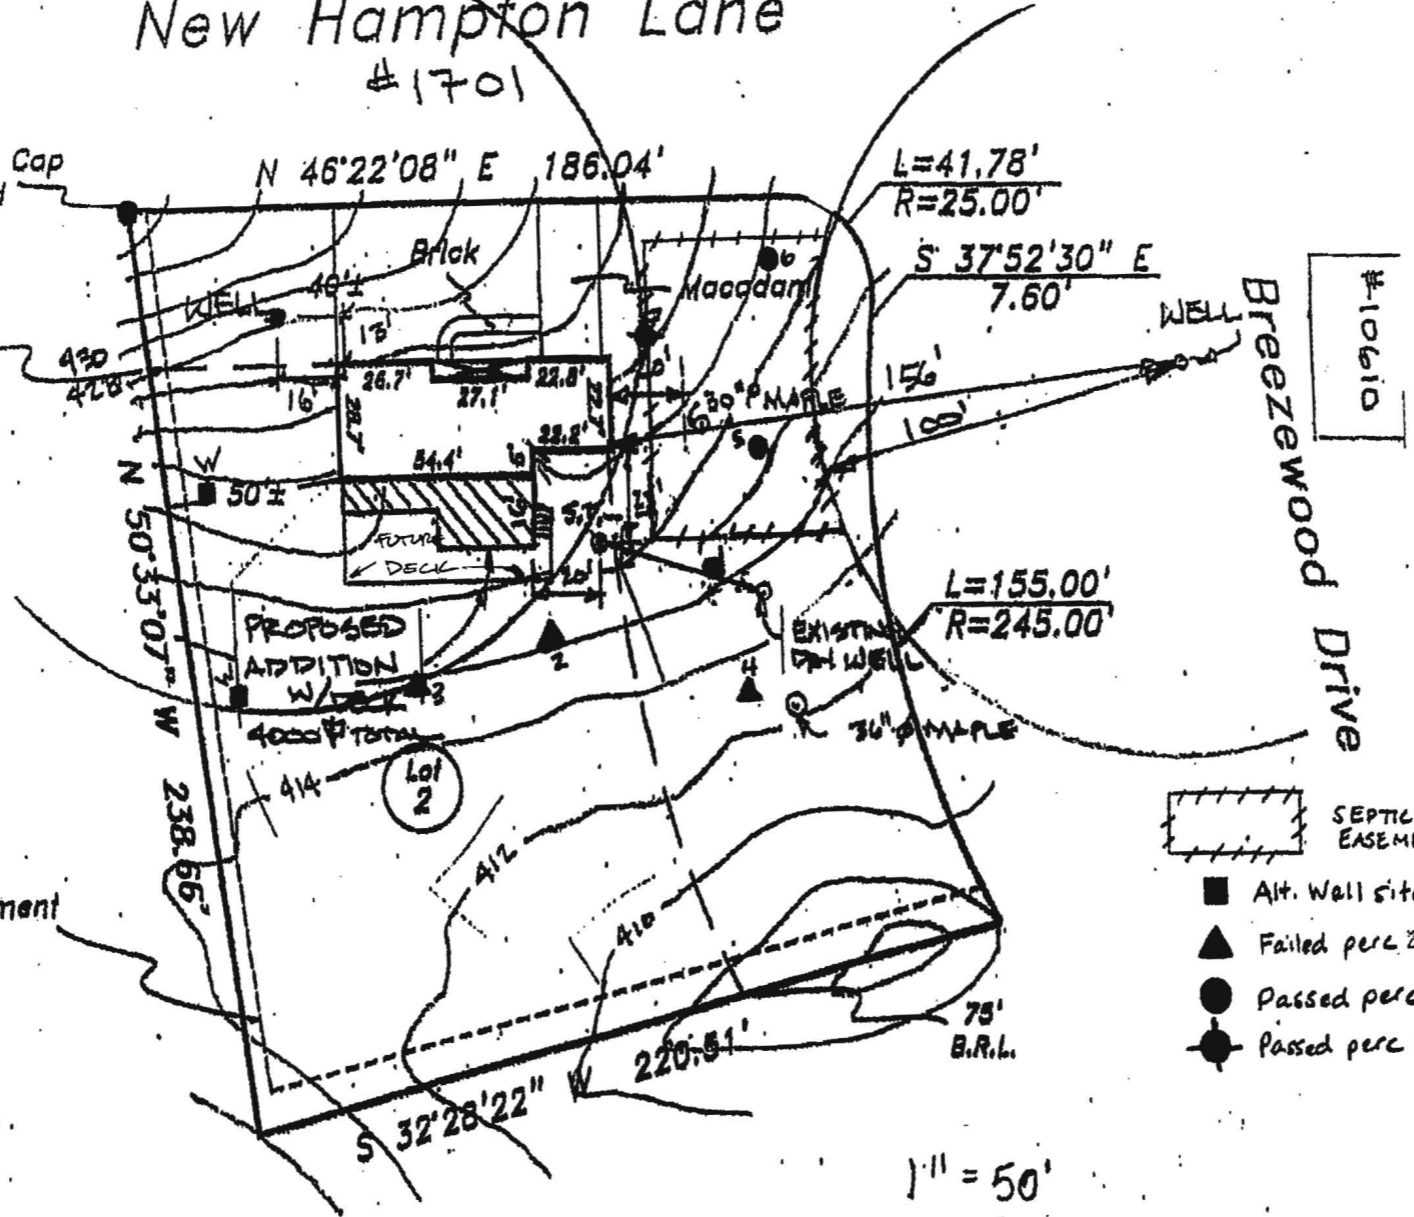
New Hampton Lane #1701

- The purpose of this plan is to show an area suitable for the replacement of the existing septic system.
 - The existing septic system will be upgraded prior to building permit approval.

- Alt. Well site
- ▲ Failed perc 2010
- Passed perc 2010
- Passed perc 1965
