DEMOLITION REQUEST FORM

RE: 9201 Old Guilford Rd.
Columbia, MD 20146
Map: 42, Grid: 15, Parcel 28
(Demolition of existing structures – rebuild new building)

9201 OLD GUILFORD ROAD – ABOVE GROUND STORAGE TANK REMOVAL

PHASE I ENVIRONMENTAL SITE ASSESSMENT

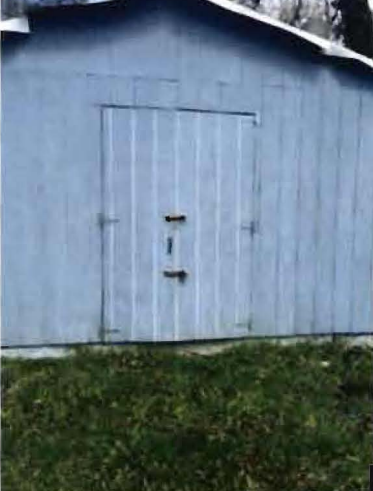
Front elevation of subject property garage

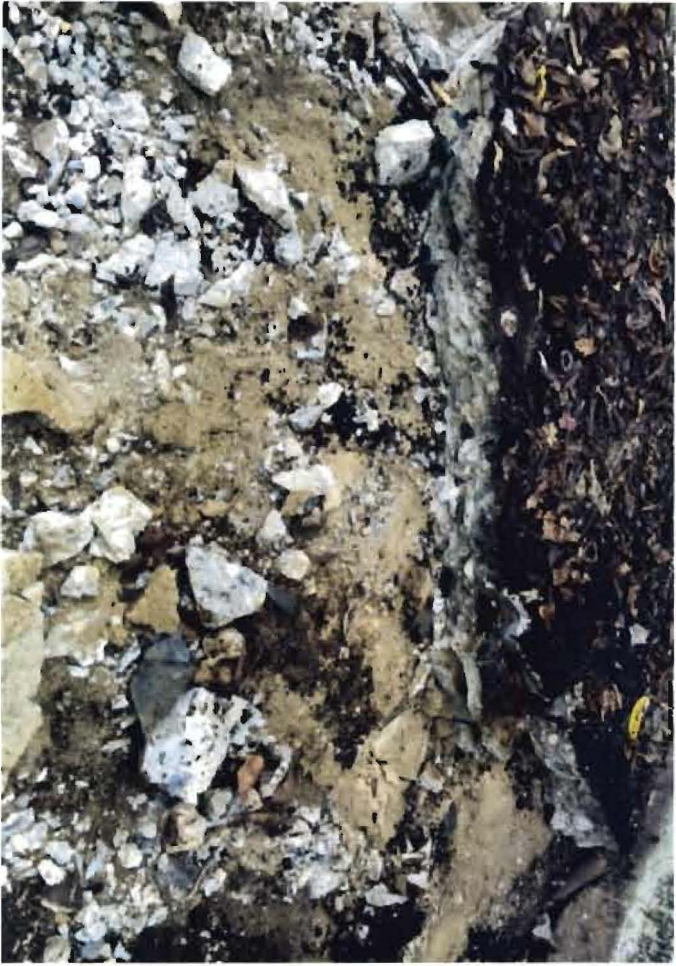
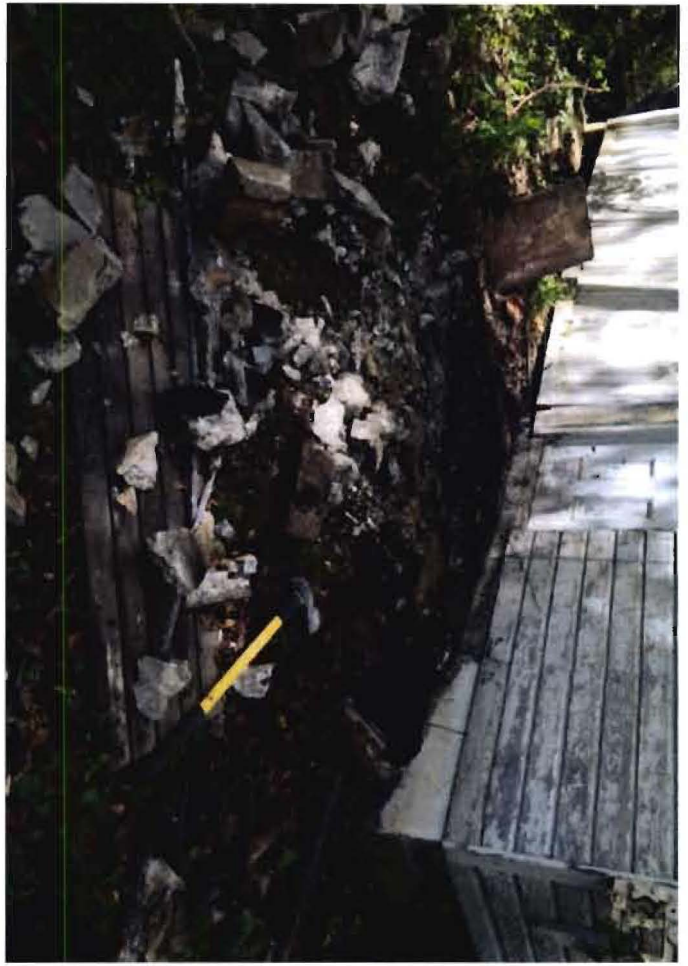
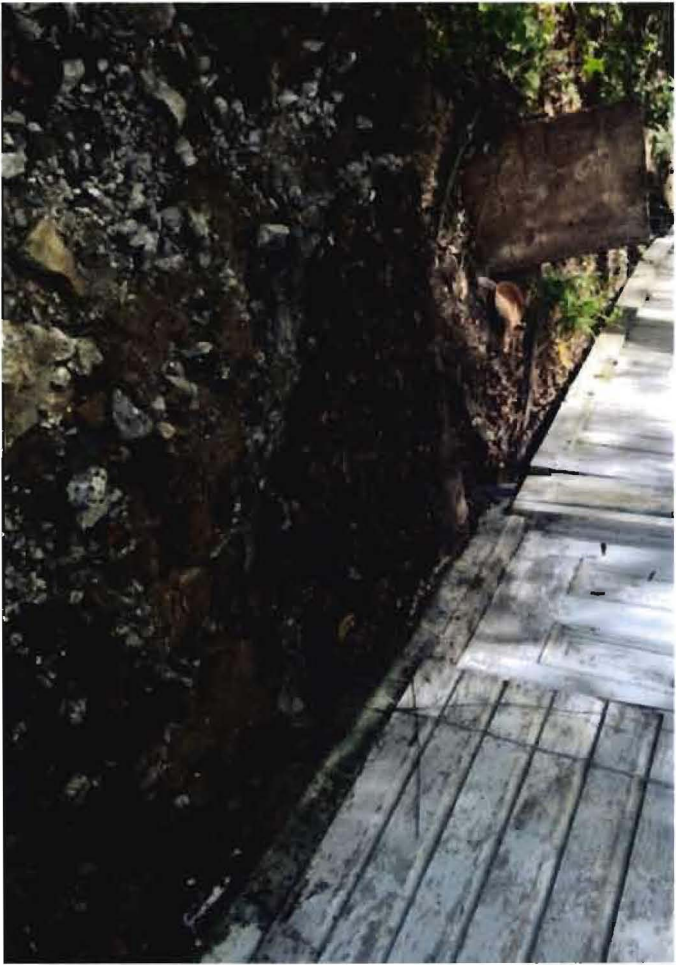
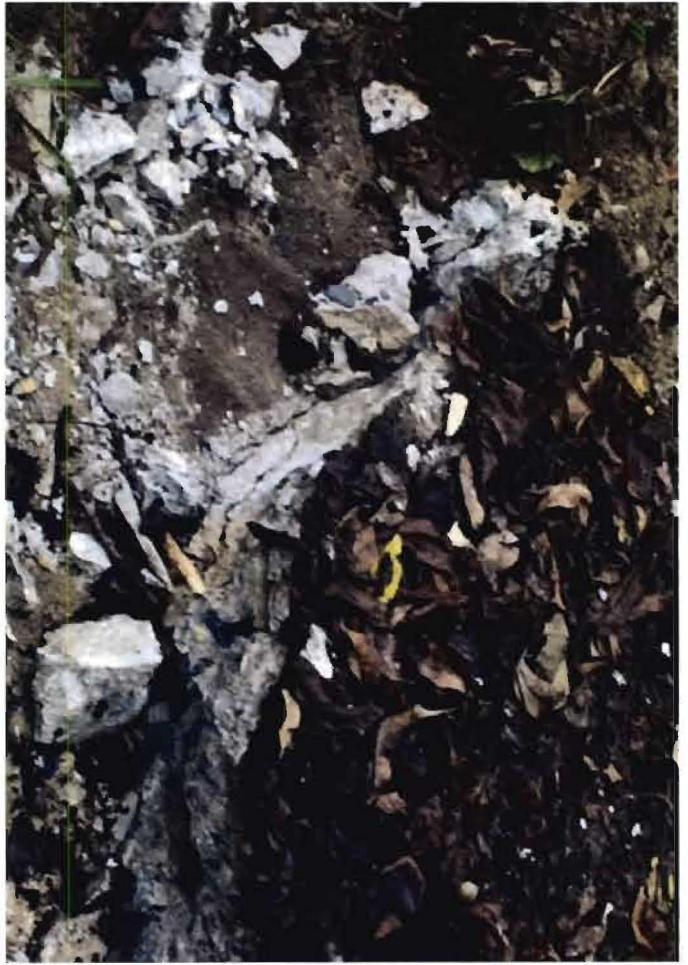
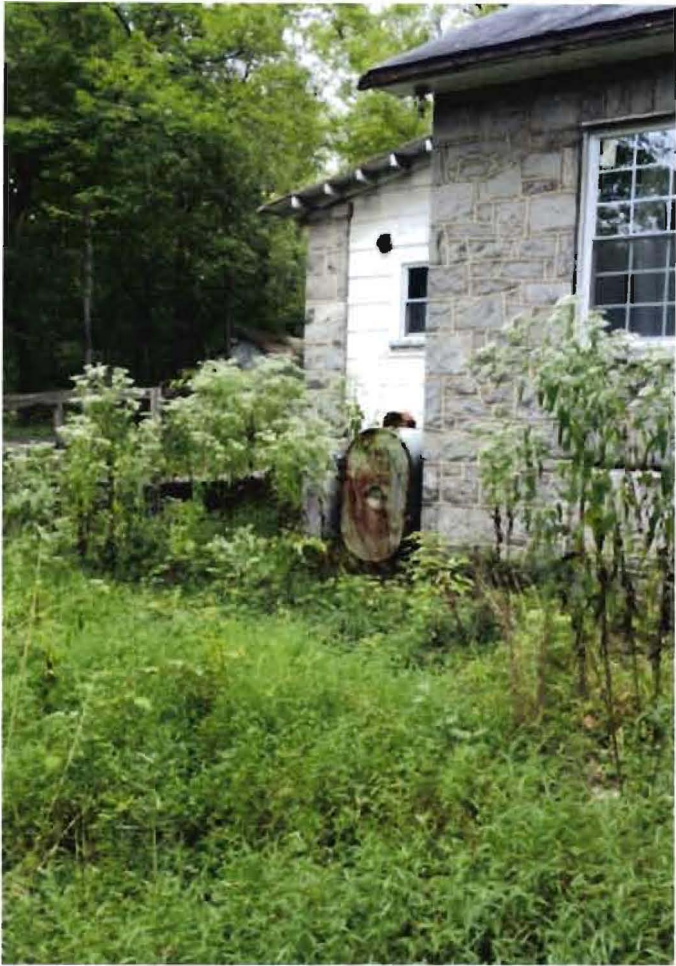
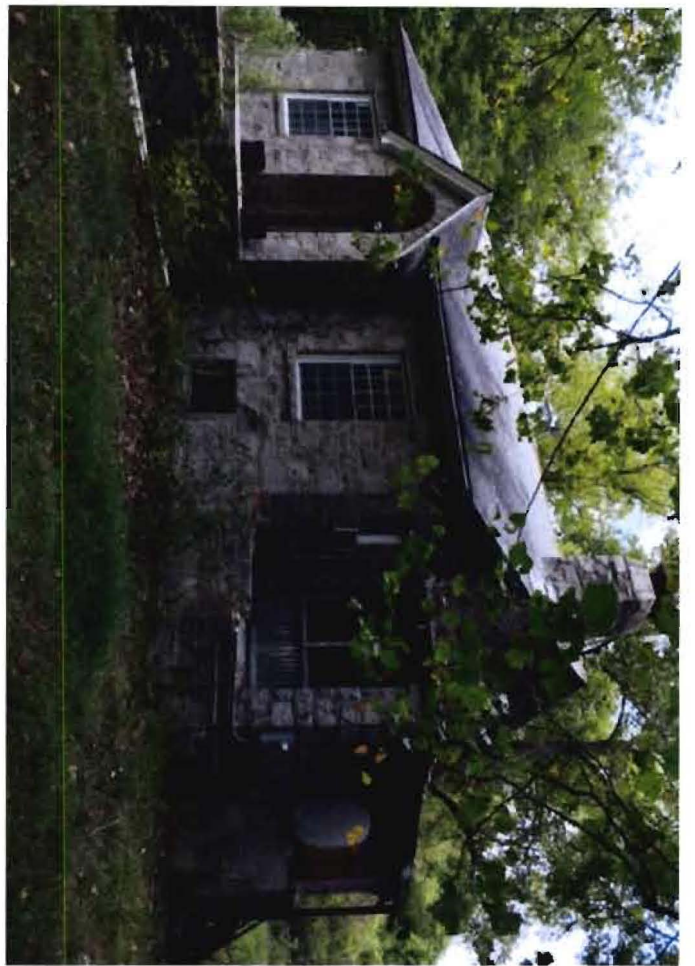
Howard County Health Dept – photos taken by R. Rappaport on 9/20/2016
9201 Old Guilford Road – Septic area which requires pump out & abandonment
