RE: Property Status for On-Site Sewage Disposal Systems: Soil conditions undetermined,  
(Tax Map 8, Parcel 266; 5.2285 acres)

Thomas Harrington  
Property  
Tax Map 8, Parcel 266  
5.2285 Acres

SITE INSPECTION SHEET

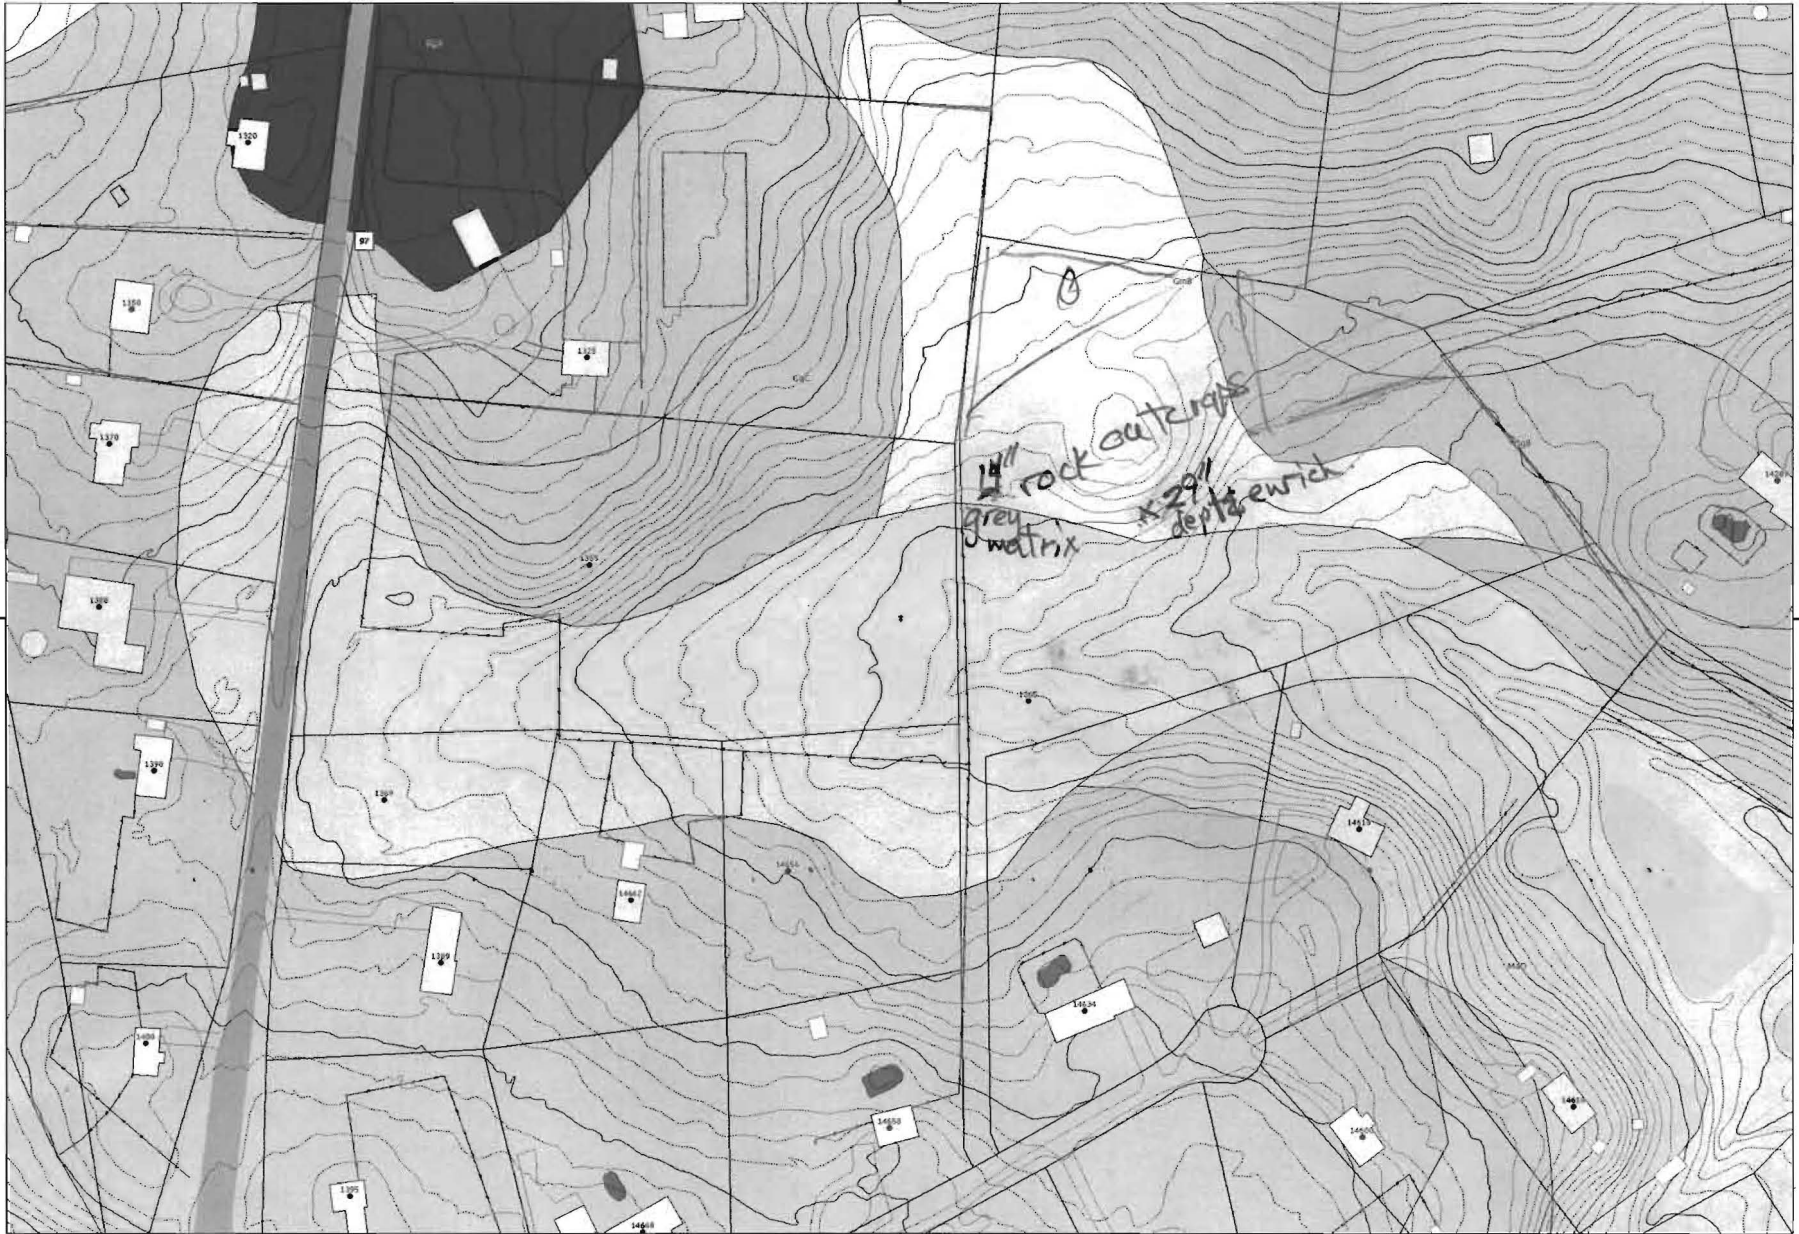
Soil properties were observed on September 20 by Robert Bricker, CPSS, REHS/RS, an Environmental Sanitarian employed by the Howard County Health Department. A hand-auger was utilized to describe soil properties to depth of observed water table at four specific locations in a meadow mapped as 'Glenelg' soil series. The meadow is at the northeast corner of the subject property, and the topography is appropriate for sand mounds. A perched water table was noted at 37 inches and at 45 inches depths respectively at auger locations '1' and '2'. The area represented is along the northern property boundary to about 60 feet downhill of the property boundary. The area represented by auger locations '3' and '4' is immediately downhill of the area represented by locations '1' and '2'. Perched water occurred at depths of 23 inches and 14 inches at locations '3' and '4', respectively.

The area represented by auger locations '1' and '2' contains at least one potential sand mound location near the northeast property corner. The area immediately to the west and uphill may be evaluated and tested for a 2<sup>nd</sup> potential sand mound location. A third potential sand mound location can be evaluated and tested near the northwest property corner.

The remainder of the subject property is unsatisfactory for wastewater disposal as it is severely impacted by shallow rock layers, shallow water tables, and well-defined drainage features.
