INFORMATION FORM - SEPTIC SYSTEM REPAIR/UPGRADE

# HOME LAND

<b>Date:</b> June 3, 2019 <b>Name of Evaluator:</b> Adam Brown <b>Time:</b> 8:00 AM <b>Property Address:</b> 3513 Hipsley Mill Road Woodbine, MD 21797 <b>Recent Weather Conditions:</b> Normal		<b>Ordered By:</b> Margaret Melvin  <b>Buyers:</b> Lisa Davis  <b>Homeowner Interview:</b> The homeowner interview was requested, but was not received prior to the evaluation.		<b>Occupied:</b> <input checked="" type="checkbox"/> Yes <input type="checkbox"/> No <b>Length of Time Vacant:</b> N/A <b># of People Living in Home:</b> 3 <b># of People moving in:</b> 2 <b>Property Age:</b> 1964 <b>System Age:</b> Unknown <b>Last Date of Cleaning:</b> Unknown <b>Recomm'd Pumping Freq:</b> 1-2 Years	
<b>Liquid level in tank is:</b> <input type="checkbox"/> Above Normal <input checked="" type="checkbox"/> Normal <input type="checkbox"/> Below Normal			<b>Bottom Solids Depth:</b> 36 Inches		
<b>Depth of tank:</b> 22 Inches		<b>Type of Tank Access:</b> Lid On Tank		<b>Depth of tank access:</b> 22 Inches

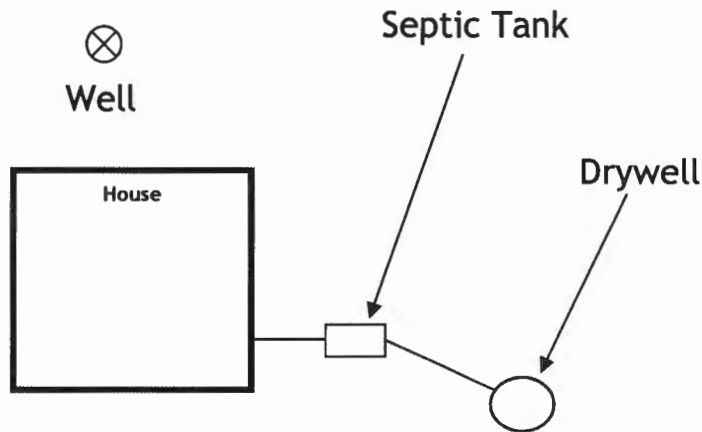
### Sketch of System

Shows the septic tank to be located in close proximity to the dwelling and trees. This may make future repairs difficult.
