Bureau of Environmental Health

RECEIPT DATE: 2/26/20 ONSITE SEWAGE DISPOSAL SYSTEM P 567325

APPROVAL DATE: 3/9/2020 PERMIT: REPAIR A

PROPERTY ADDRESS: 6392 Guilford Road

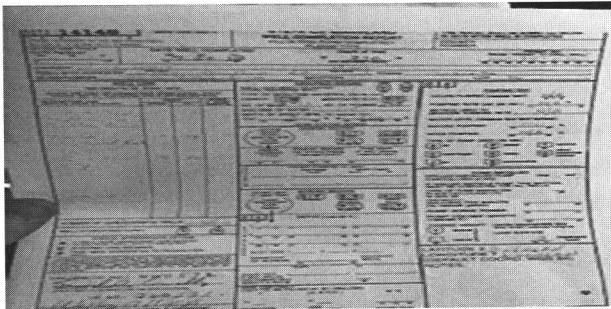
Picture 6:

Shows the records for the well provided by the buyers at the time of the evaluation for the property at 6392 Guilford Road, Clarksville, MD 21029.

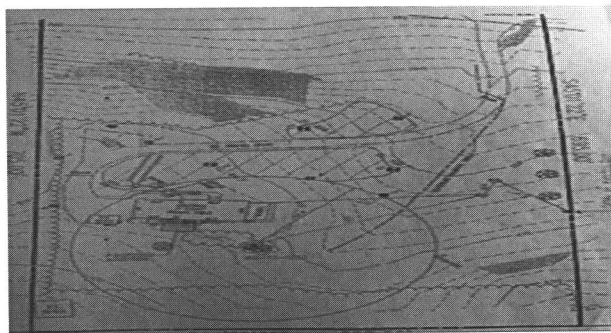
Picture 7:

Shows the records for the septic system provided by the buyers at the time of the evaluation for the property at 6392 Guilford Road, Clarksville, MD 21029.

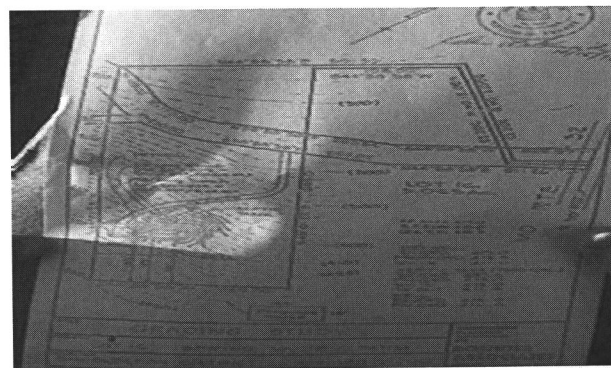
Picture 8:

Shows the records for the septic system provided by the buyers at the time of the evaluation for the property at 6392 Guilford Road, Clarksville, MD 21029.
