RECEIPT DATE: 2/26/21 **ONSITE SEWAGE DISPOSAL SYSTEM** P 568774

APPROVAL DATE: 03/10/2021 **PERMIT: REPAIR** A \_\_\_\_\_

PROPERTY ADDRESS: 17740 Hardy Road

<b>Date:</b> February 8, 2021 <b>Name of Evaluator:</b> David Vincent <b>Time:</b> 9:00 AM <b>Property Address:</b> 17740 Hardy Road Mount Airy, MD 21771 <b>Recent Weather Conditions:</b> Snow		<b>Ordered By:</b> Charlie VanSwol  <b>Buyers:</b> William Van Cleave  <b>Homeowner Interview:</b> The homeowner interview was requested but was not received prior to the evaluation.		<b>Occupied:</b> <input type="checkbox"/> Yes <input checked="" type="checkbox"/> No <b>Length of Time Vacant:</b> ~6 Months <b># of People Living in Home:</b> N/A <b># of People moving in:</b> 4 <b>Property Age:</b> 1975 <b>System Age:</b> Unknown <b>Last Date of Cleaning:</b> Unknown <b>Recomm'd Pumping Freq:</b> 2-3 Years	
<b>Liquid level in tank is:</b> <input type="checkbox"/> Above Normal <input type="checkbox"/> Normal <input checked="" type="checkbox"/> Below Normal		<b>Bottom Solids Depth:</b> 13 Inches			
<b>Depth of tank:</b> 17 Inches		<b>Type of Tank Access:</b> 6" Cleanouts (2)		<b>Depth of tank access:</b> At Grade

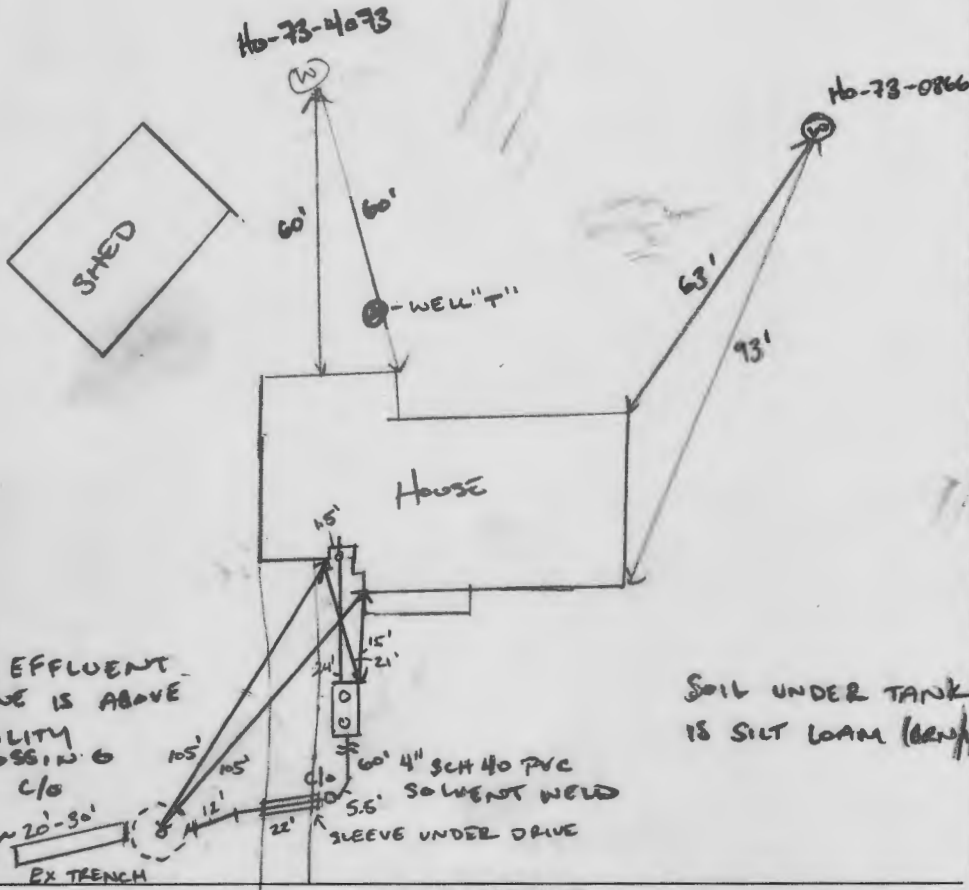
EXISTING	TRENCH/DRAINFIELD DATA		
	WIDTH	INLET	BOTTOM
	2'	~4.5-5'	
	NUMBER OF TRENCHES 1		
	TOTAL LENGTH UNKNOWN ~20-30' (?)		
	ABSORPTION AREA + EX DRY		
	DISTRIBUTION BOX LEVEL WELL		
	DISTRIBUTION BOX BAFFLE -		
	DISTRIBUTION BOX PORT -

03/09/2021 REPLACED FRONT LINE W/ SCH 40 PVC AND ADDED CLEANOUT.
