RECEIPT DATE: 4/26/2022    **ONSITE SEWAGE DISPOSAL SYSTEM**    P 571515

APPROVAL DATE: 5/5/22    **PERMIT:**    **REPAIR**    A Repair

PROPERTY ADDRESS: 13416 Arada Court

## Onsite Disposal Inspection

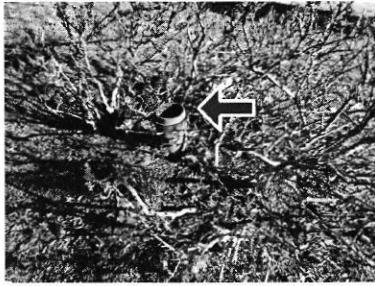
### 3.8 SOIL ABSORPTION SYSTEM OBSERVATIONS

UNACCEPTABLE

Water level in septic tank when it failed.

The soil absorption system and drywell have failed. Water backflowed into the septic tank after only 175 gallons of water. A normal septic inspection with an occupied home should take 300 gallons of water. Contact a licensed septic company for repairs.

Damaged observed to driveway in the same areas the drain pipes from the septic run. Damage was observed to pipe between septic and drywell. There is no way to access the drain from the drywell to drainfield. Water was still making it to the drywell. Contact a licensed septic company for repairs.

Due to the age of the septic system and the failed soil absorption system and damaged drains a whole new system may be recommended by the county. Homeowner said septic company that pumped it mentioned there may be a problem with the septic. This is for your information.
