**INSPECTION OF THE  
ASBESTOS CONTAINING ACOUSTICAL PLASTER CEILING  
AT THE ABBOTT HOUSE APARTMENT BUILDING  
4539 CEDAR LANE IN COLUMBIA, MARYLAND**

**COLUMBIA RESIDENTIAL MANAGEMENT, INC.  
AND  
COLUMBIA CEDAR LIMITED PARTNERSHIP  
POST OFFICE BOX 1816  
COLUMBIA, MARYLAND 21044-0816**

**ENERGY VENTURES ANALYSIS, INC.  
1901 N. MOORE STREET, SUITE 1200  
ARLINGTON, VIRGINIA 22209-1751**

**AUGUST 1988**

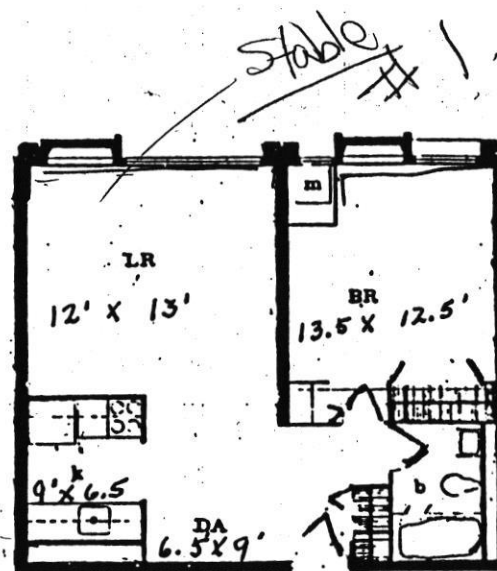
#312  
**1 BEDROOM**

COND RATING	APT #	CRACKS ALONG WALL & SEAMS	PAINT OVER CRACK (Y/N)	SCRAPS ON CEILING (Y/N)	SCRAP COND- ITION (Y/N)	PARTIAL DETACH FLAKES (Y/N)	AREA (FT2)	FLAKING FOUND (Y/N)	REMARKS- CEILING TREATMENT CONDITION IN EACH APARTMENT
1	301 S			N		N	0	N	Crack repaired
1	302 S		Y	Y	paint	N	0	N	Some scraps but painted over and stable
1	303 S			Y	good	N	0	N	Some scraps but all stable. Air sample taken showed ambient total fiber concentration of 0.002 f/cc which is 50 times below OSHA's action limit for asbestos.
1	304 S			Y	Good	N	0	N	Minor stable scrapes. Minor stable crack in master bedroom
1	305 S			N		N	0	N	Minor stable cracks
0	306						0		No access to apartment during inspection
1	307 S			N		N	0	N	Minor cracks- all stable
1	308 S			N		N	0	N	Minor cracks- all stable
1	309 S			N		N	0	N	Minor cracks- all stable
1	310 0			N		N	0	N	No cracks
1	311 S			N		N	0	N	Minor cracks- all stable.
1	312 S			N		N	0	N	Minor cracks- all stable

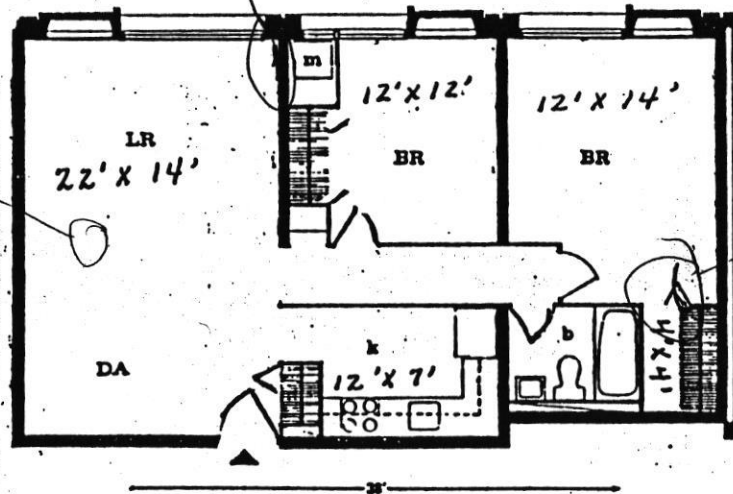
*#1 Stable cond.*

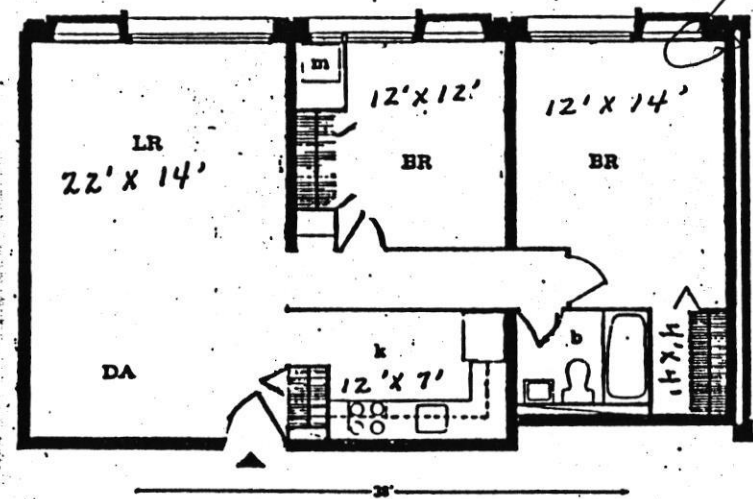
#410

1	407	S		N		N	0	N	Minor Cracking- all stable
1	408	S		N		N	0	N	Some holes in ACM but all stable
1	409	S		N		N	0	N	Minor cracking- all stable.
1	410	S		N		N	0	N	Patch missing in corner of master bedroom. Stable
1	411	S		N		N	0	N	Patch missing adjacent to vent- all stable and painted over.
1	412	S		Y		N	0	N	Prior scrapes are stable. Minor cracking- all stable
3	4H	Y	P	Y		Y	0	N	North Corridor- Scrapes by 404/403 have partially detached flakes. Condition rating #2. Remaining cracks minor and stable. West Corridor- Seam by fire door is partially detached. Condition rating #2. Remaining cracks minor and stable. SE Corner- Damaged area by window with partially detached flakes. Condition rating #3. Air sample showed ambient total fiber concentration was 0.002 f/cc which 50 times below EPA action level for asbestos of 0.1 f/cc. North Foyer- Minor cracking and some scrapes. West Foyer-Cracks minor and stable. Condition rating #1.

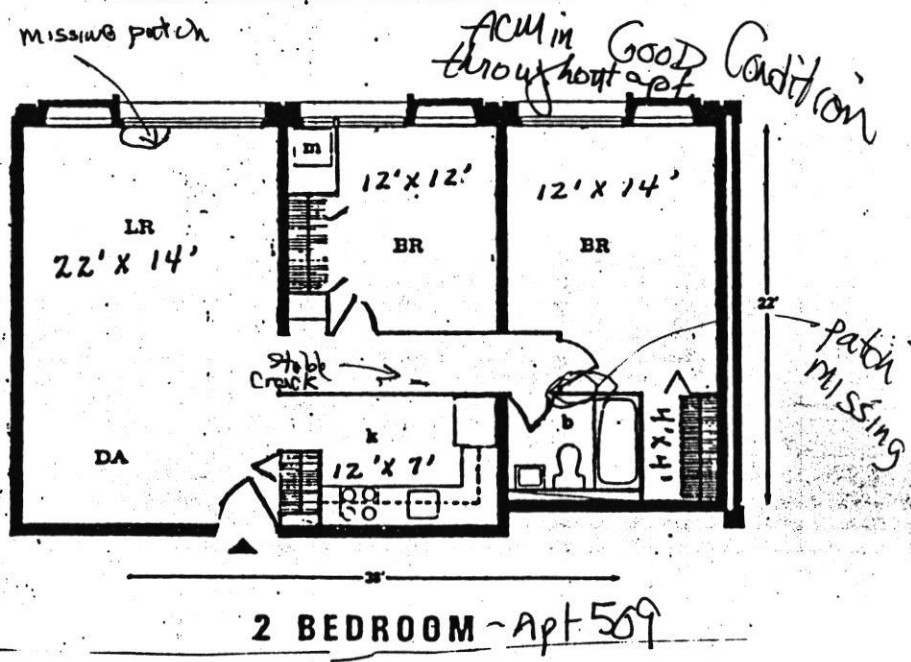
COND #1

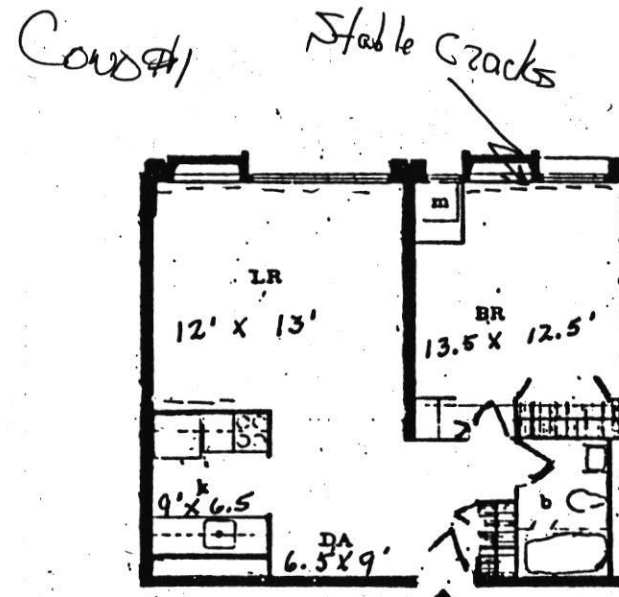
1 BEDROOM - Apt 510

1	510 S			N		N	0	N	Only stable cracks observed along outer walls and ceiling
1	511 S			N		N	0	N	Minor cracks all stable
1	512 S			N		N	0	N	All stable cracks along windows
3	5H Y	Y		N		Y	12	Y	North Exit Foyer- West wall has area 7 ft by 3.5 ft with unstable crack with pressure from door closing. South and North walls have cracks with partial detached flakes. Condition rating #3. Dust samples had no detectable asbestos. Air samples verify no fibers were being released as air concentrations for total fibers were below detectable limits. SE Corner- 0.5 sq-ft area was damaged and patched. Partial damage Copndition rating #2 West hallway- seam crack between 508/511 partially detached, end of corridor seam crack stable but discolored. Condition rating #2. West Exit Foyer- Crack along all 4 walls which are active when door is shut in stairway/corridor. Condition rating #2. Dust samples showed no detectable levels of asbestos. North Corridor- Seam crack between 503/504 shows signs of

COND #1

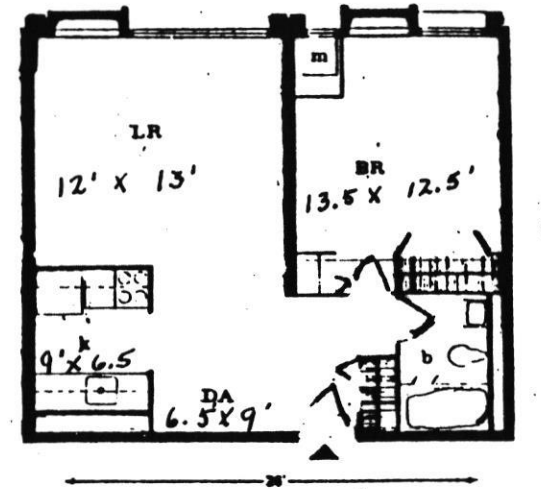
Apt 707

*mirrors painted over.* *2 flakes. P.D. #2*
