SITE INSPECTION SHEET

PROPOSAL: Site inspection done to verify septic functioning ok.

OWNER: PROP. TRANSFER PHONE #: \_\_\_\_\_  
 ADDRESS: 12203 ETCHINSON CONTRACTOR: HATFIELDS  
ELICOTT CITY WELL TAG #: \_\_\_\_\_  
 SUBDIVISION: \_\_\_\_\_ LOT: \_\_\_\_\_ COUNTY #: (111)  
 PROPOSAL: PROP. TRANSFER; EVALUATING SYSTEM PERC

Subject: Percolation Certification Plan  
Woodmark, Lot 28 Section II, Block B, Csanady Property

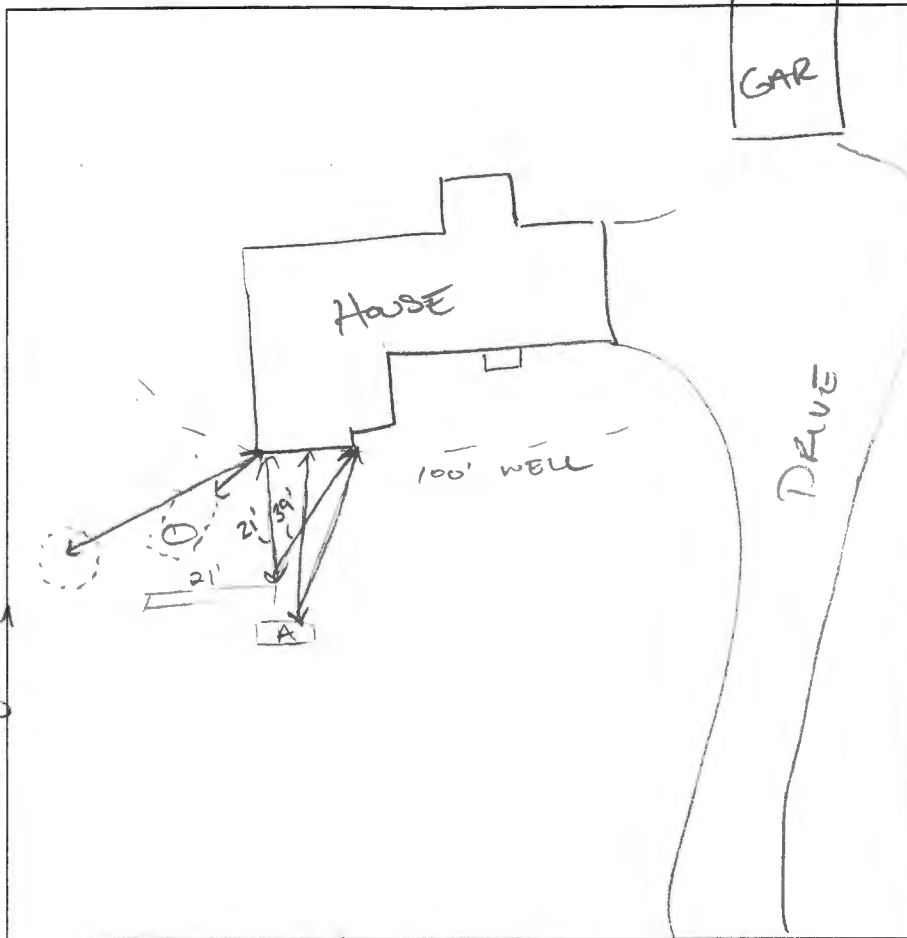
✓ AUGER

48" RED YEL SCL FEW MICA

96" YEL LBEN SAP FEW MICA WK FR SANDY LOAM

126" YEL BRN LOAMY SAND

144"

SHELF/PIT BOTTOM

DATE	TEST #	DEPTH	START	BREAK 1" DROP	STOP 2" DROP	TIME OF 2ND INCH	P/F/H
11/25/2000	A	4' / 12'	0:00	2:06	5:17	3:11	P

REMARKS REP SYSTEM BTWN 100' + 200' WELL SET BACKS 1x84' TR
