LANGENFELDER
12640 RT. 108
CLARKSVILLE

HOWARD COUNTY HEALTH DEPARTMENT

During the course of the recent septic repair inspection (repair approved, copy of inspection report enclosed), a well construction defect was observed.

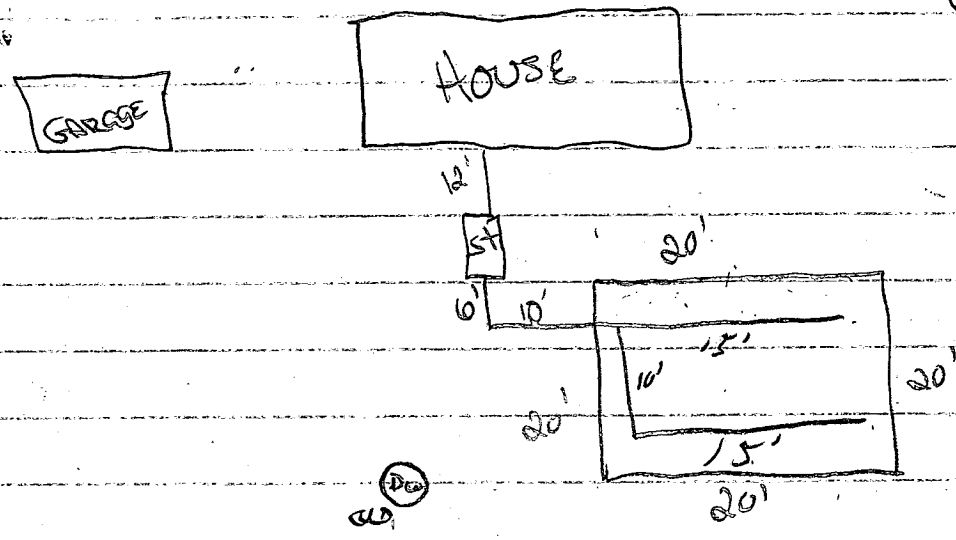
①
Test hole
water at
10.5 ft
5-9-90

5-9-90
Well cap
cracked, flush
w/ ground, open
to contamination
JEN

REMARKS 5-9-90 Leaching bed 6.5 ft deep at upper end, 4.5 ft deep at lower end. Existing drywell to be abandoned with leaching bed connected to existing septic tank. JEN 6-29-90 Contractor indicated depth to inlet is 2.5 ft from original grade and drywell had been abandoned. JEN

Depth to Inlet $2\frac{1}{2}$, to $5-5\frac{1}{2}$
