DATE	TEST #	DEPTH	START	BREAK 1" DROP	STOP 2" DROP	TIME OF 2ND INCH	P/F/H
2/10/17	(A)	76 14V	00:38	00:42	00:48	6	P

TEST HOLES USED IN SDA 1 AVG. PERC TIME 6 SQ. FT/BR 0.85/ft²

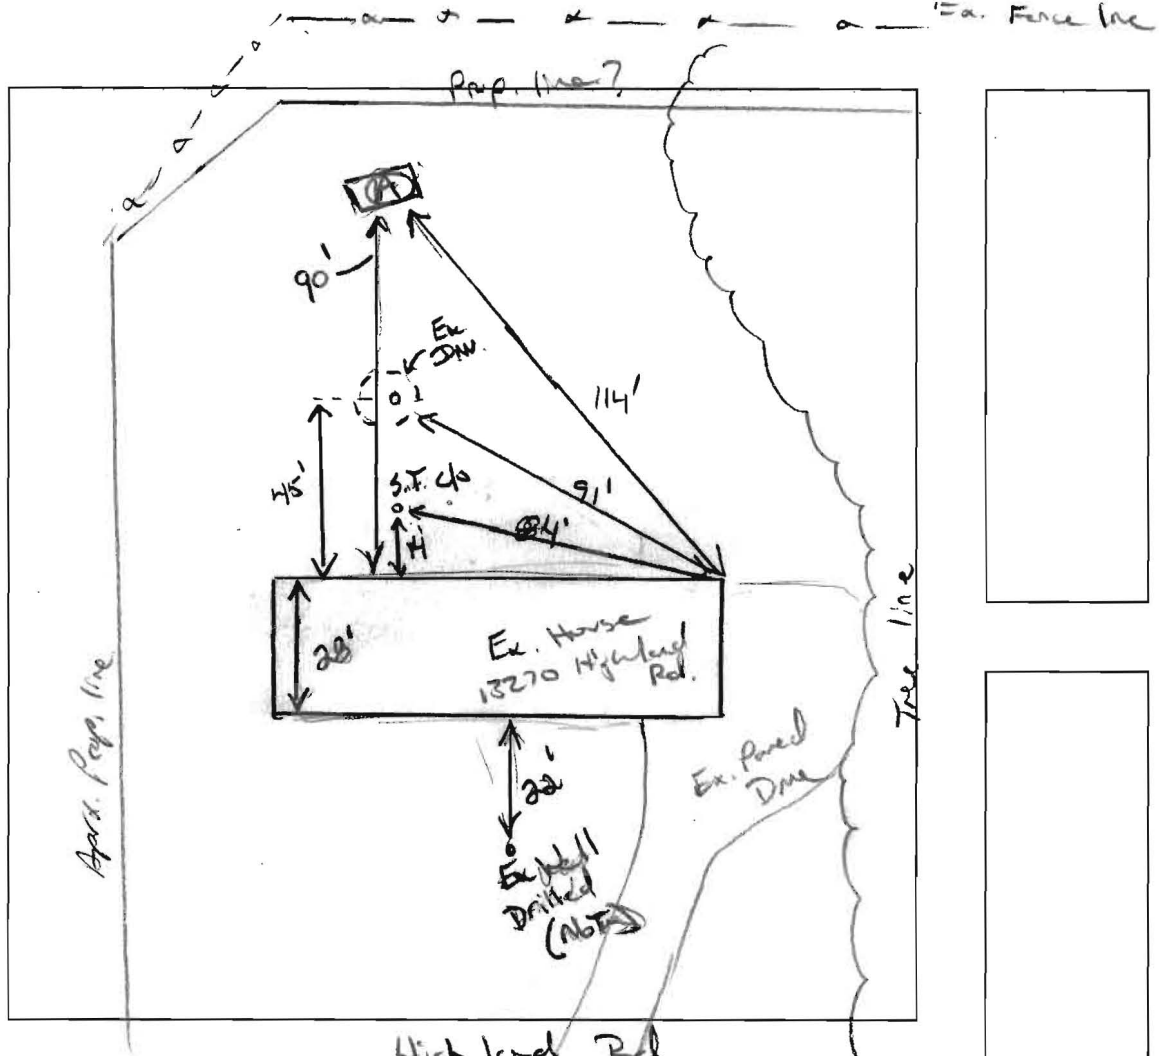
(A)

8" wk sm roots
roots, msbl
Strs Brck
Frickle, low
Furniture
Prop. roots

3'
Br/Rd L,
msbl.

6'
roots
L Br/Y FSL
very possible, prop.
roots, wk pl
micaceous, sm

10'
L Br/Y/R VFSL
consistent, prop

14'
