STATE OF MARYLAND WELL COMPLETION REPORT

OWNER: Bates Bruce, STREET OR RFD: Blights Ln., TOWN: Fulton, SUBDIVISION: Beaufort Park, SECTION: , LOT: 53

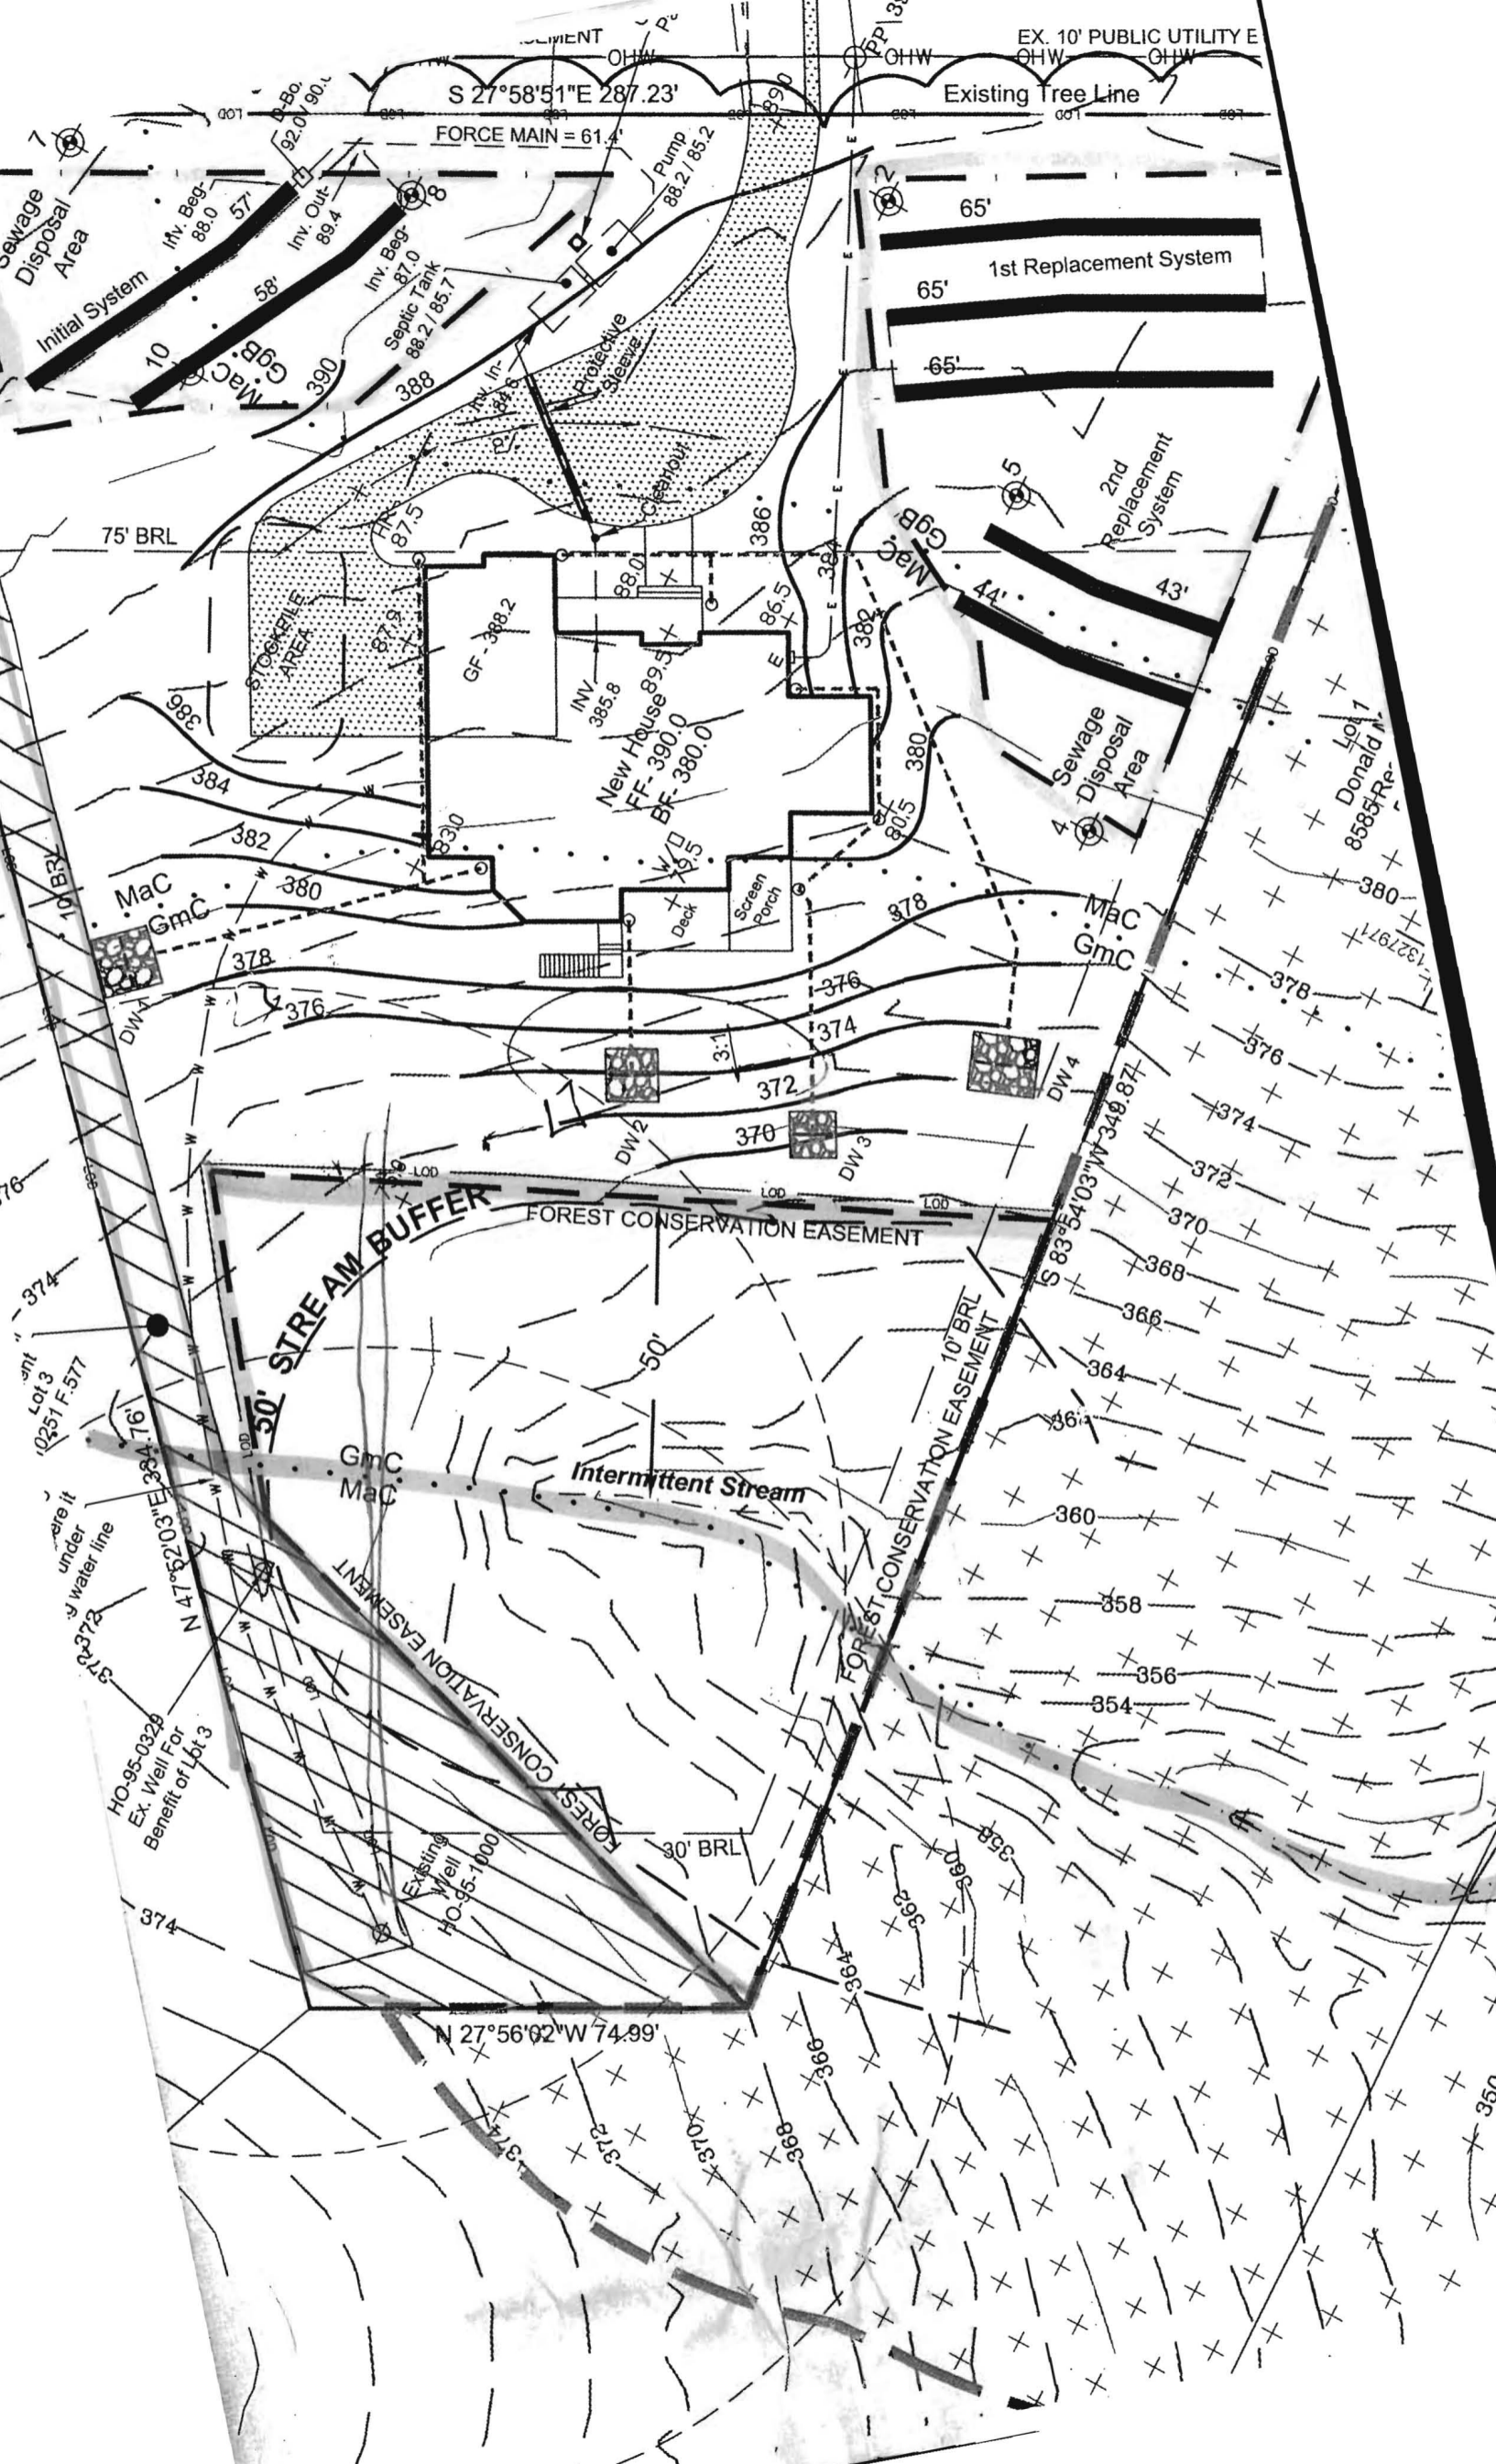
S 27°58'51"E 287.23'
FORCE MAIN = 61.4'

EX. 10' PUBLIC UTILITY E
OHW OHW OHW
Existing Tree Line

65'
65'
65'
1st Replacement System

2nd Replacement System
