# APPLICATION

## SEWAGE DISPOSAL TESTING

STATE OF MARYLAND - DEPARTMENT OF HEALTH AND MENTAL HYGIENE

ROAD AND DESCRIPTION Highland Road - approx. 1/4 mile from Brighton Dam Road - on left side - several lots past Nichols Drive

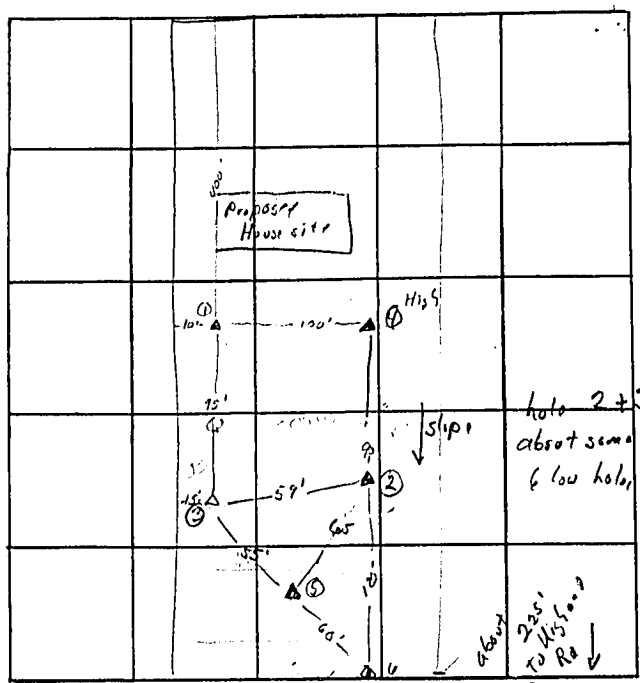
1. - 0 clay loam  
 + 2'  
 - 4' mix  
 ↓  
 grading  
 from  
 surface  
 into  
 sandy loam  
 - 11%

INDICATE NORTH. - NAME ADJOINING ROADWAY AS BASE LINE  
 Highway Rd.

REMARKS no good soil at 3'

TYPE OF SOIL All sandy loam with a 6 silt band in all visual holes
