**OWNER**  
 Robert A. Schremp  
 6883 Haviland Mill Road  
 Clarksville, Md. 21029

**PERCOLATION CERTIFICATION**  
 SCHREMP PROPERTY  
 5th Election District  
 Howard County, Maryland  
 Scale: 1" = 100' Date 1-7-83 Pnn: TGH

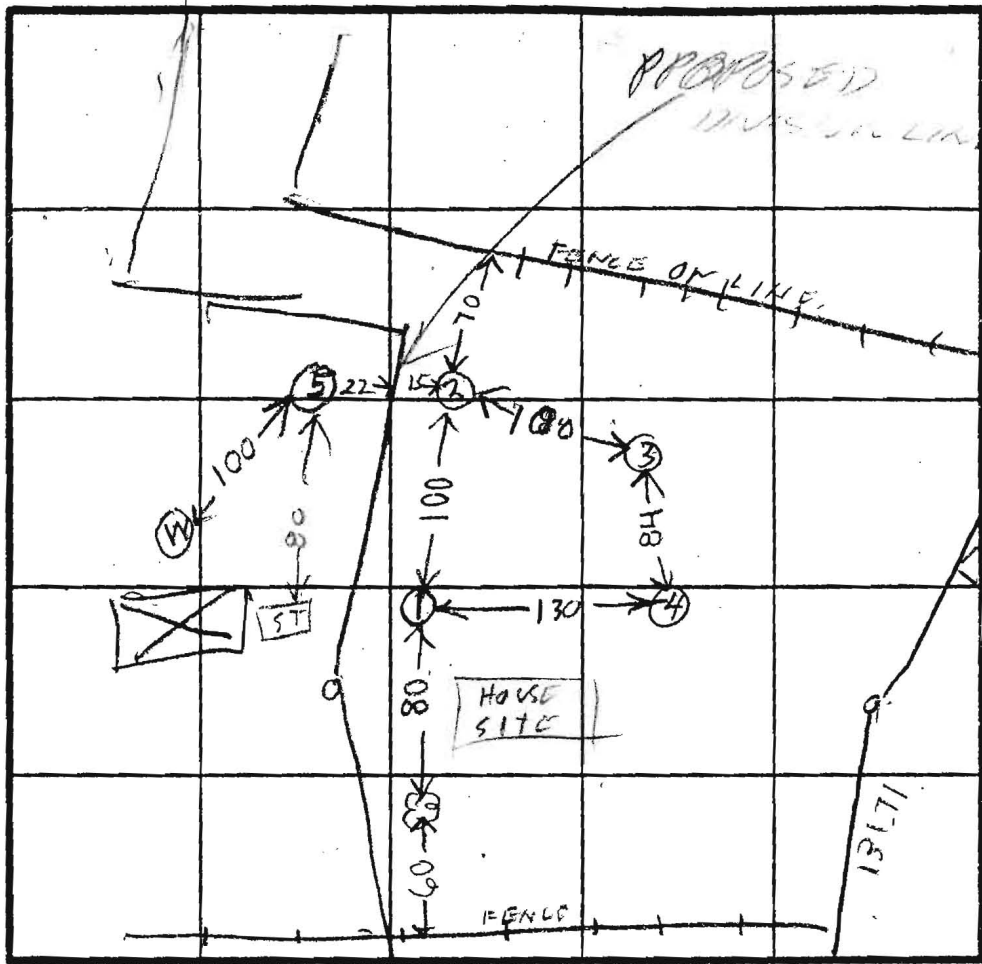
DATE	TEST NO.	DEPTH	PRE-WET		TEST - 1" DROP		TIME
			START	STOP	START	STOP	
11/1/82	1S	2	1020	1022	1022	1024	2
	1D	5 1/2	1020	1021	1022	1025	3
	1V	12 1/2	LOOKS	OK	SEE	SOIL PROFILE	
	2S	3	1028	1029	1029	1031	2
	2V	1-1	LOOKS	OK	SEE	PROFILE	
	3S	2	1032	1034	1034	1037	3
	3V	12 1/2	LOOKS	OK	SEE	PROFILES	
	4V	12 1/2	LOOKS	OK	SEE	PROFILES	
	5V	12 1/2	VISUAL HOLE ON EXISTING				
			HOUSE LOT	LOOKS	OK	SEE	PROFILE

REMARKS: EXIST HOUSE LOT IS OK GOOD VISUAL HOLE & NO OVERFLOWING SEWAGE

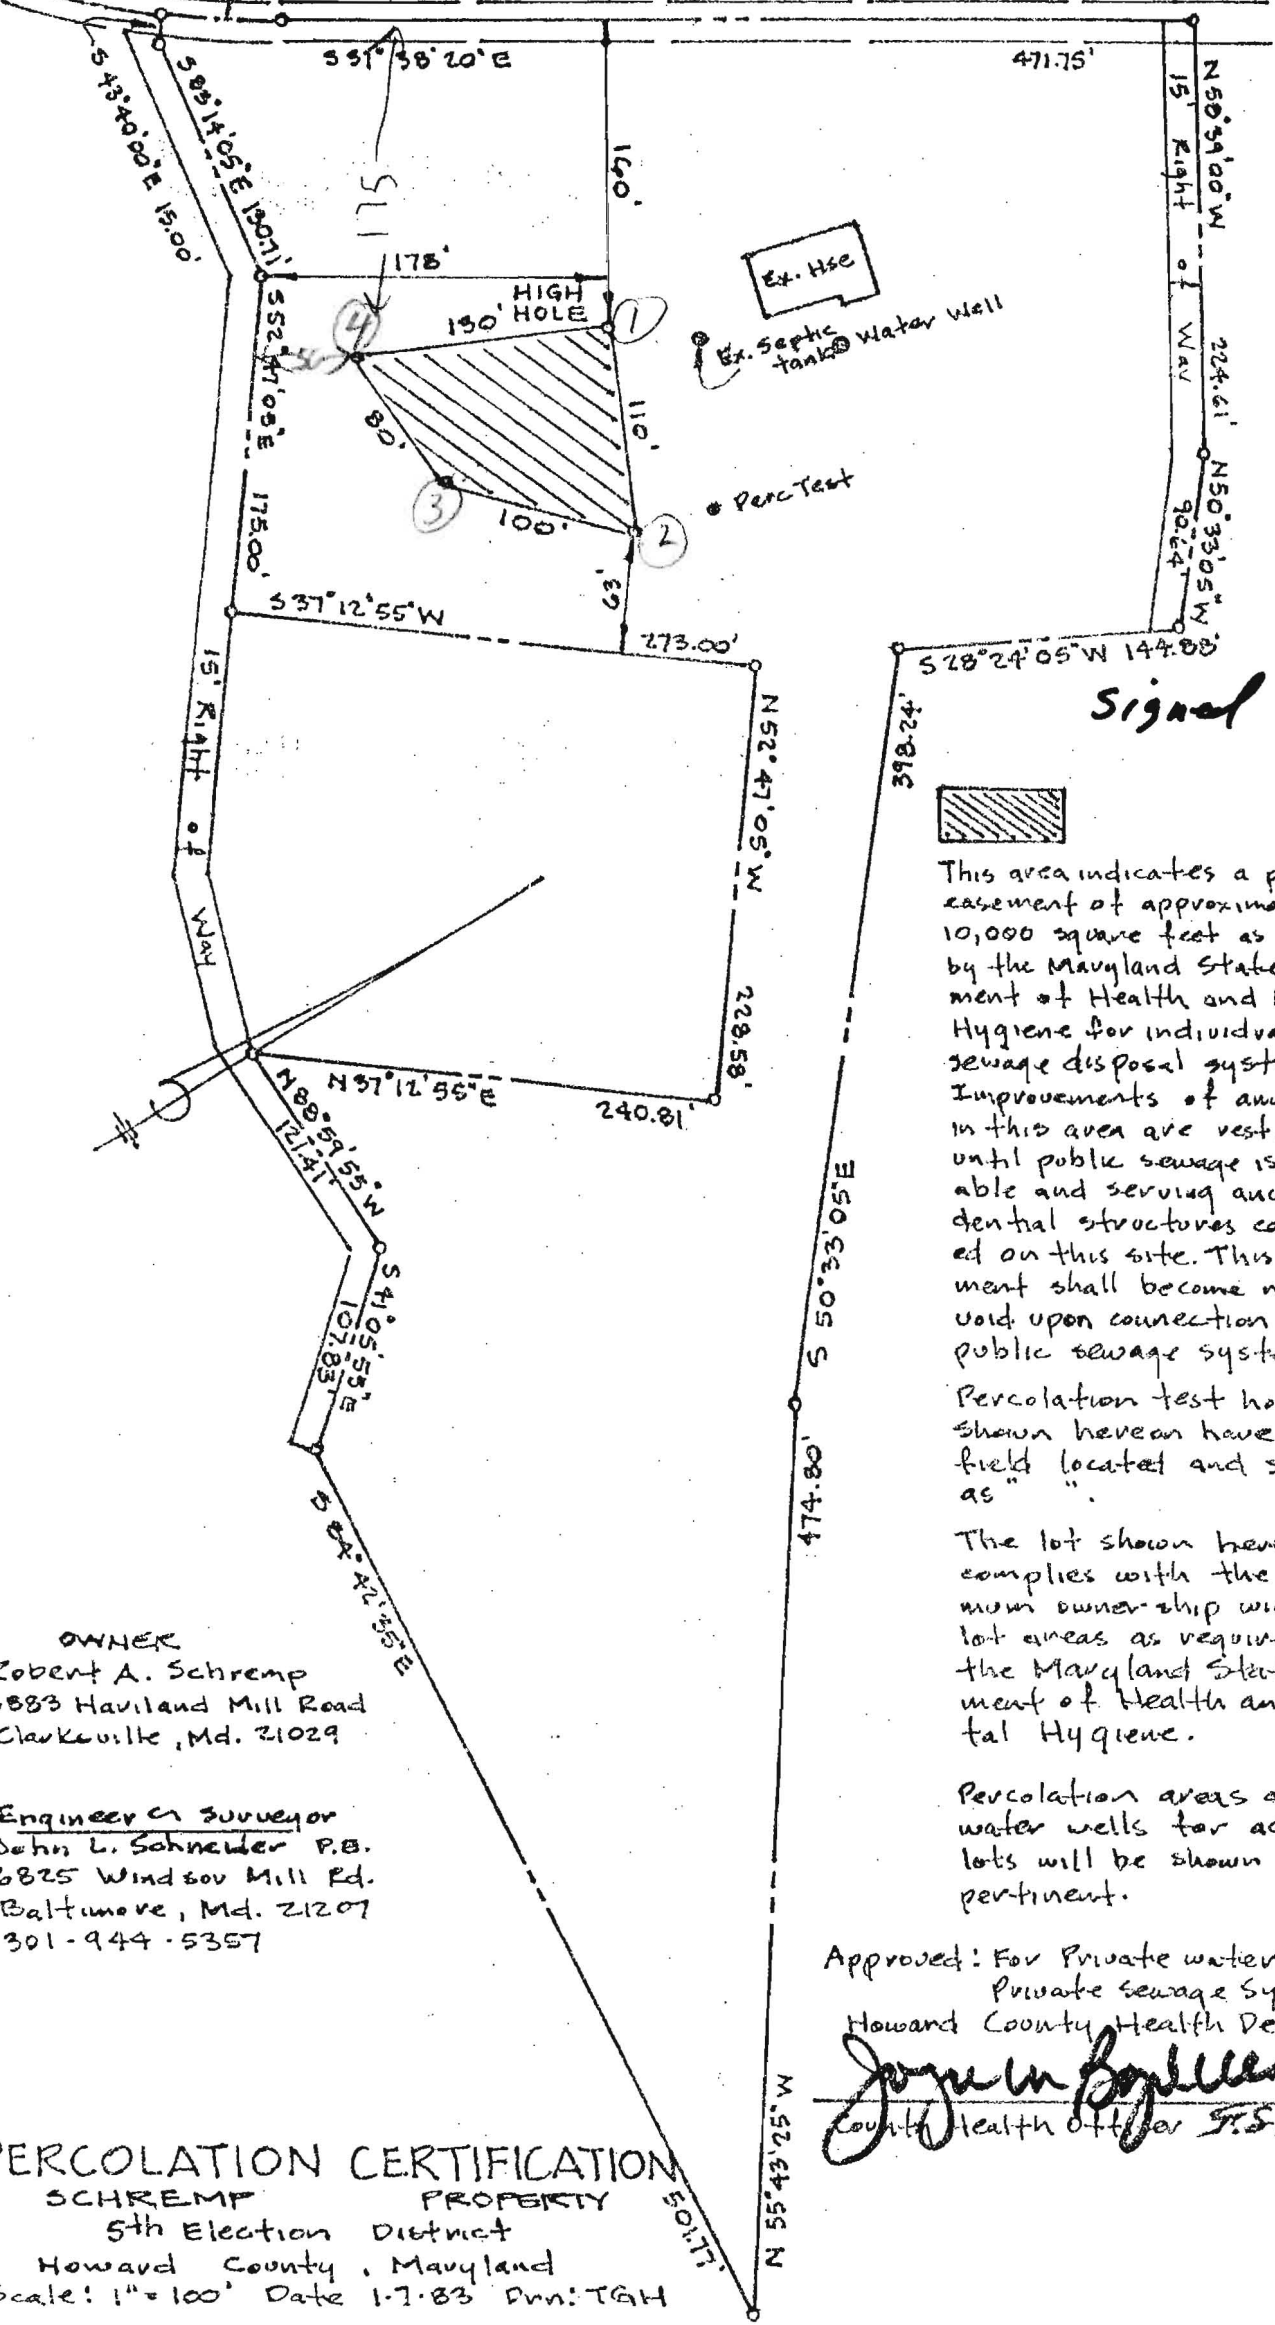
INDICATE NORTH - NAME ADJOINING ROADWAY AS BASE-LINE.

- ① = HIGHEST
- ② = LOWEST
- ③④ = MEDIUM
